# LICENSEE EVENT REPORT (LER)

Washington Nuclear Plant - Unit 2

MANUAL REACTOR SCRAM DUE TO CORE INSTABILITY

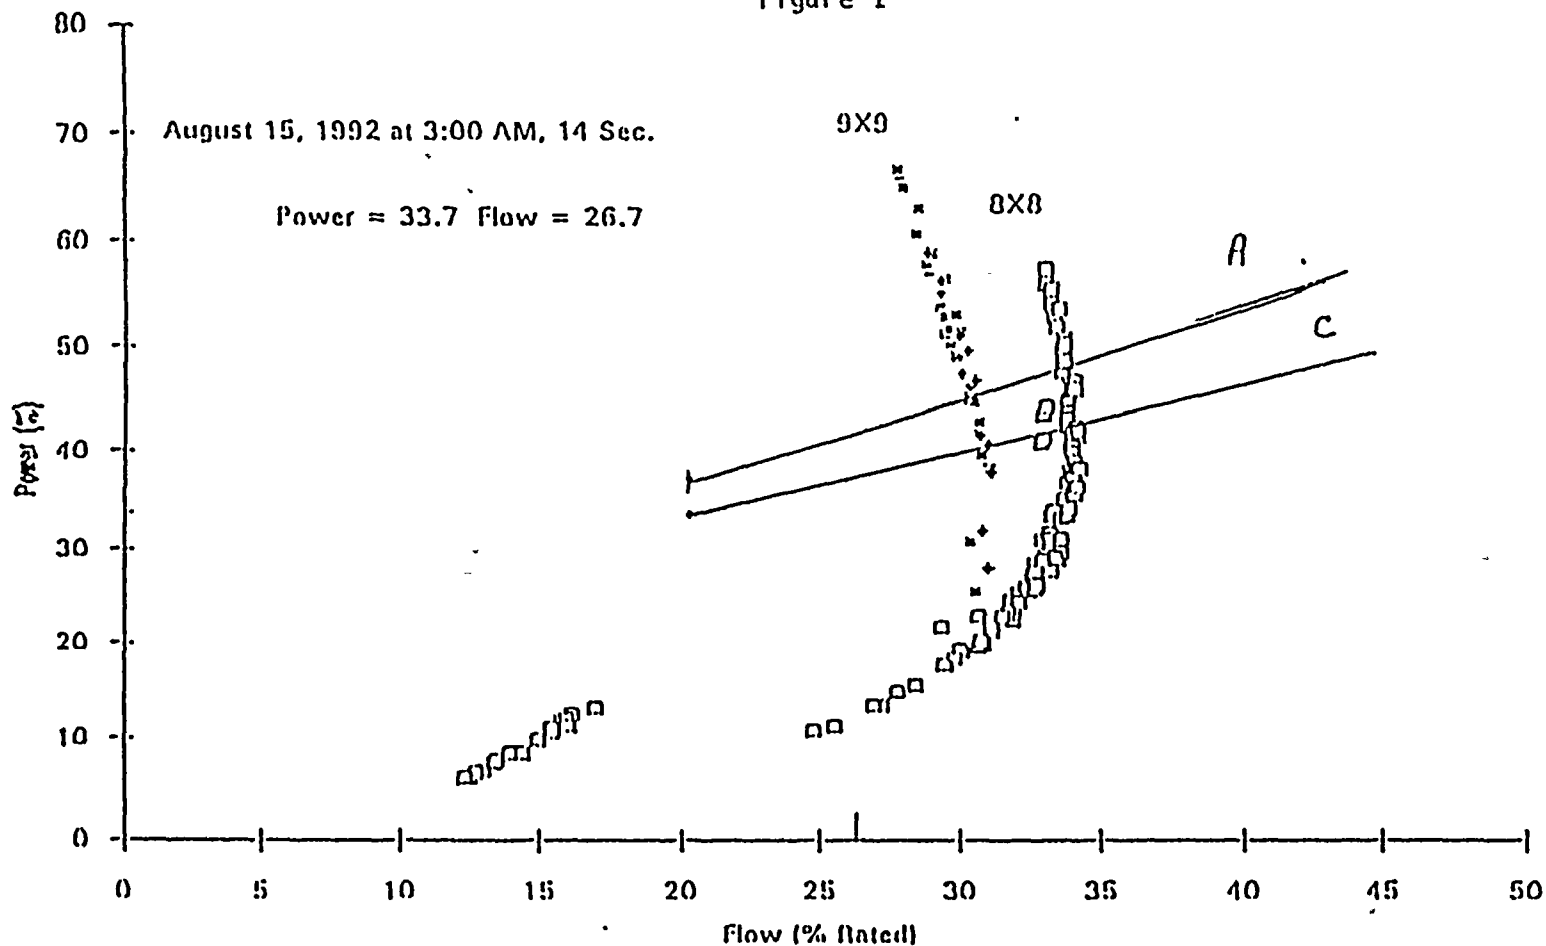
Figure 1

3. Further evaluation found that radial and axial flux profiles established in the core and the core and fuel assembly design, combined to cause thermal-hydraulic induced power oscillations. The rod pattern selected caused the 9x9 bundles to be operating at higher power levels than the 8x8 fuel resulting in significantly reduced flow due to 1) higher pressure drop across the 9x9 bundle, and 2) higher power level per bundle causing increased flow resistance. Specifically, the 9x9 bundles in the core have a greater hydraulic pressure drop across them as compared to the 8x8 design. Currently in Cycle 8, WNP-2 has about 26% of its core with 9x9 design and the remaining 74% of the core is 8x8 design including 12 LFAs. As can be seen from the attached Figure 1, a significant

number of assemblies were operating at high power and relatively low flow. Thus, a number of individual assemblies were actually operating in the region where instabilities can occur. Enough individual assemblies reached the point of hydraulic instability and the overall core flux oscillations followed.
