SUBJECT: LER 88-031-01: on 880902, determined that due to single failure CR HVAC sys could operate in recirculation mode. Caused by lack of communication between AE design groups. CR HVAC recirculation mode of operation analyzed. W/930212 ltr.

**SUBJECT: NUCLEAR PLANT WNP-2, OPERATING LICENSE NPF-21
LICENSEE EVENT REPORT NO. 88-031-01**

TITLE (4)
SINGLE FAILURE COULD CAUSE CONTROL ROOM HVAC TO OPERATE IN AN UNANALYZED OPERATION MODE DUE TO DESIGN

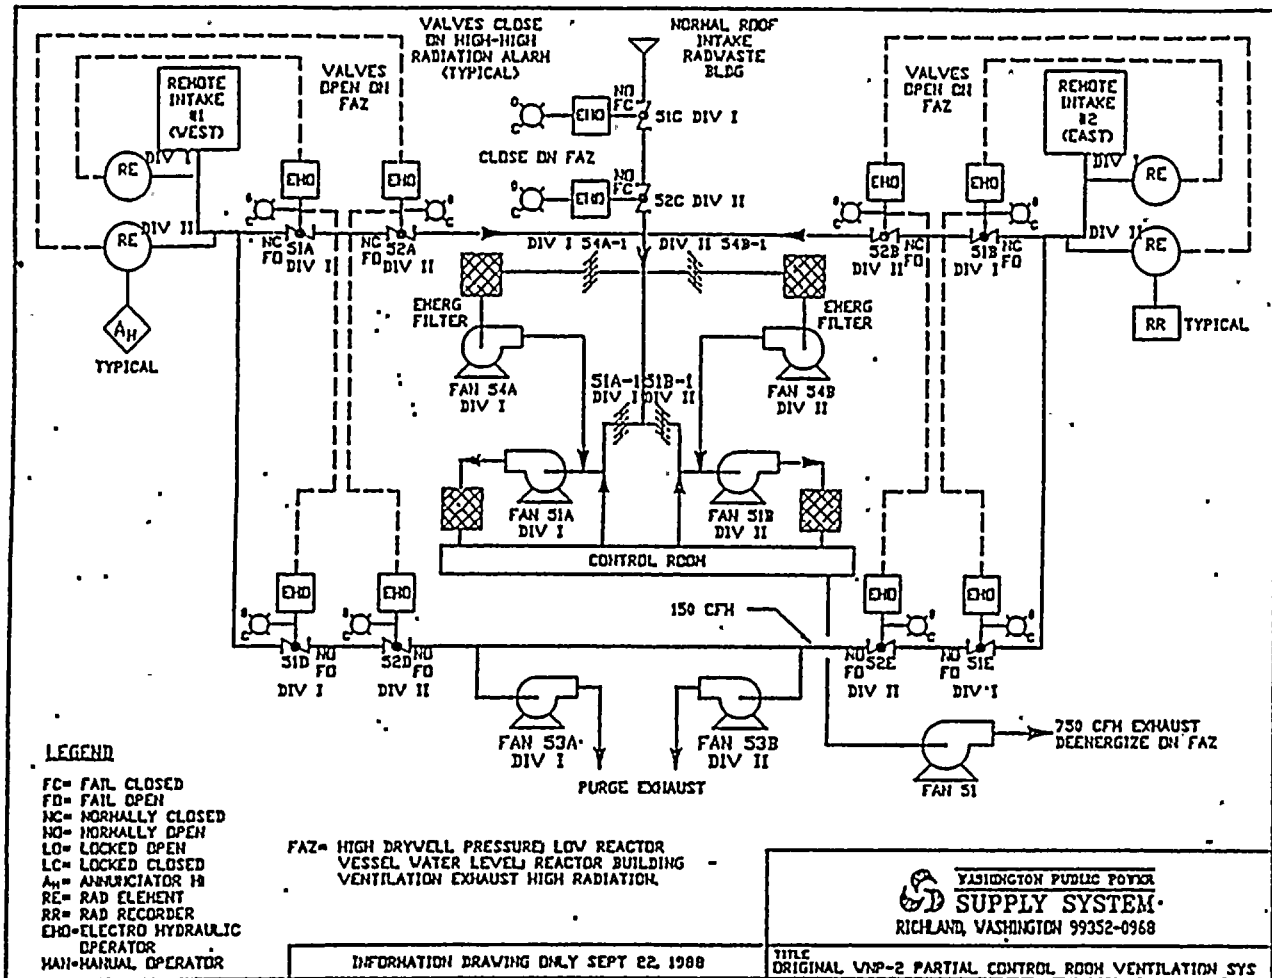
The following brief description of the Control Room HVAC System (before modification) for normal operation and emergency operation during a Loss of Coolant Accident (LOCA) is presented to aid in understanding the event and the changes made to the system. Figure 1 is a partial diagram of the Control Room HVAC System prior to the event. The Control Room HVAC System consists of two redundant systems for both normal and emergency operation. During normal operation, 1000 cfm of fresh air from the normal roof intake Radwaste Building is mixed with 20,000 cfm of recirculated air (through fan 51A or 51B). Seven hundred and fifty (750) cfm is exhausted from the control room through fan 51 and the remaining 250 cfm pressurizes the control room and is exfiltrated. Also during normal operation, the remote air intake isolation valves (51A and B and 52A and B) are closed and the radiation monitor purge line valves (51D and E and 52D and E) are open with radiation monitor purge line fans 53A and B operating. During a LOCA when any of the following trip levels are reached 1) High drywell pressure ("F" signal), 2) Low low reactor water level ("A" signal) or 3) Reactor building ventilation exhaust high radiation ("Z" signal) the following actions occur:

The event described in LER 88-005 was for leakage around the emergency filters in excess of the technical specification allowable limit. During the engineering evaluation committed to in LER 88-005 to determine the effect of the excess leakage on control room habitability, a design engineer determined that postulated single failures could cause some combination of remote air intake line isolation valves to fail to open or to reisolate and; thus, isolate both remote air intake lines. If this condition existed during LOCA conditions, the Control Room HVAC would be running in a recirculation mode only since the normal roof intake is also isolated. In the recirculation mode the 20,000 cfm would continue to be drawn from the control room and recirculated back to the control room; however, without the fresh air input the control room would not be pressurized. In a neutral pressure condition the inleakage to the control room would increase and this condition is not analyzed.

The cause of this event was the failure of the Plant Architect/Engineer (Burns & Roe Inc.) to provide a system design for which a single failure could not isolate both remote air intakes and cause the Control Room HVAC System to operate in the recirculation mode, or to analyze the recirculation mode of operation. The root cause of this event is a lack of communication between the Architect/Engineer design groups.

Figure 1 Pre-Event Control Room HVAC

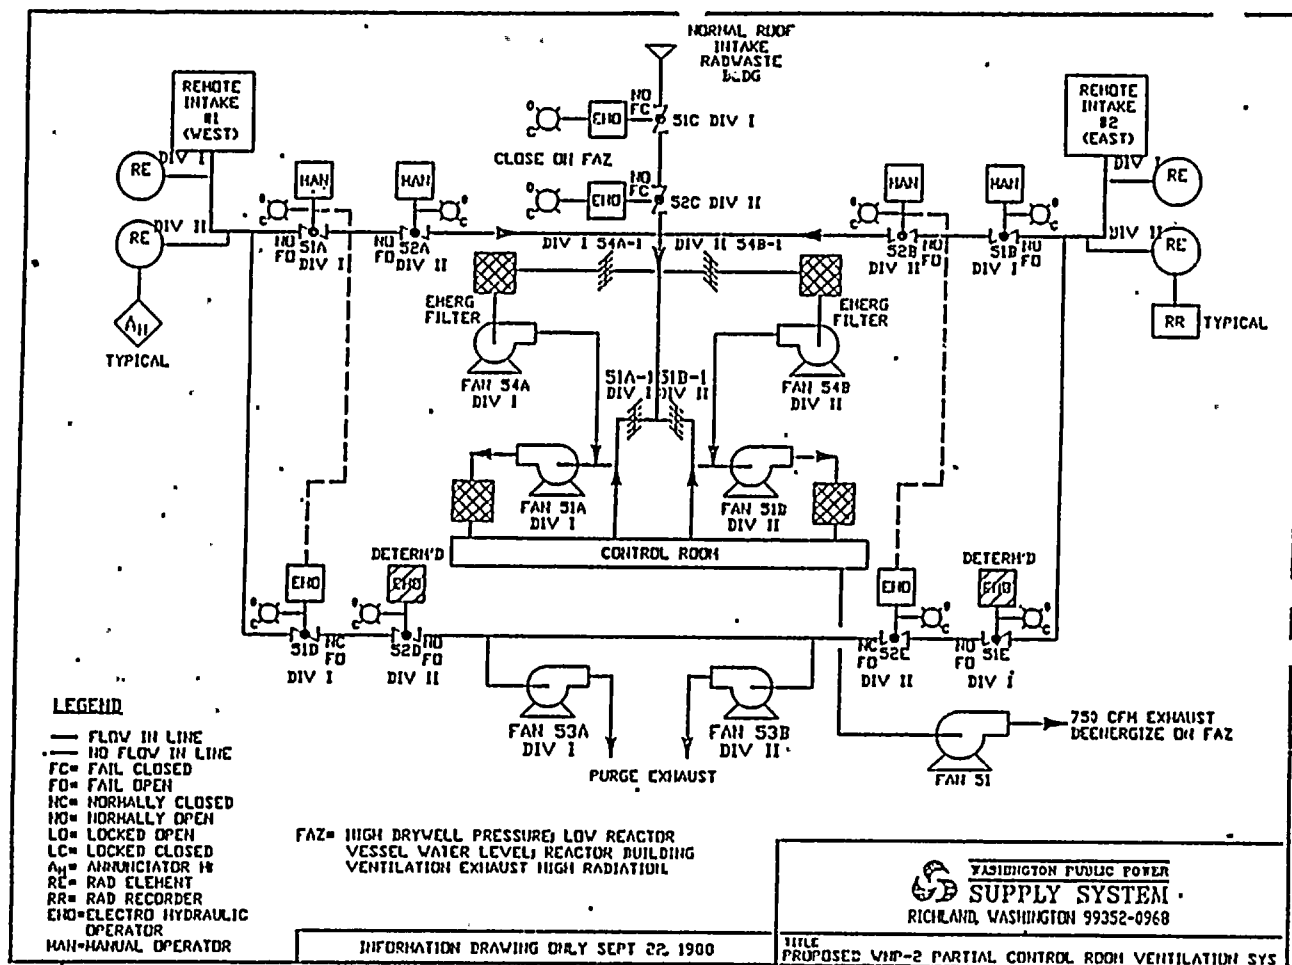
Figure 2 Post-Event Control Room HVAC

The planned Plant Startup was delayed until the following actions were completed. 1) The motor operators were removed and manual operators were installed on the remote air intake isolation valves (51A and B and 52A and B). The valve operators were changed to manual so the isolation valves on the remote intake lines could be opened without an FAZ signal present; thereby, assuring that a single failure could not cause operation in the recirculation mode. With the remote air intake lines open, the control room emergency filtration system is started, fan 51 is deenergized, and the associated damper is closed. This put the Control Room HVAC system in the pressurization mode of operation which satisfied the action statement of Technical Specification 3.3.7.1. The current Plant configuration has both remote intakes open during normal operation. Figure 2 shows the post event Control Room HVAC configuration. 2) Two of the radiation purge line isolation valve electro-pneumatic operator motors (52D and 51E) were electrically disconnected which causes the valves to open. This was done so that only one manual action is required to isolate a remote path and cause the associated purge path to open or vice versa. 3) The 750 cfm control room exhaust fan (51) was deenergized. 4) Specific directions for Plant Operators to execute to maintain design bases in the event of a LOCA were provided in (approved) deviated Plant procedures. Each new operations crew was provided training by Operation Managers.

- 1) The Control Room HVAC recirculation mode of operation was analyzed. The results are summarized under safety significance below.
- 2) Technical Specification Amendment 74 was received allowing operation of the Control Room HVAC system in the revised configuration.
- 3) A letter was sent to Burns & Roe Inc., providing notification of a potential 10CFR Part 21 condition.
