U.S. NUCLEAR REGULATORY COMMISSION
REGION V

Inspection Report: 50-397/94-04
Operating License: NPF-21
Licensee: Washington Public Power Supply System
P. O. Box 968
Richland, WA 99352
Facility Name: Washington Nuclear Project No. 2 (WNP-2)
Inspection At: WNP-2 site near Richland, Washington
Inspection Conducted: January 11 - February 21, 1994
Inspectors: R. C. Barr, Senior Resident Inspector
D. L. Proulx, Resident Inspector
S. P. Sánchez, Resident NRR Intern
D. E. Corporandy, Project Inspector (1/31-2/4/94)
D. F. Kirsch, Technical Assistant (2/14-2/18/94)

Inspection Summary:

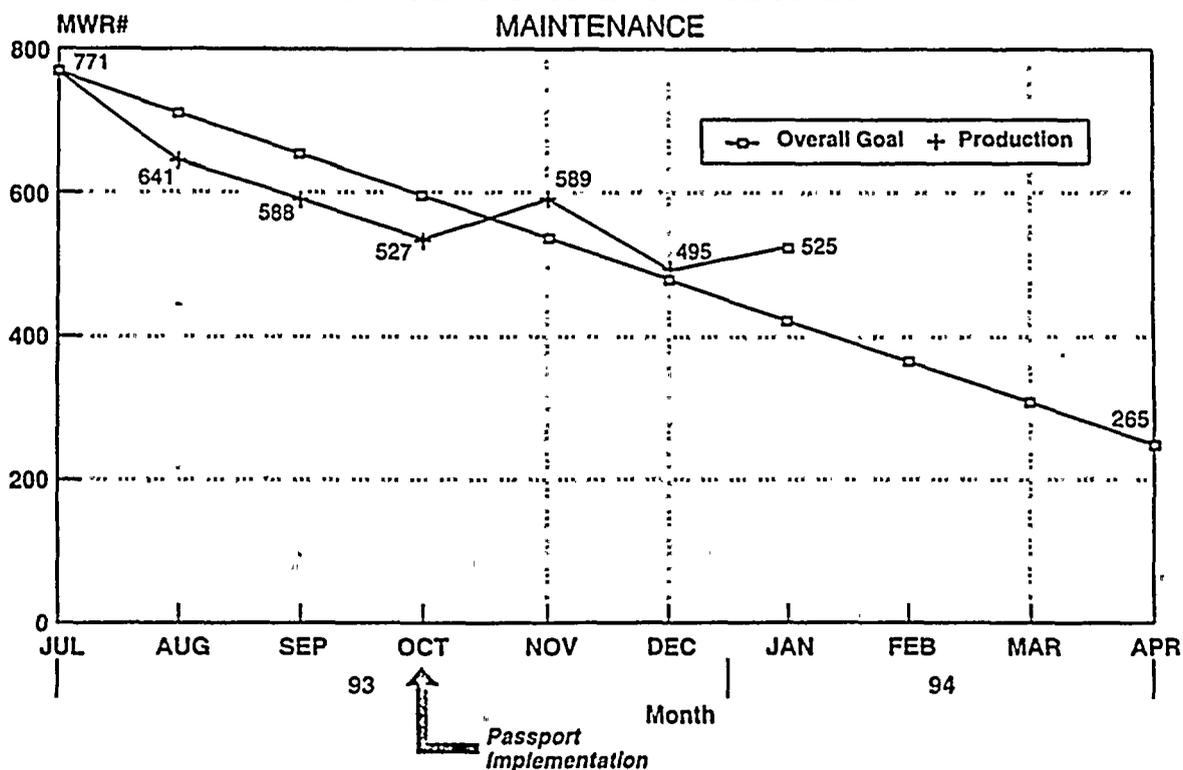
BACKLOG REDUCTION CM

- Reevaluate plant working hours to provide more backshift support (to be implemented following R-9).
- Continued efforts to implement and streamline the PASSPORT and Total Exposure System.
- Continue efforts to improve the schedule to accurately represent what is being worked.
- Regain the previous trend in backlog reduction.

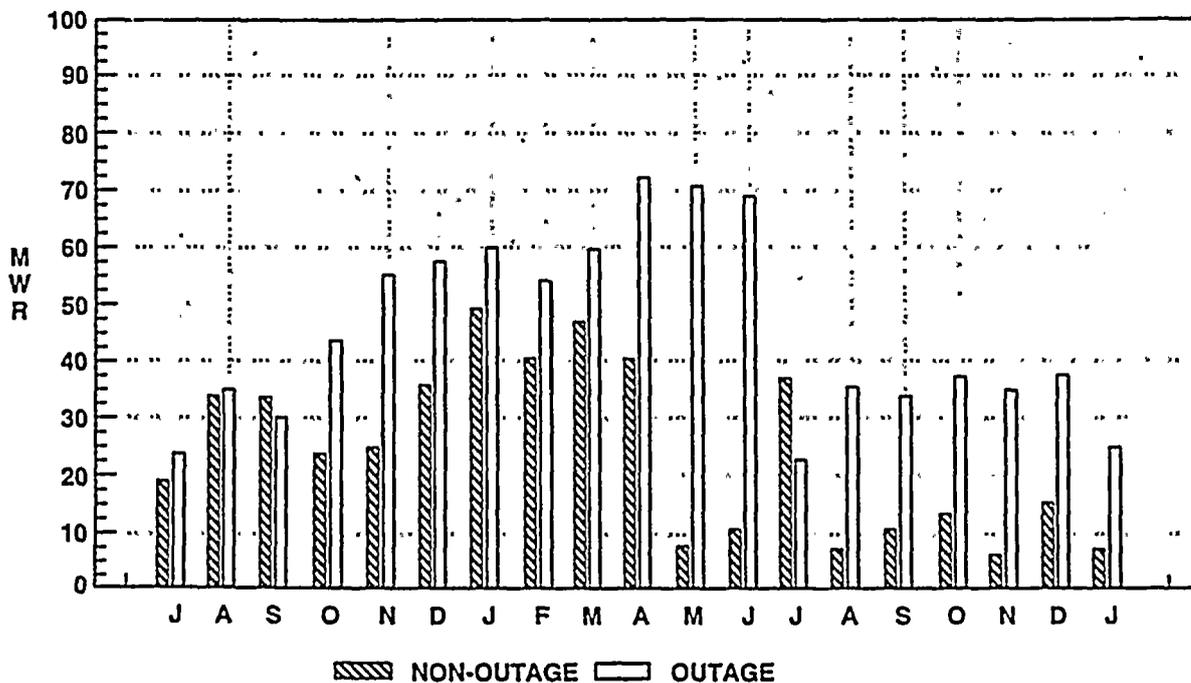
CONTROL ROOM DEFICIENCIES NON-OUTAGE AND OUTAGE (7/92 TO 1/94)

Operator's ownership (control room deficiencies + TMRs)

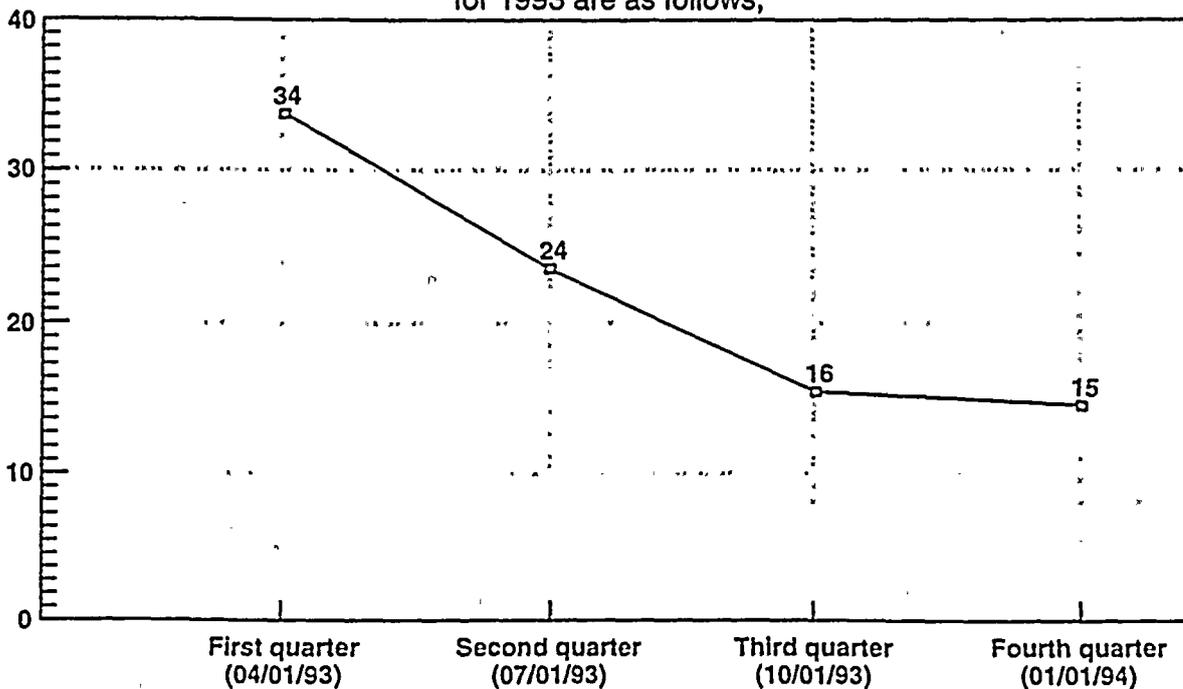
TMR TRENDING

The number of open TMRs at the end of each calendar quarter for 1993 are as follows;
