AUGMENTED INSPECTION TEAM (AIT) REPORT

Inspection Report: 50-397/95-13

Facility Name: Washington Nuclear Project 2 (WNP-2)

Inspection Conducted: April 24-26, with additional inoffice inspection
between May 3 and 25, 1995

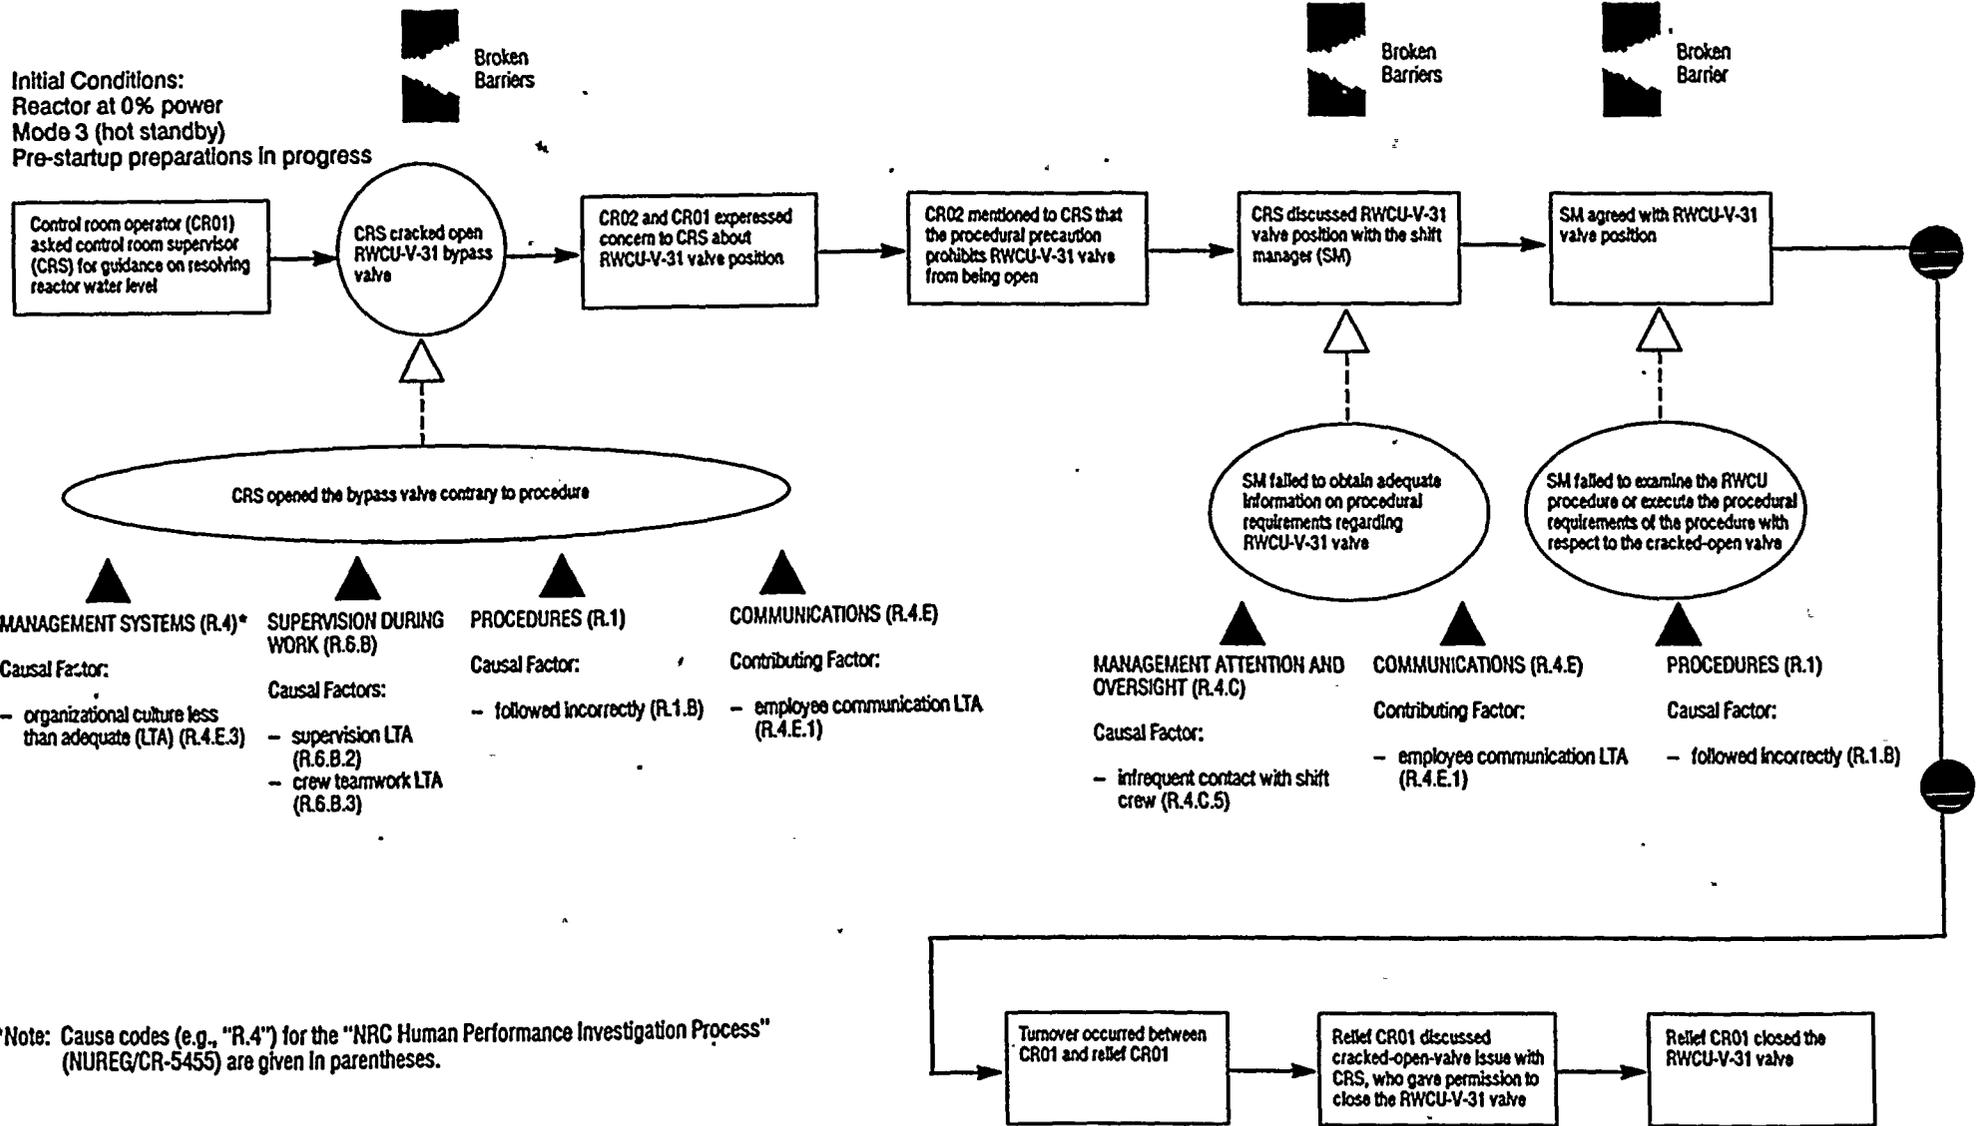
Events and Causal Factors Chart of the April 9, 1995, Procedure Noncompliance Event

The AIT determined that the root causes of the April 9, 1995, event were as follows:

The team concluded that the licensee's root cause analysis was incomplete and generally addressed symptoms emphasizing what had happened rather than causes that address why it happened. In addition, the team considered that the licensee's root cause did not address the possibility that the action was either a deviant or malicious action when they performed their Management Oversight and Risk Tree analysis, nor did they address the human performance factors associated with these issues.
