UNITED STATES
NUCLEAR REGULATORY COMMISSION

MEMORANDUM TO: Jeffrey Shackelford, Senior Reactor Analyst
FROM: Ellis W. Merschoff, Regional Administrator
SUBJECT: AUGMENTED INSPECTION TEAM AT WASHINGTON
NUCLEAR PLANT-2

Detailed Sequence of Events for the June 17, 1998 Fire Main Rupture and Flooding Event at WNP-2
(ALL TIMES ARE PACIFIC DAYLIGHT)

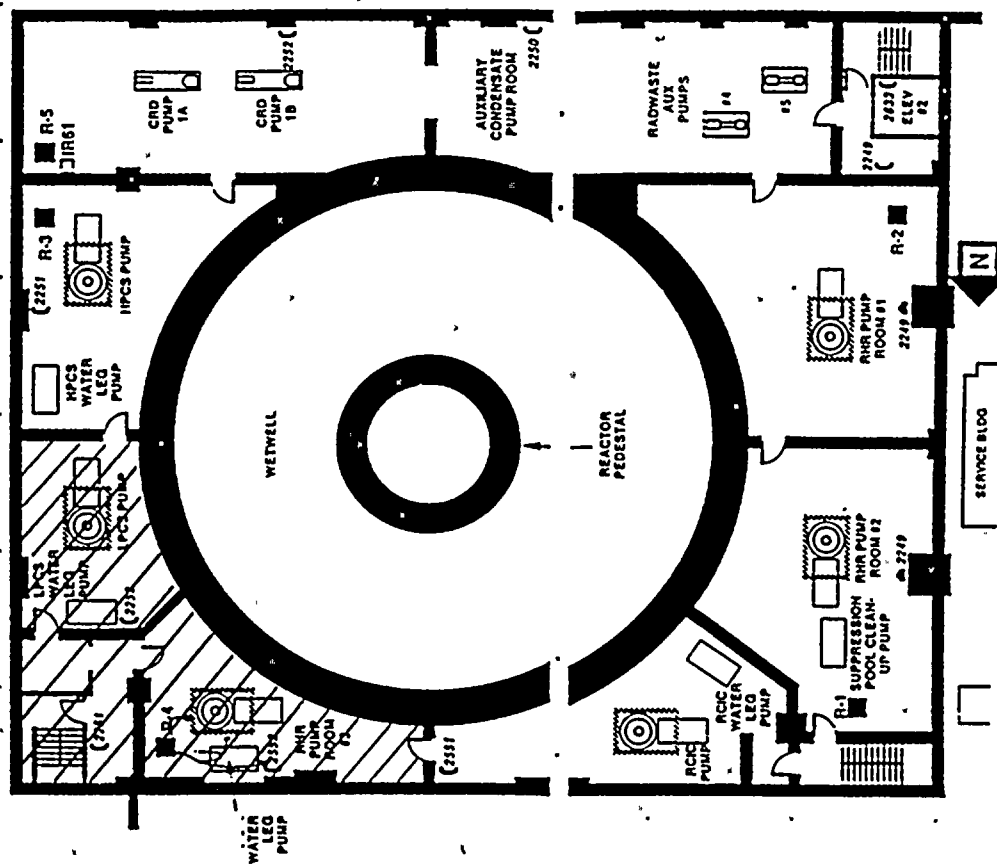
Simplified Diagram of Flood Affected Areas

REACTOR BUILDING ELEV. 422'
