ACCESSION NBR: 9812310117 DOC.DATE: 98/12/21 NOTARIZED: NO DOCKET #
 FACIL: 50-397 WPPSS Nuclear Project, Unit 2, Washington Public Powe 05000397
 AUTH.NAME AUTHOR AFFILIATION
 PICK, G.A. Region 4 (Post 820201)
 RECIPIENT NAME RECIPIENT AFFILIATION
 PARRISH, J.V. Washington Public Power Supply System

SUBJECT: Informs that NRC insp rept 50-397/98-99 initiated for SALP canceled since SALP process suspended for two yrs.

SUBJECT: NRC INSPECTION REPORT 50-397/98-99

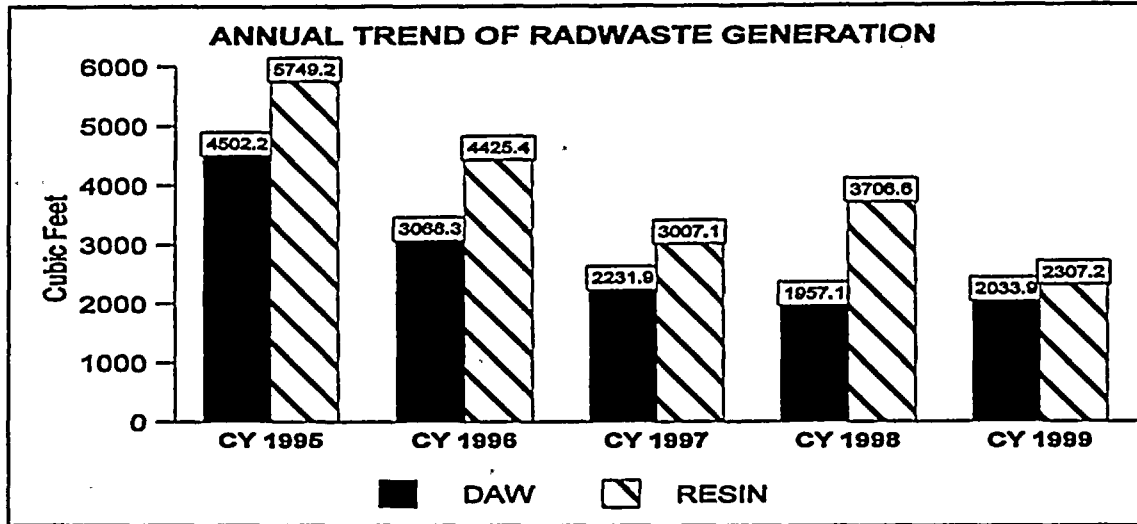
The inspector noted that the licensee had reduced the amount of solid radioactive waste generated during the past 5 years. Radworker awareness to minimize radioactive waste when performing their assigned tasks was emphasized during general employee training. Licensee data trends showed that the radioactive waste minimization efforts were effective.

The volume of solid radioactive dry active waste and resins generated were tracked by the licensee. A summary of the volume of solid radioactive dry active waste and resins generated during the time period 1995 through 1999 is presented in the graph below. For 1995 through 1999, the licensee's data showed a continuing decline in solid radioactive waste generated. The licensee met the dry active waste generation goals established for fiscal years 1997, 1998, and 1999. However, a comparison of the licensee's 3-year average amounts of solid radioactive waste generated for the periods 1995 through 1997, 1996 through 1998, and 1997 through 1999 to the industry's 3-year median values for the respective time periods showed that the licensee generated more solid radioactive waste than the industry's 3-year median values for boiling water reactors over the past 5 years.

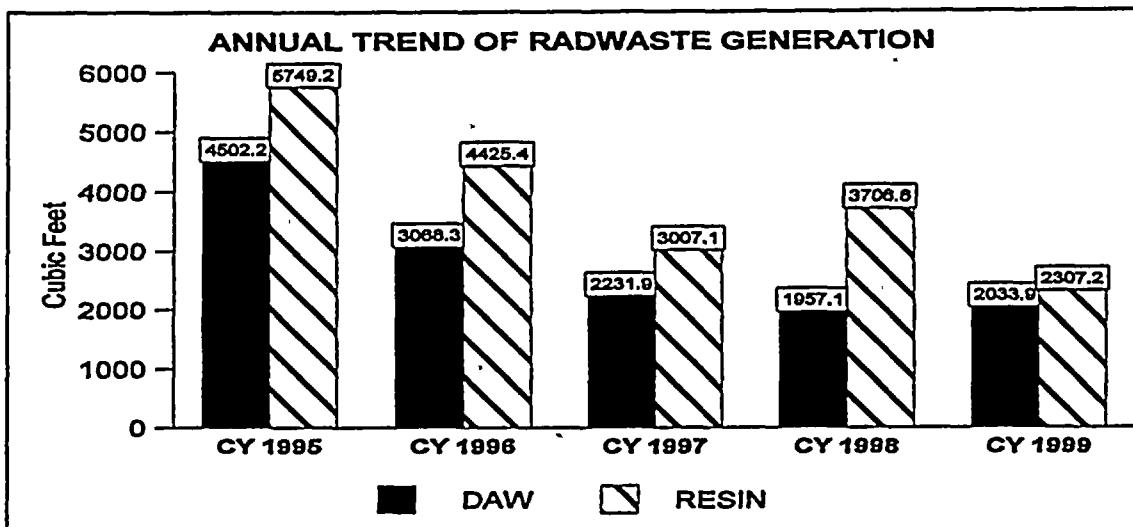
The inspector noted that the licensee had reduced the amount of solid radioactive waste generated during the past 5 years. Radworker awareness to minimize radioactive waste when performing their assigned tasks was emphasized during general employee training. Licensee data trends showed that the radioactive waste minimization efforts were effective.

The volume of solid radioactive dry active waste and resins generated were tracked by the licensee. A summary of the volume of solid radioactive dry active waste and resins generated during the time period 1995 through 1999 is presented in the graph below. For 1995 through 1999, the licensee's data showed a continuing decline in solid radioactive waste generated. The licensee met the dry active waste generation goals established for fiscal years 1997, 1998, and 1999. However, a comparison of the licensee's 3-year average amounts of solid radioactive waste generated for the periods 1995 through 1997, 1996 through 1998, and 1997 through 1999 to the industry's 3-year median values for the respective time periods showed that the licensee generated more solid radioactive waste than the industry's 3-year median values for boiling water reactors over the past 5 years.
