UNITED STATES  
NUCLEAR REGULATORY COMMISSION  
REGION V

IE Bulletin No. 78-12A

ATYPICAL WELD MATERIAL IN REACTOR PRESSURE VESSEL WELDS

## UL FIRE TEST

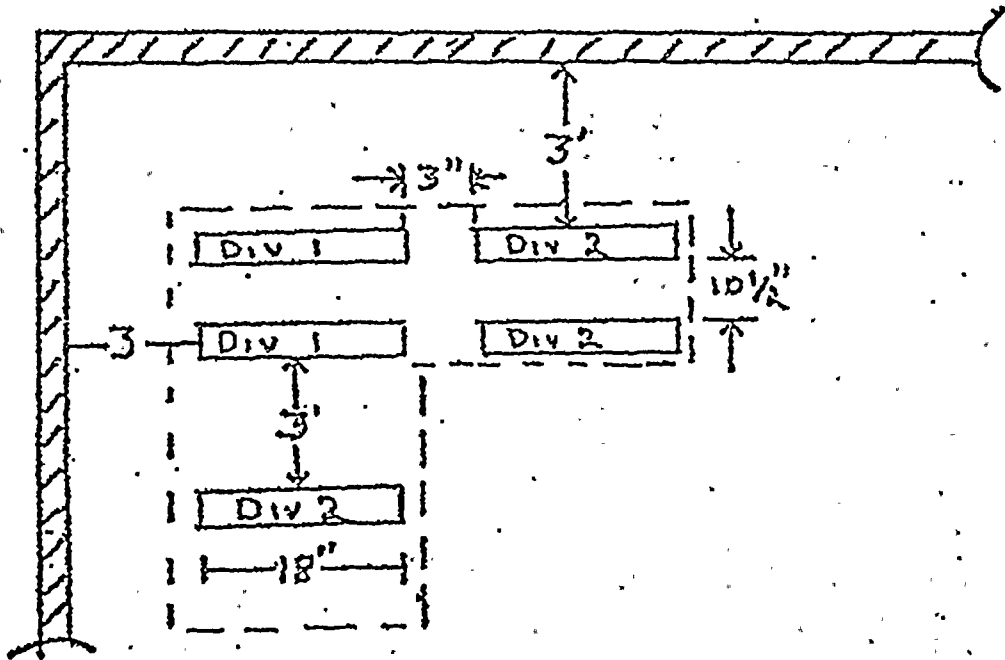
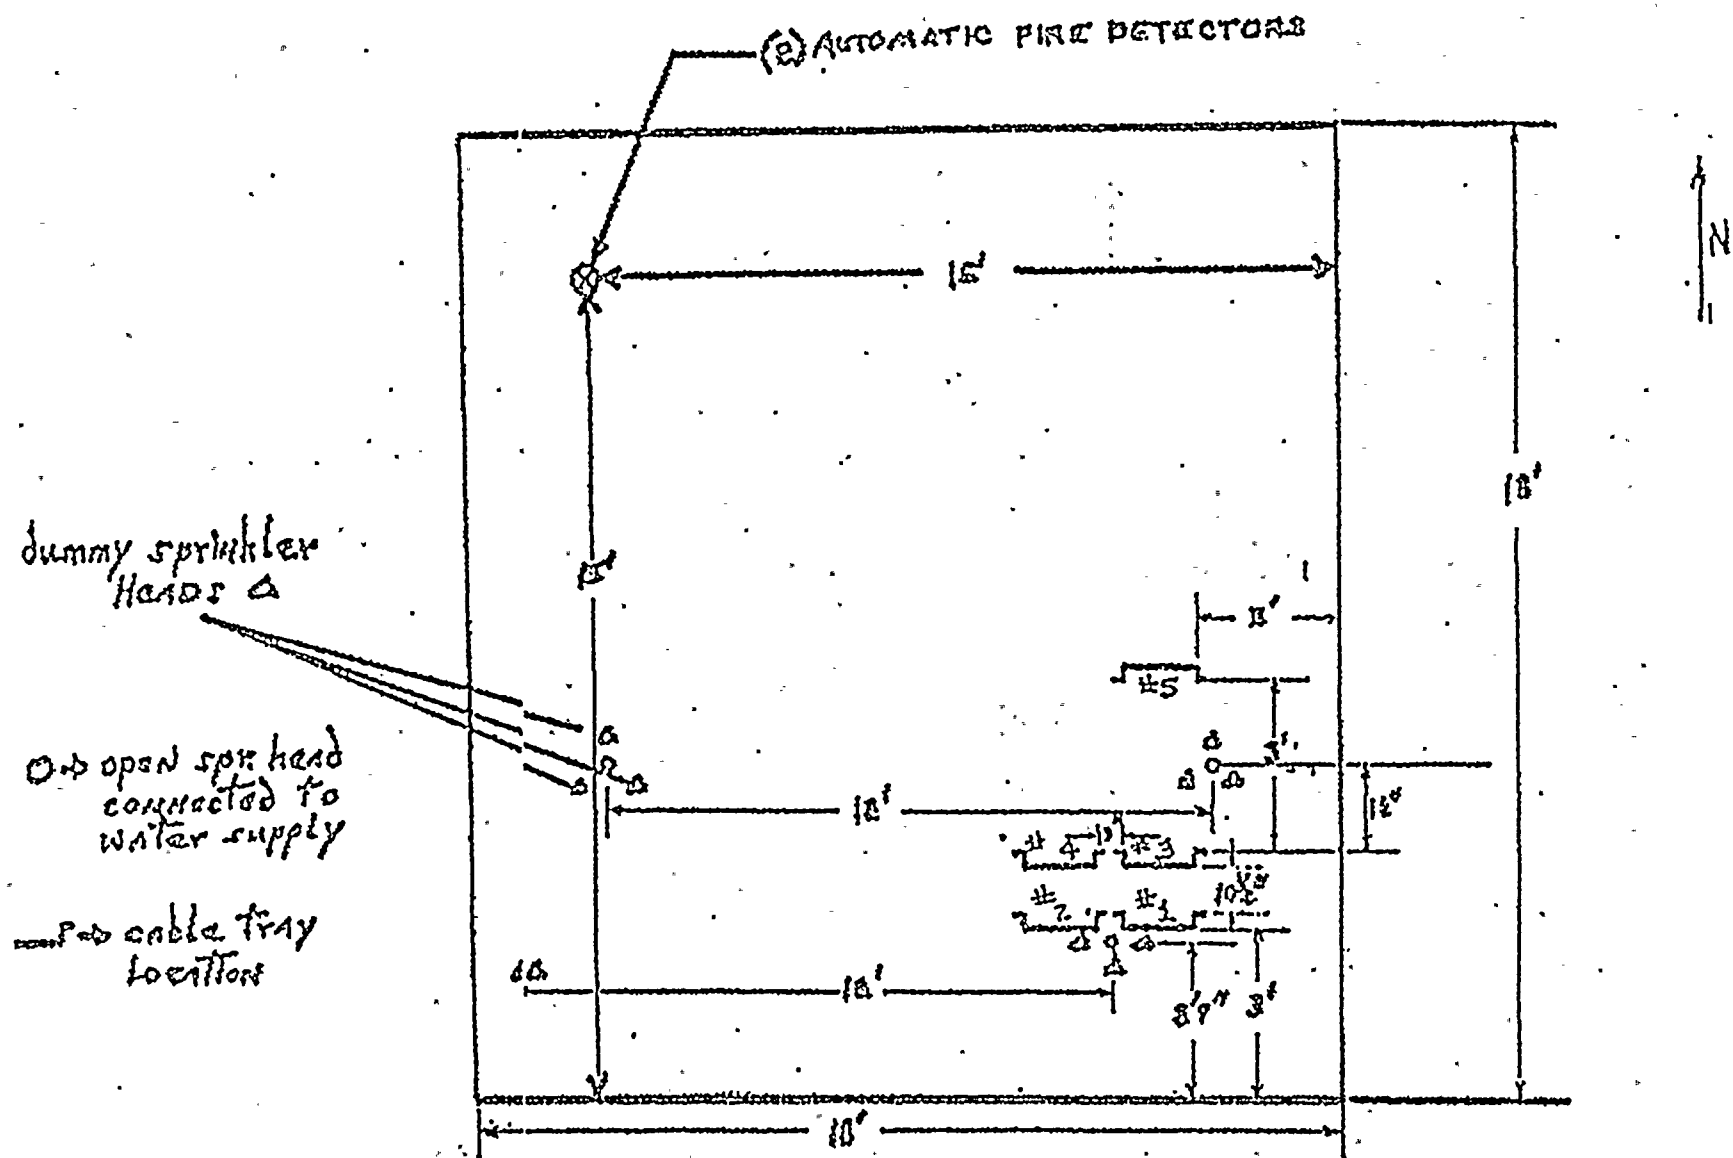
Figure 1

Preliminary information indicates that the flammable liquid or flames penetrated the protective barriers at the bottom of the vertical trays and caused fire damage to the polyvinyl chloride insulation on cables in four of the five trays.

The most probable cause of the fire damage in certain cable trays appears to be related to the absorption or seepage of heptane under the ceramic fiber blanket at the juncture with the floor. Once the heptane entered the interior regions of the cable tray, then ignition apparently occurred via the small opening at the floor or through a vapor/air path within the joints. There is some indication that some cable damage was caused by absorption of heptane on the inside of the barrier (wicking effect) and its ignition which heated a cable tray ladder rung, causing damage to a cable in contact with the rung. The ingress of the heptane into the ceramic fiber needs to be further evaluated since this appears to be the most significant failure mode.

1. To protect against spills of flammable liquids, barriers or curbs may be needed to prevent entry of the flammable liquid behind fire barriers. A wick effect may also need to be considered in the design of fire barriers.
2. Some small fires may not actuate sprinkler heads. To reduce this possibility in sprinkler systems to be installed, fast response sprinkler heads should be considered (less than approximately 3 minutes in the UL Standard 199 "Automatic Sprinklers for Fire Protection Service").
3. The location of the fire detection devices and the sprinkler heads relative to the fire and components being protected is of great importance. The path of the air movement in the area influences the actuation of such devices and should be considered in the system layout.
