Watts Bar Nuclear Plant, Units 1 and 2
Facility Operating License Nos. NPF-90 and NPF-96
NRC Docket Nos. 50-390 and 50-391

Subject: **Licensee Event Report 390/2017-012-00, Error in Plant Emergency
Procedures Leads to a Condition Prohibited by the Technical
Specifications**

Error in Plant Emergency Procedures Leads to a Condition Prohibited by the Technical Specifications

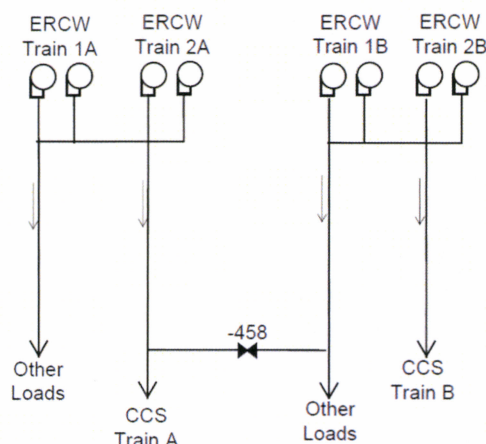
Simplified ERCW Figure

The WBN plant is provided with a common ERCW system serving both units (see Figure). Eight ERCW pumps are provided, with two pumps aligned to each 6.9 kV Shutdown Board (SDBD) and aligned to two ERCW trains A and B. The ERCW system supplies cooling water to the Component Cooling Water System (CCS) heat exchangers, the containment spray heat exchangers, the emergency diesel generators, containment coolers, and various other system loads.

The CCS is an intermediate cooling loop cooled by the ERCW system. Three CCS heat exchangers serve both units aligned into two trains. CCS heat exchangers A and B serve Train A for Units 1 and 2, respectively, and CCS heat exchanger C serves Train B for both units. The CCS heat exchangers provide heat removal for the Residual Heat Removal (RHR) heat exchangers, the Spent Fuel Pool heat exchangers, the Chemical and Volume Control System (CVCS), various pump coolers, and various other loads. ERCW flow to the CCS heat exchangers is controlled using the discharge flow control valves, each heat exchanger with a pair of valves, one normally throttled which is used during normal conditions and the other normally closed and used during accident conditions which can be positioned to one of three (A, B, Open) preset opening positions.

A separate issue was identified in Condition Report (CR) 1331422 that is the subject of this report where incorrect change to procedure 1-E-1 and 2-E-1, Loss of Reactor or Secondary Coolant, were made prior to Unit 2 initial operation. Steps were added to both procedures where for a LOCA concurrent with a loss of offsite power and a train failure while the other unit was on RHR cooling, an ERCW supply side cross connect between the A and B trains would be open. This erroneous change had the potential to reduce ERCW flow to the functioning train.
