Subject: Control Room Design Review/Audit Report, Palo Verde Nuclear  
Generating Station

HUMAN FACTORS ENGINEERING  
CONTROL ROOM DESIGN REVIEW/AUDIT REPORT

PALO VERDE NUCLEAR GENERATING STATION  
ARIZONA PUBLIC SERVICE COMPANY

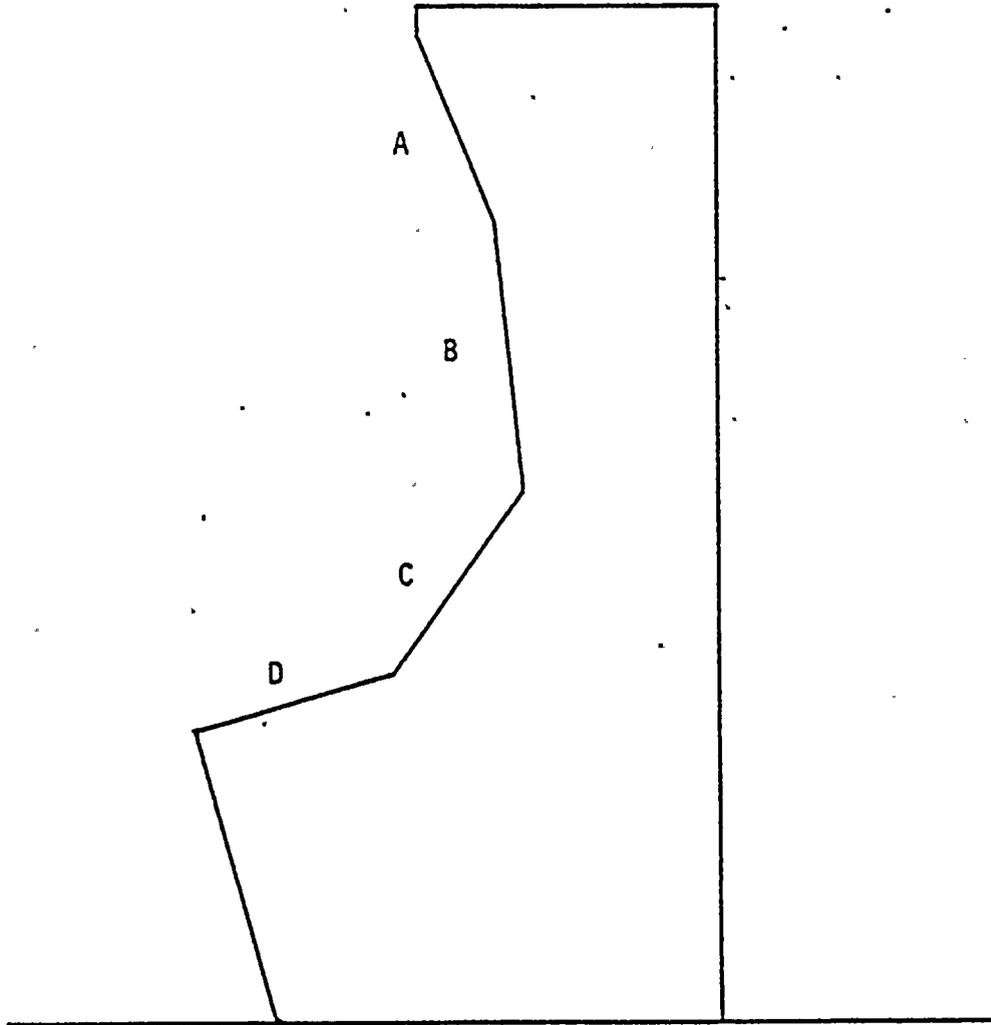
FIG. 1. Identification of control board surfaces.

<u>PRIORITY RATING</u>	<u>FINDING</u>
3	1* The control room bookshelves are inadequate. (056C)
2	2* Glare is a problem for most displays on all of the panels. It is worst on the "C" surfaces, depending on viewing angle. (See Fig. 1 on page 3 for the meaning of "A", "B", "C, and "D" surfaces.) (049C) (064C) (100B) (101B) (103C)
1	3* Glare on CMC switch surfaces hinders "light-on" determination. This is more apparent on the "C" surfaces. A matte surface might not be as effective a solution as brighter lights. Example: (Panel B02) a.) ESF SWGRA/EQPT Room switch (098C)
3 <sup>1</sup>	4* The concrete control room floor is not carpeted, which will lead to earlier fatigue during long periods of standing by the operators. (068B)
