Subject: **Palo Verde Nuclear Generating Station Unit 1
Docket No. STN 50-528
Relief Request 57 - Request for Alternative to American Society of
Mechanical Engineers Code Case N-729-4 for Replacement Reactor
Vessel Closure Head Penetration Nozzles**

Relief Request 57

**Request for an Alternative to ASME
Code Case N-729-4 for Replacement Reactor Vessel Closure
Head Penetration Nozzles**

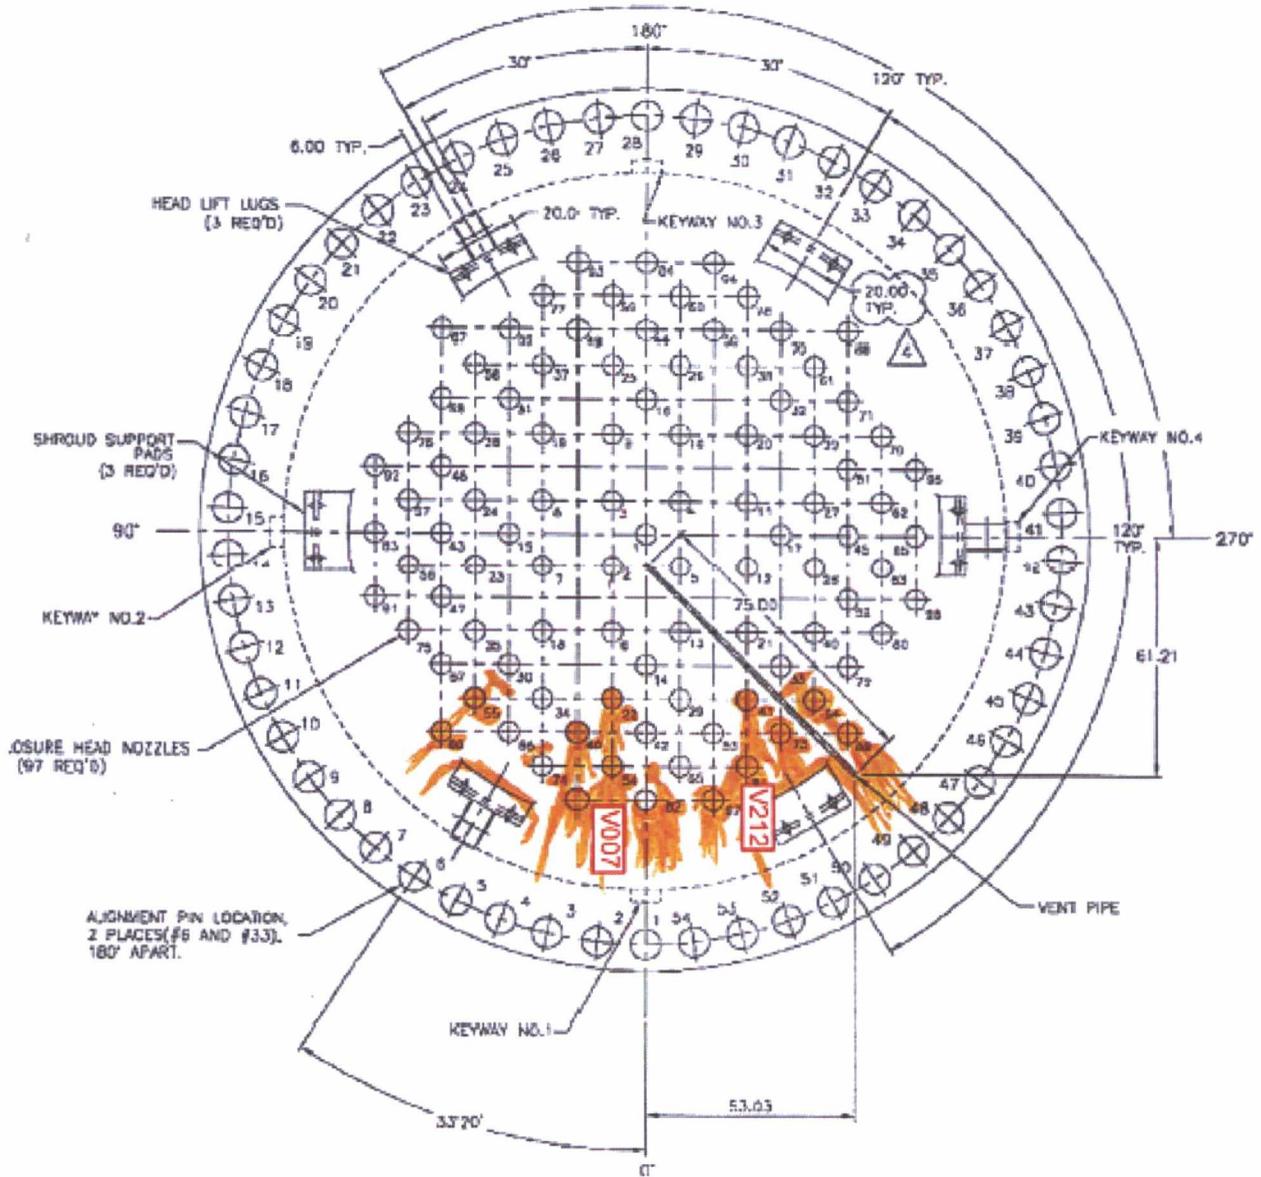
APS scheduled visual examinations (VE) of the RRVCH nozzle penetrations during the current Unit 1 refueling outage (1R20) because a spill emanating from the RRVCH vent valves had occurred on the RRVCH during the previous refueling outage (1R19) just prior to startup. The spill occurred due to a RRVCH vent valve misalignment and was terminated when the vent valves were closed. During 1R20, the RRVCH head nozzle penetrations were examined in the as-found condition using ASME Code Case N-729-4 and 14 penetrations were determined to have relevant conditions pursuant to Code Case N-729-4, paragraph 3141(c). See Attachment 1 of this enclosure for nozzle and vent valve locations.

Area of Identified RRVCH Vent Valve Spill
