Arizona Nuclear Power Project

Subject: Final Report - DER 86-29
A 50.55(e) Condition Relating to Letdown Heat Exchanger Nozzle
Crack
File: 87-006-216

FINAL REPORT - DER 86-29
DEFICIENCY EVALUATION 50.55(e)
ARIZONA NUCLEAR POWER PROJECT (ANPP)
PVNGS UNITS 1, 2, 3

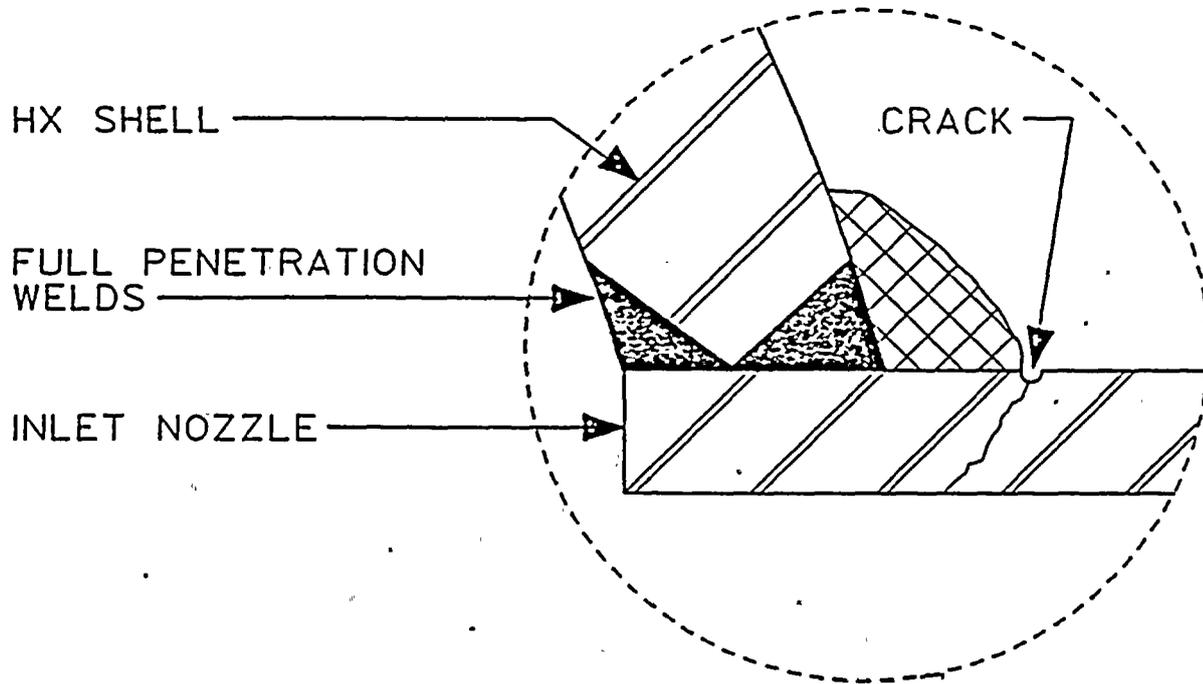
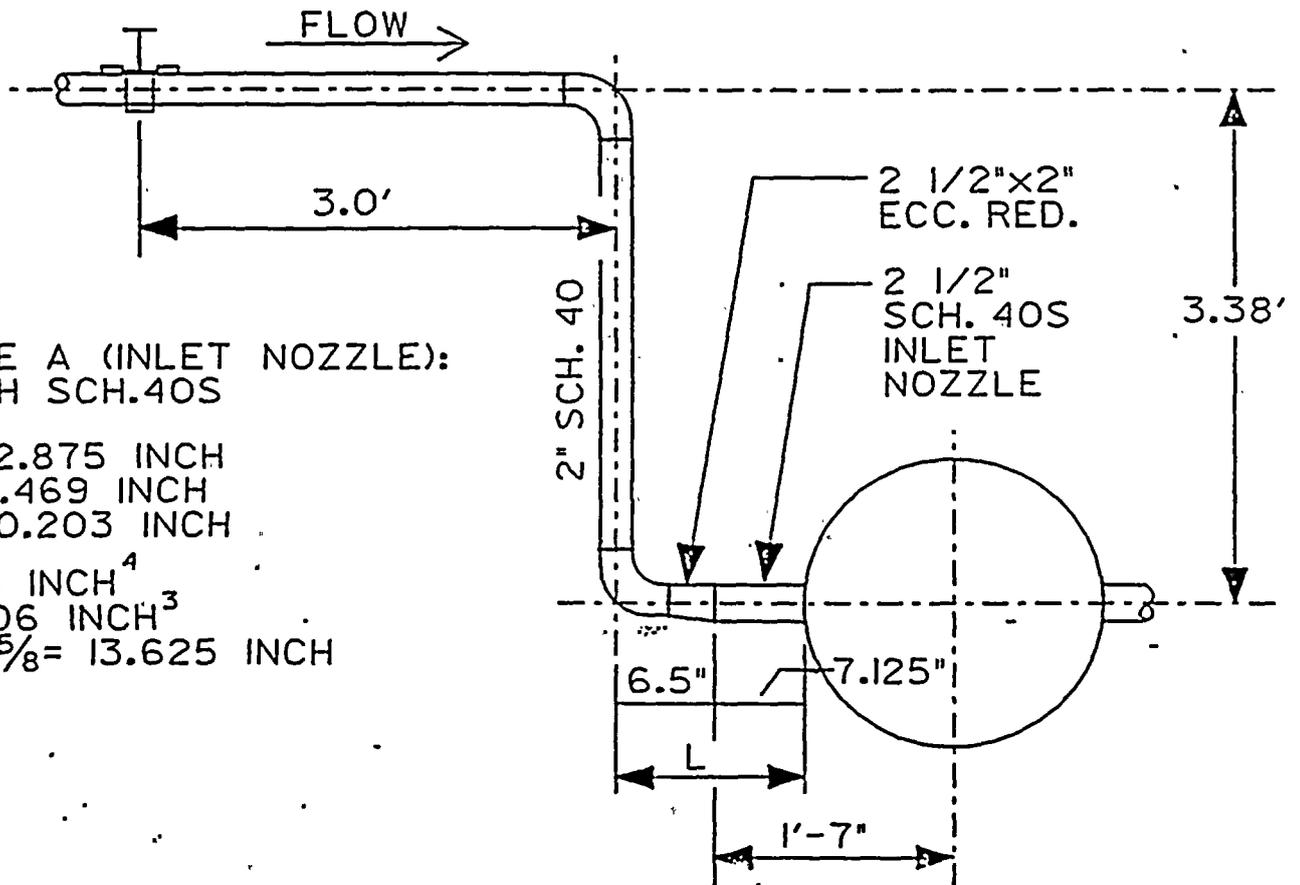
FIGURE 1

Nozzle A is a 2-1/2 inch diameter, Schedule 40, stainless steel (SA312-TP304) pipe stub, attached to the heat exchanger shell by a full penetration, double-ended bevel weld, which is reinforced with an external 1/2 inch fillet weld. (See Figure 1) This nozzle configuration conforms to ASME III, Class 2 Code requirements.

A visual inspection performed by the an ANPP metallurgist of the cracked nozzle resulted in the following observations: The failure occurred on the top side of the nozzle adjacent to the toe of the reinforcing weld. As indicated in Figure 1, the toe of the

weld adjacent to the failure had been ground back leaving a groove approximately 1/32 inch deep by 1/8 inch wide and 2 inches long where the failure occurred. In addition, the geometry of the weld did not provide a smooth transition between the vessel and nozzle. As discussed later, this geometry and groove resulted in a stress concentration which significantly contributed to the nozzle failure.

The failure consisted of a main through-wall circumferential crack approximately 3 inches long on the nozzle exterior, and two other disconnected cracks parallel to the first, which did not penetrate the nozzle wall. The main crack was not perpendicular to the nozzle surface, but sloped back under the fillet weld at a slight angle. The length of this crack on the nozzle interior was about 1 inch shorter than on the nozzle exterior. This indicates that the crack started on the outside at the toe of the reinforcing fillet weld (where the groove was located) and propagated through the nozzle base metal. The main crack appears to be made up of two smaller hairline cracks that grew together as they propagated. This is a typical configuration for a high cycle/low stress fatigue failure.

1. The primary root cause is believed to be the geometry of the weld area including the presence of the circumferential groove with grinding marks into the base metal where the crack occurred.

UNIT 3 LDHX INLET NOZZLE A

The nozzle crack was initially weld repaired under NCR NA-1942 in order to support HFT. After HFT was completed, additional welding was performed to increase the size of the reinforcing weld from the original 1/2 inch size to 3/4 inch. The final weld provides four benefits:
