SUBJECT: Forwards discussion on B61224 reactor trip & util plans for resolution of plant protection sys power supply problem. Bistable relay power supplies will be tested monthly to detect failed power supplies.

Subject: Palo Verde Nuclear Generating Station (PVNGS)
Unit 2
Docket No. STN 50-529 (License No. NPF-51)
Plant Protection System Power Supplies
File: 87-F-056-026

ATTACHMENT

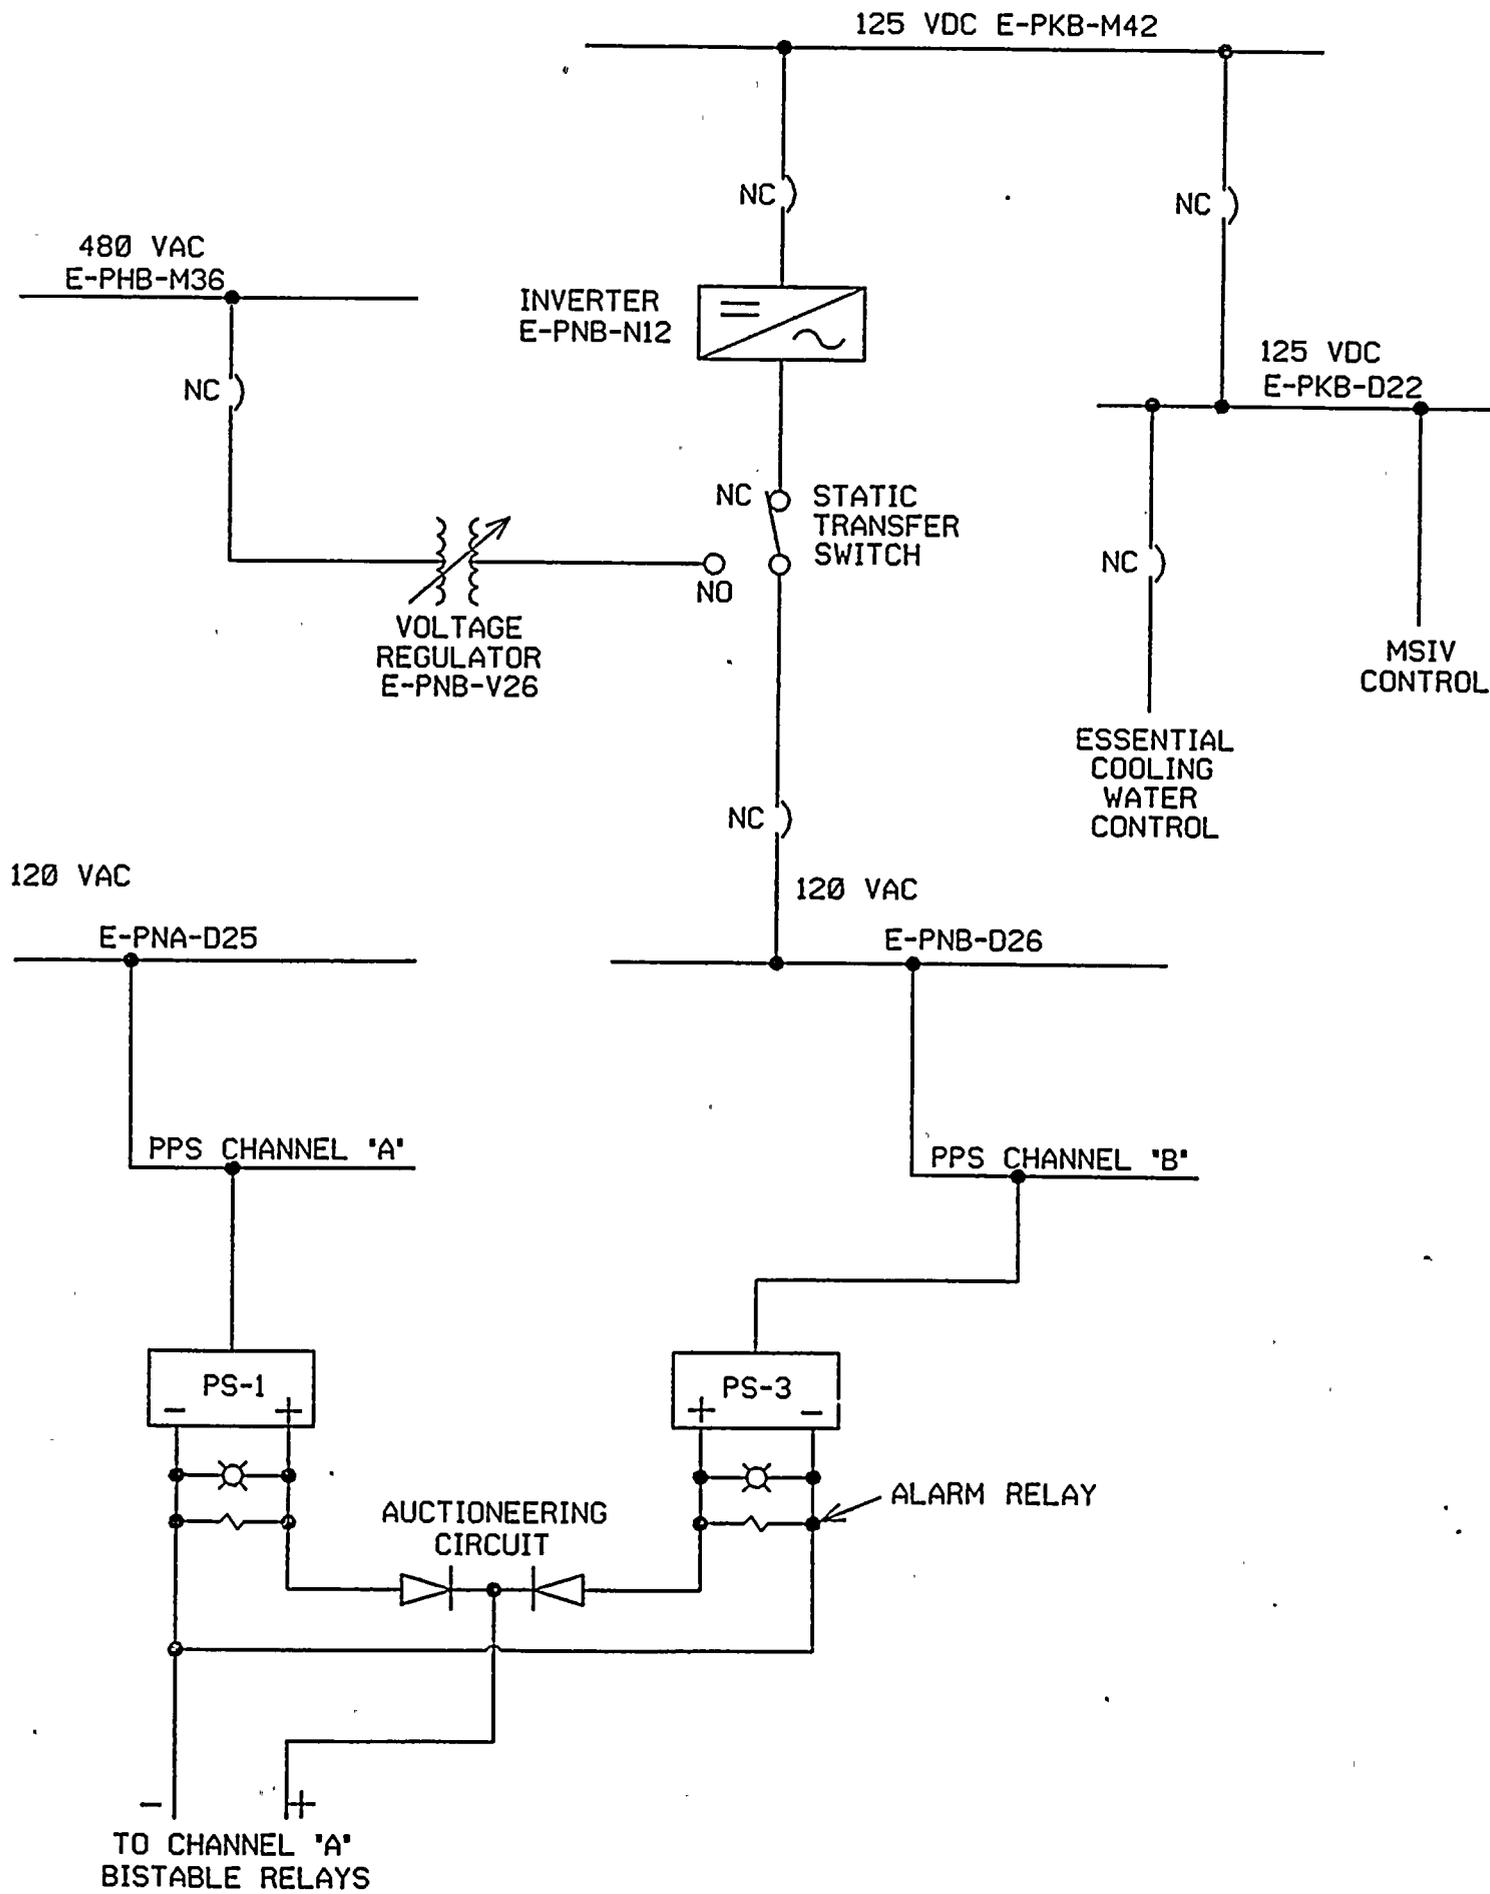
POWER SUPPLY SCHEMATIC

The events described above resulted in a loss of power to 120 volt AC bus D26 which resulted in a loss of power to the PPS Channel "B" instrumentation and a loss of power to Power Supply 3 (PS-3) which provides an alternate power supply to the PPS Channel "A" bistable relays. Additionally, the other power supply for the Channel "A" bistable relays (PS-1) was in a degraded voltage or "lockdown" condition at the time that D26 lost power. Thus, power was lost to the Channel "A" bistable relays due to the loss of PS-3 concurrent with PS-1 being in the "lockdown" condition. The loss of power to the Channel "A" bistable relays and the Channel "B" instruments satisfied the "AB" logic matrix and resulted in the PPS actuation.

During the review of the event, ANPP identified the fact that the degraded voltage condition of PS-1 had gone undetected because the "lockdown" condition for the power supply occurs at a higher voltage than the alarm relay actuation voltage. ANPP recognizes that it is clearly undesirable for a failed power supply in the PPS to go undetected. Therefore, ANPP is pursuing a modification to correct this undesirable condition. It should be noted that the objective of this modification is to ensure that any credible power supply failure is alarmed so that the power supply can be promptly repaired or replaced.

The resolution of this problem involves the implementation of a modification to the existing bistable relay power supplies to ensure that the power supplies are latched to a low output voltage for the over voltage lockdown condition. This will result in a positive alarmed condition. This power supply modification is being implemented at the vendor's facility. The modified power supplies will then be sent back to PVNGS for installation in the units. Additionally, ANPP is considering a modification to the power supply alarm relays. This modification would involve replacing or modifying the existing alarm relays to ensure that the alarm relays actuate at a higher voltage. The alarm relay modification would provide further assurance that power supply failures would be alarmed. Due to the uncertainties currently involved in the scheduling and completion of these modifications, a schedule for completion cannot be provided at this time. However, the monthly testing described below will be continued until such time as the modification is completed.

In the interim, until such time as the power supply modification can be completely implemented, the bistable relay power supplies in PVNGS Units 1, 2, and 3 will be tested monthly to detect failed power supplies. It should be noted that this monthly testing will not be conducted when the units are in shutdown modes where the PPS is not required to be operable. If plant conditions are such that the power supply test cannot be conducted without jeopardizing safe plant operations, then the test will be postponed until such time as it can be safely performed. ANPP believes that this monthly test is an acceptable interim measure until the modification is completed. This conclusion is supported by a reliability analysis which ANPP has performed. The analysis indicates that the probability of subsequent PPS actuations due to the specific scenario experienced on December 24, 1986, (loss of one instrument bus and a failure of a specific bistable power supply) is $9.4E-06$ per month per unit. This low probability of a subsequent similar event shows that the PVNGS units can be operated in a safe manner until the final solution can be implemented.
