SUBJECT: Forwards Rev 0 to "Rept on Steam Generator Tube Leak at Unit 1," per 870220 request. Rept provides requested info for Units 1 & 2 & discussion of alternatives considered for Unit 3.

Subject: Palo Verde Nuclear Generating Station (PVNGS)
Units 1, 2 and 3
Docket Numbers: STN 50-528 (License No. NPF-41)
STN 50-529 (License No. NPF-51)
STN 50-530
Report on the PVNGS Steam Generators
File: 87-E-056-026; 87-F-056-026

TUBE LEAK AT PVNGS UNIT 1

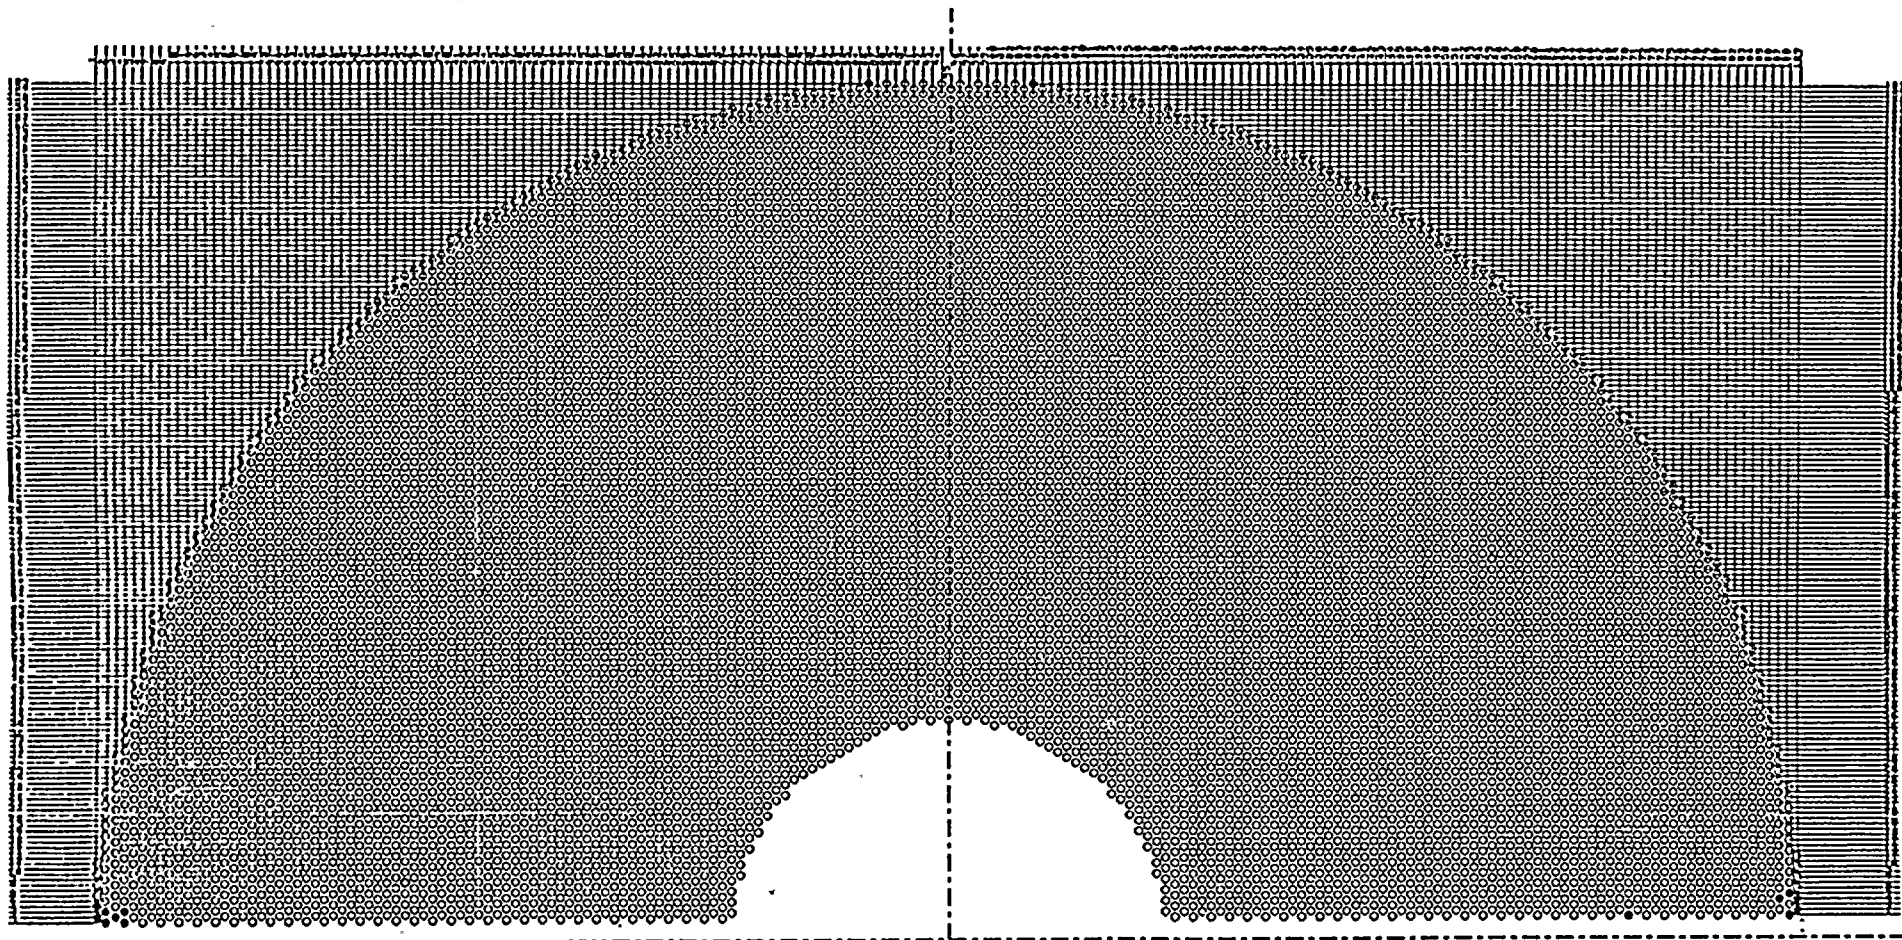
Figure 6

Indications of tube wall thinning were found on several tubes (Table 1) of steam generators 1 and 2 in both Units 1 and 2. These worn tubes are confined to a particular region of the steam generator (Figures 6 through 9). The region where tube wear has been observed is referred to as the cold leg corner region. The cold leg corner region is located on the outer periphery of the tube bundle adjacent to the economizer divider plate on the cold leg side of the steam generator. There are two cold leg corner regions in each steam generator. The indications of worn tubes are located at the second through sixth tube supports (first through fifth eggcrate supports) on the cold leg side of the steam generator.

Unit 1, Steam Generator #1 Tube Wear

An evaluation of the eddy current test data determined the indications to be typical of that caused by tube-to-support wear resulting from tube vibration. The cause of the tube vibration is postulated to be local high radial velocity flow streaming of entering recirculating fluid.

The root cause of this condition has been determined to be the unique condition at the intersection of the recirculating water entrance window and the tube lane where high radial flow velocities can exist. This configuration was not analyzed or tested during the design process. This condition did not exist in previous CE steam generators since only the System 80 design features cold leg side recirculating water entrance above the integral economizer.

ANPP has plugged and staked all tubes with any indication of wear in the local high velocity region in Units 1 and 2. Those tubes with no wear to date are postulated to be sufficiently supported to preclude vibration and a mechanism by which this condition could change has not been identified. Therefore, these tubes will remain in service. All unplugged tubes in Units 1 and 2 in the region of interest will be reinspected during the next refueling outage to confirm that wear has not initiated in these tubes.

- ° The tubes in PVNGS Units 1 and 2 that showed indications of wear due to flow induced vibration in the economizer section of the steam generator have been plugged and staked. The stakes were installed on the cold leg side to prevent severing or collapse of the tube. Each stake is 189 inches long, 1/2 inch diameter, braided stainless steel cable. The final number of tubes that were plugged is shown in Table 3.

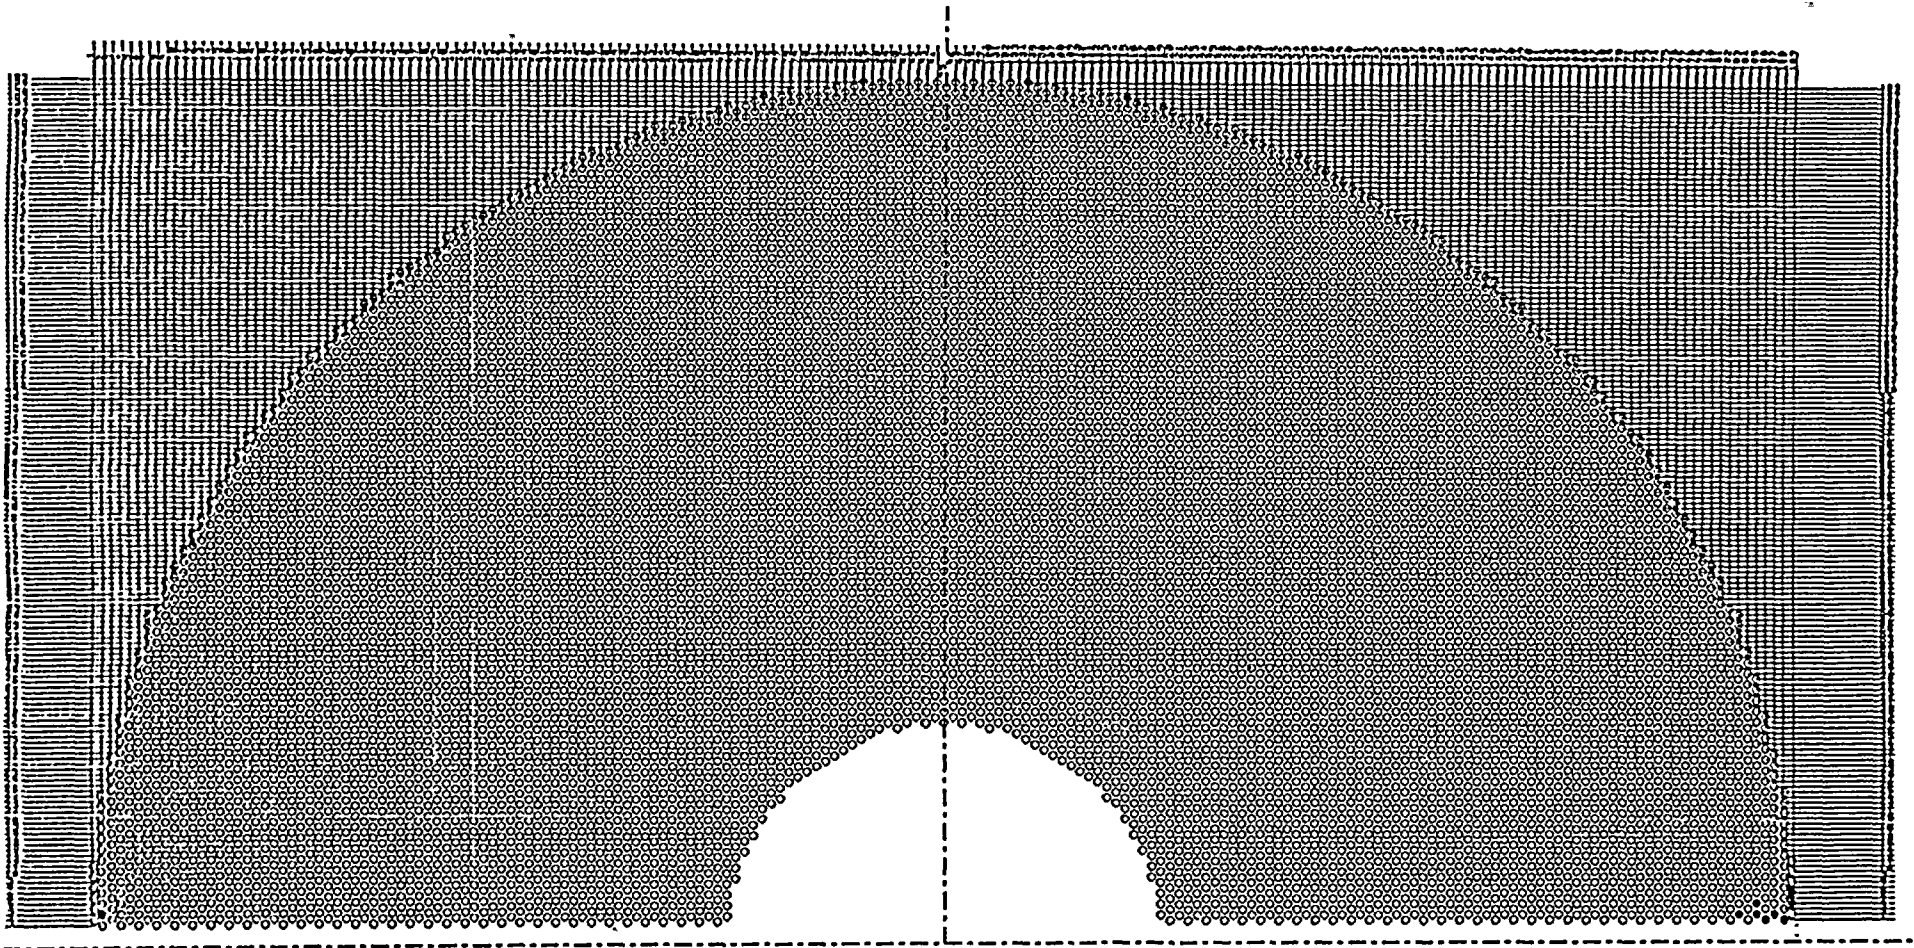
Figure 7

Unit 1, Steam Generator #2 Tube Wear

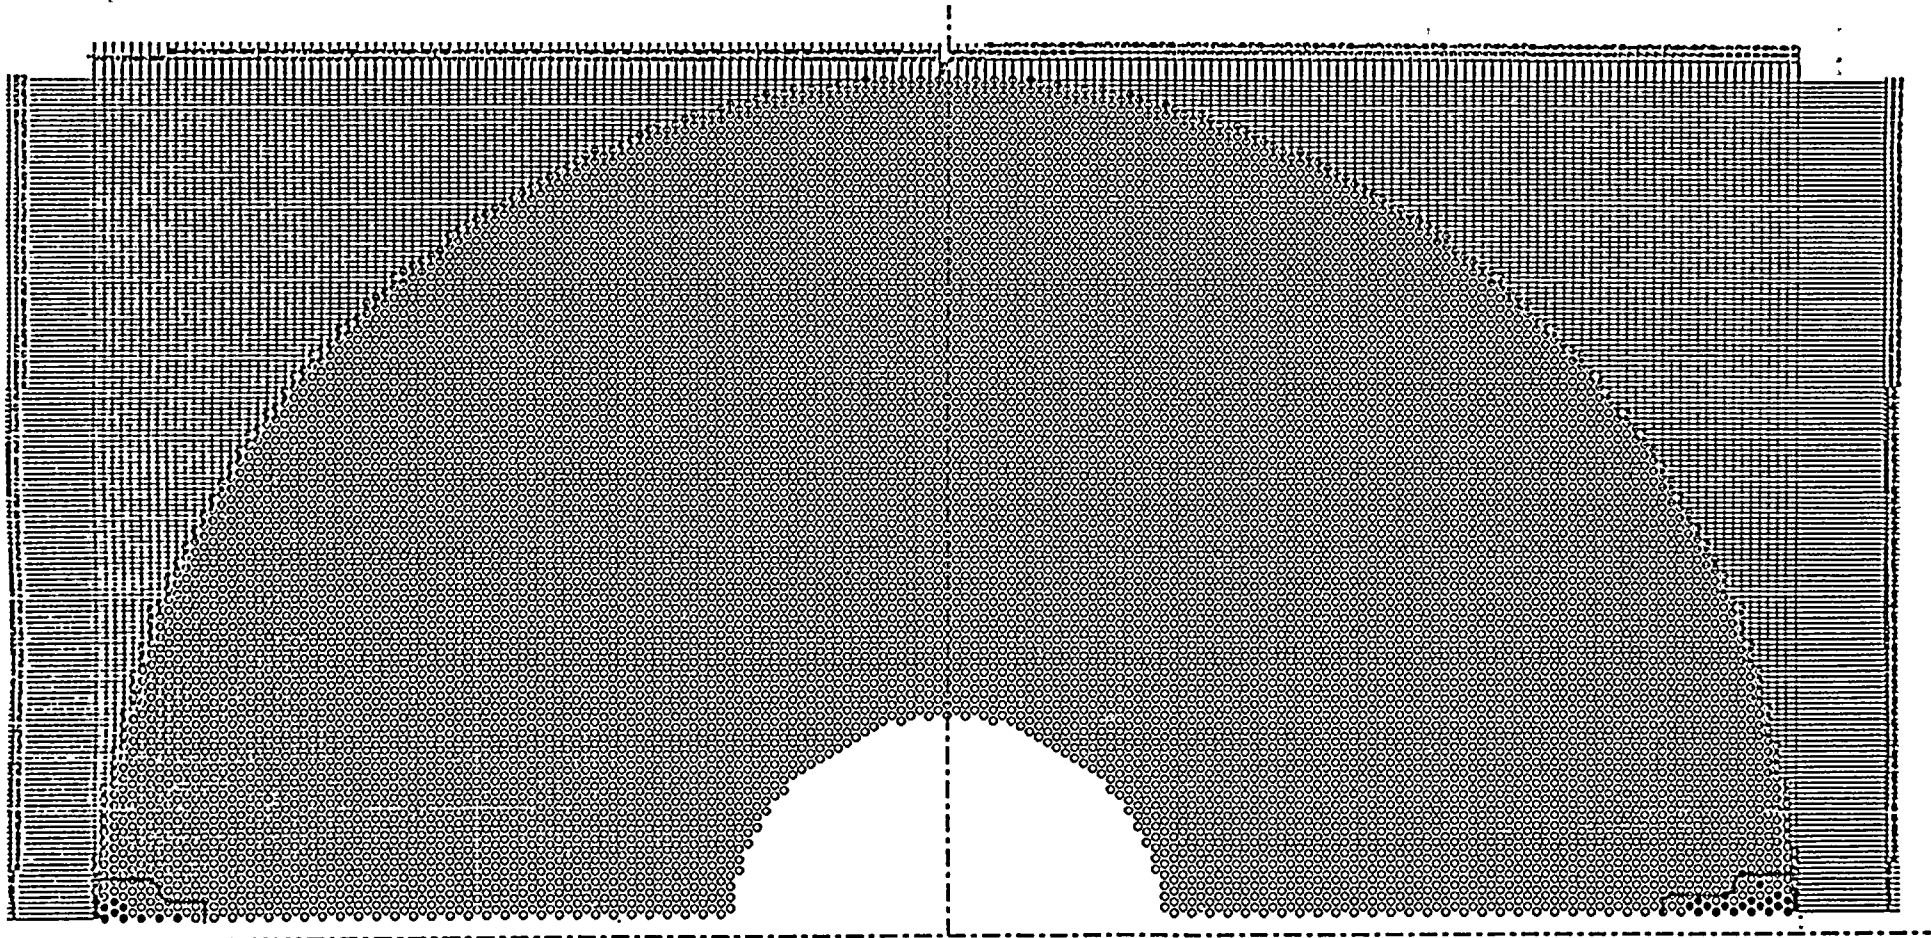
Figure 8

Unit 2, Steam Generator #1 Tube Wear
and Inspection Plan

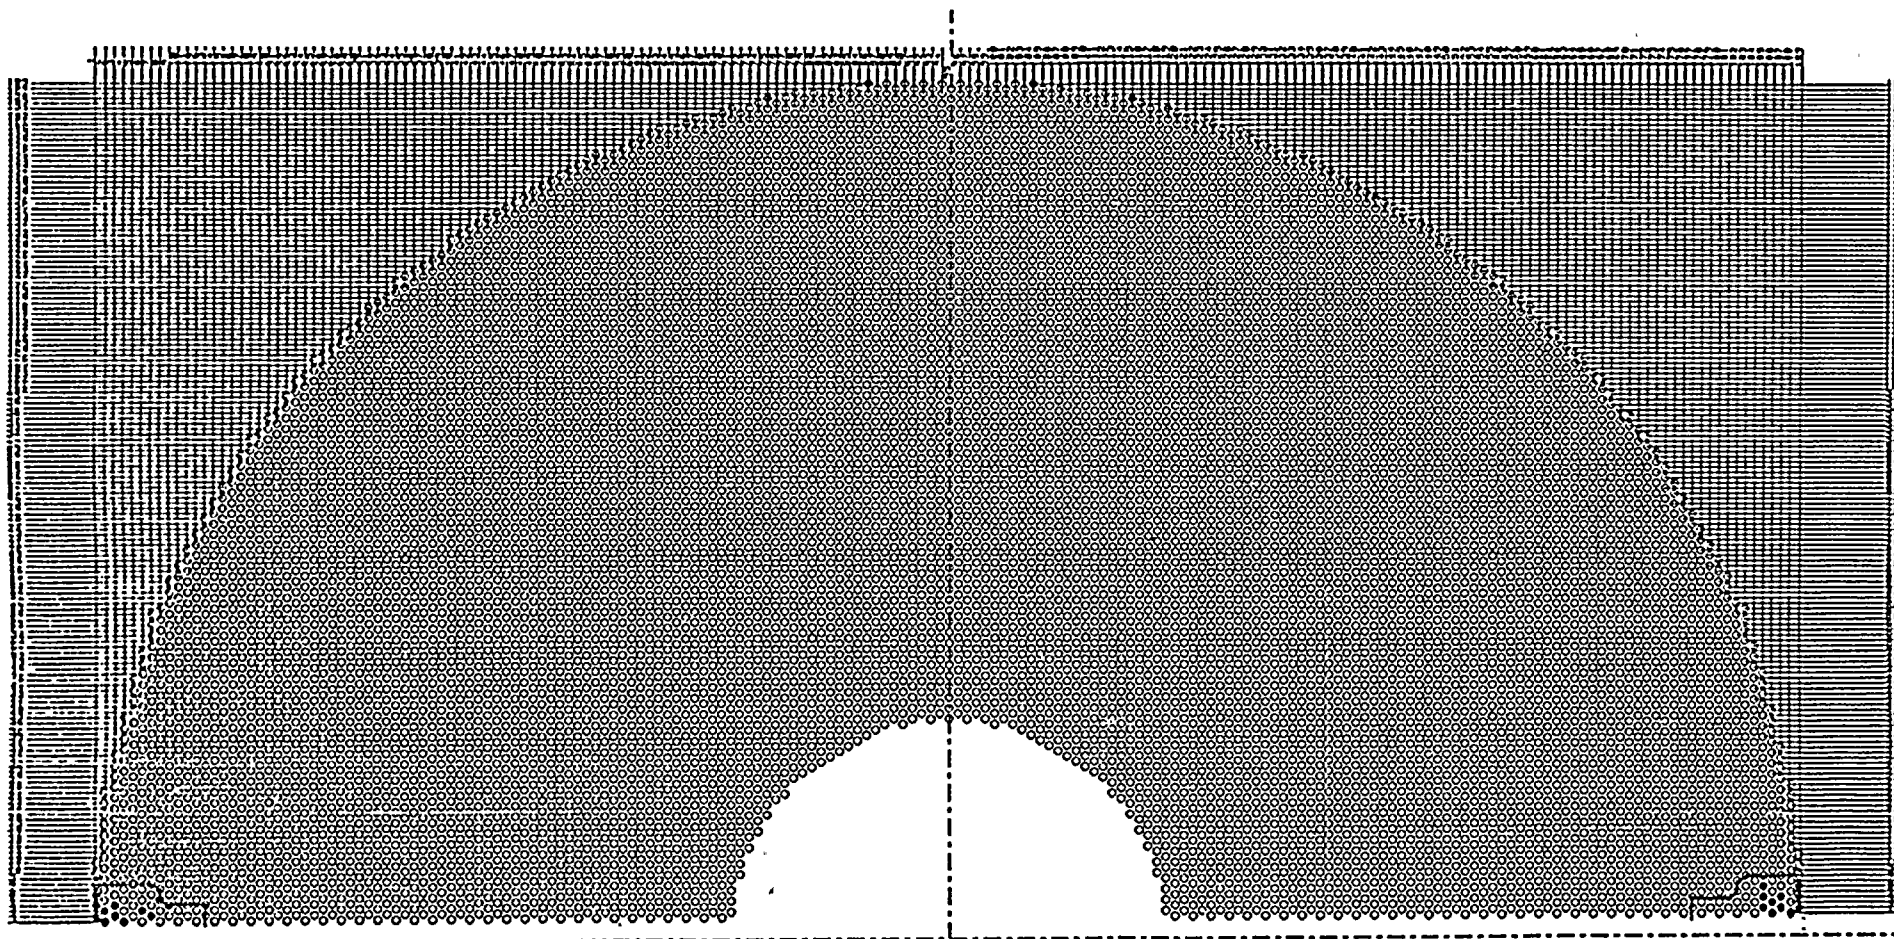
Figure 9

Unit 2, Steam Generator #2 Tube Wear
and Inspection Plan

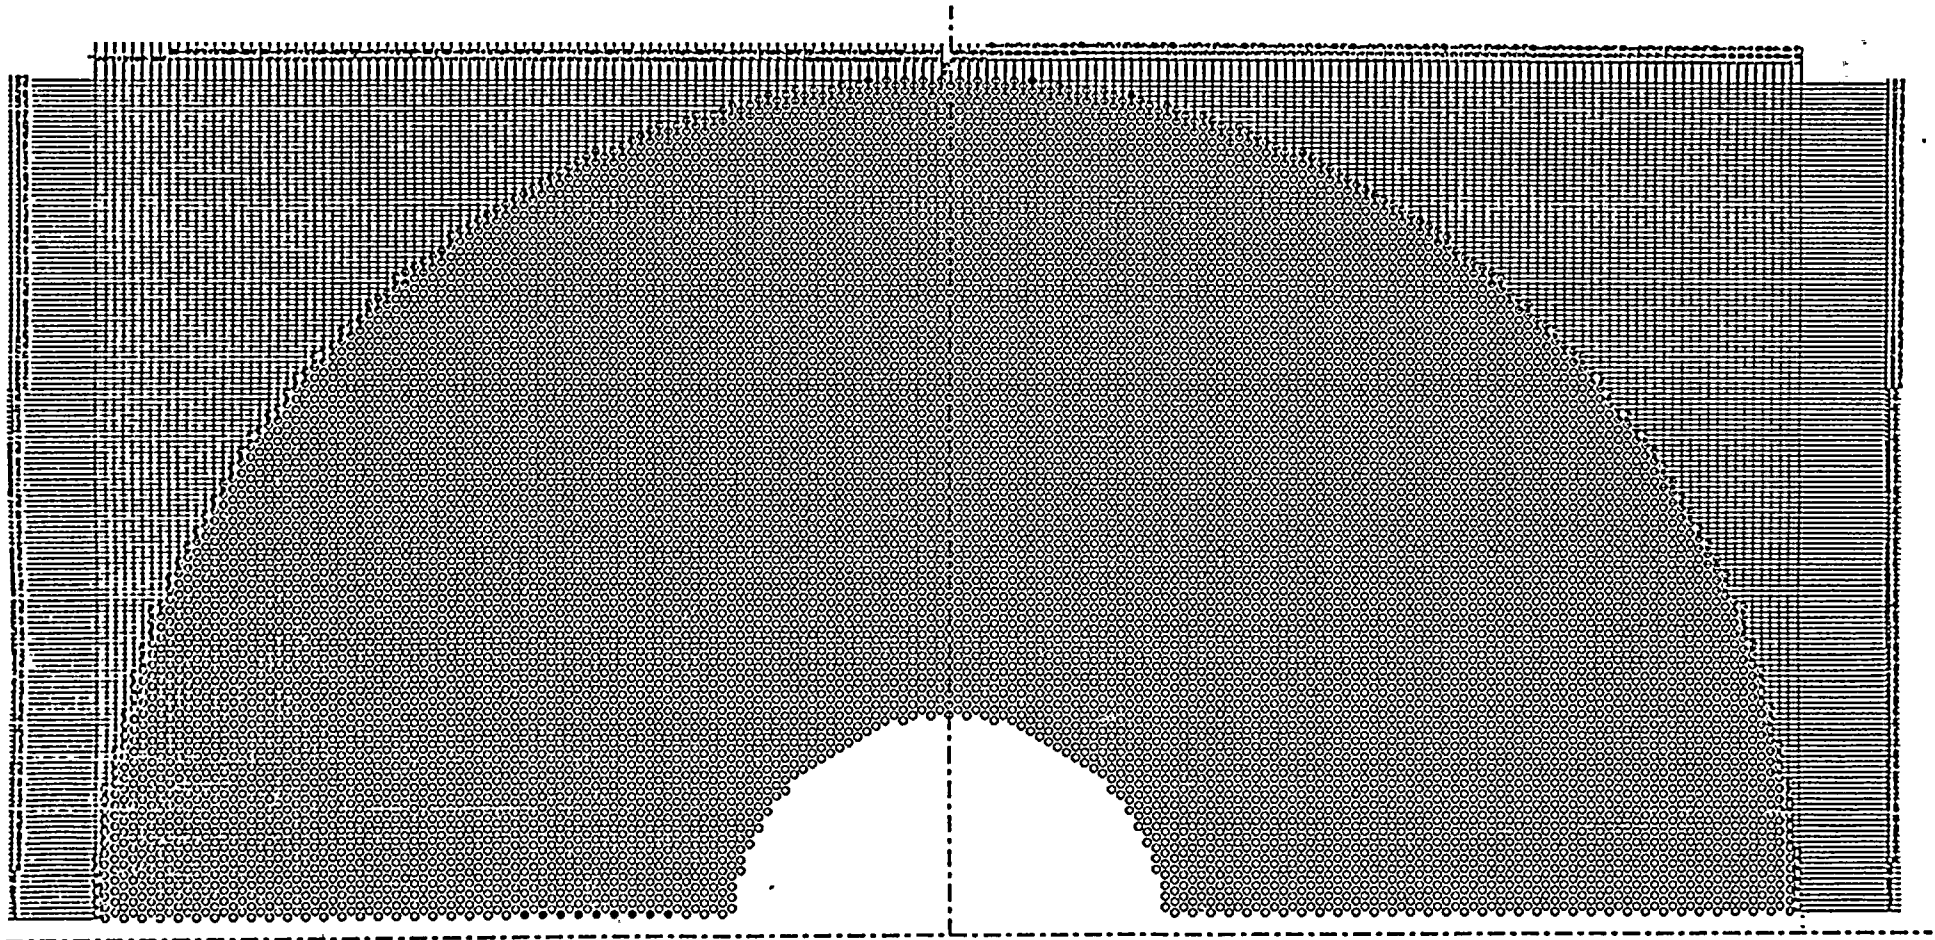
Figure 10

In steam generator #1 of PVNGS Unit 1, the tubes on the cold leg side in row 1 at columns 48 through 64 (a total of 9 tubes as shown on Figure 10), exhibited indications caused by

deformation of the tube at the top surface of the flow distribution plate (first tube support). Deformation of the tube at column 58 prevented passage of the 0.540 inch outside diameter eddy current probe. Therefore, no eddy current data was available for this tube. The other tubes that showed indications of denting were eddy current tested. There were no indications of wear or loss of tube wall for any of the inspected dented tubes.

Unit 1, Steam Generator #1 Dented Tubes

In light of the limited affected region and the detection of a metallic foreign object adjacent to the nine dented tubes, it is hypothesized that the deformation was caused by the wedging action of a metal "bar" between the economizer divider plate and the row 1 tubes during power operation. Since the flow distribution plate is made of 405 ferritic stainless steel, it has a lower coefficient of thermal expansion than the tube sheet. The relative temperature of the plate (secondary side, subcooled below saturation temperature) is also less than the tube sheet (RCS cold leg temperature). Therefore, the flow

Since the foreign object was trapped and presumably non-compressible, the tubes absorbed deformation of up to 1/8 inch. A dent of 1/8 inch would not allow passage of a 0.540 inch ECT probe. The tube could be dented at the elevation of the foreign object or at the top of the flow distribution plate by the reaction force, or by the combination of both. A fiberoptics inspection of a dented tube tended to confirm the above hypothesis. A slight straight edged indentation was found above and opposite to a smaller partial circumferential indication. This would indicate a primary dent induced by a "bar-like" object causing a reactive dent on the opposite side of a tube caused by the reaction force at the top edge of the drilled holes in the flow distribution plate.

A dent of 1/8 inch would produce a circumferential tensile strain of less than 8% on the tube inside diameter. The maximum tube inside diameter circumferential tensile strain of 8% is well below the 14% strain threshold required for "coriou" cracking (the cracking of alloy 600 tubing in high temperature PWR primary water due to a combination of high tensile stresses or strains and a susceptible micro-structure). Steam generator tubes which have become dented within drilled plates (usually due to the formation of non-protective magnetite) can take an irregular cross section as a result of being constrained from expansion in all directions.

The irregular constrained cross section can produce high inside diameter circumferential tensile strains above 14% which could then lead to tube cracking. Since the denting in PVNGS Unit 1 steam generator is above the flow distribution plate, the irregular constrained cross section will not be formed and the high circumferential inside diameter tensile strains will not be produced. Axial inside diameter strains have not produced tube cracking based on industry experience. As such, denting of these tubes is not considered to be a safety concern.

procedures, such as tube pulling, do not seem warranted in light of ALARA considerations and no further anticipated tube damage. It is ANPP's and CE's opinion that tube plugging, regardless of method, is not necessary. Monitoring selective dented tubes during a future planned eddy current inspection would confirm the non-progression of the tube dents with time.

- ° Removal of the identified part along the divider plate is not possible due to the inaccessability of the secondary side of the System 80 steam generators, both above the tubesheet and above the flow distribution plate. Since the foreign object is wedged, is in a relatively low velocity area, and bears no resemblance to the phenomena of loose parts impacting damage which has led to tube rupture, there is no immediate need to remove the object.

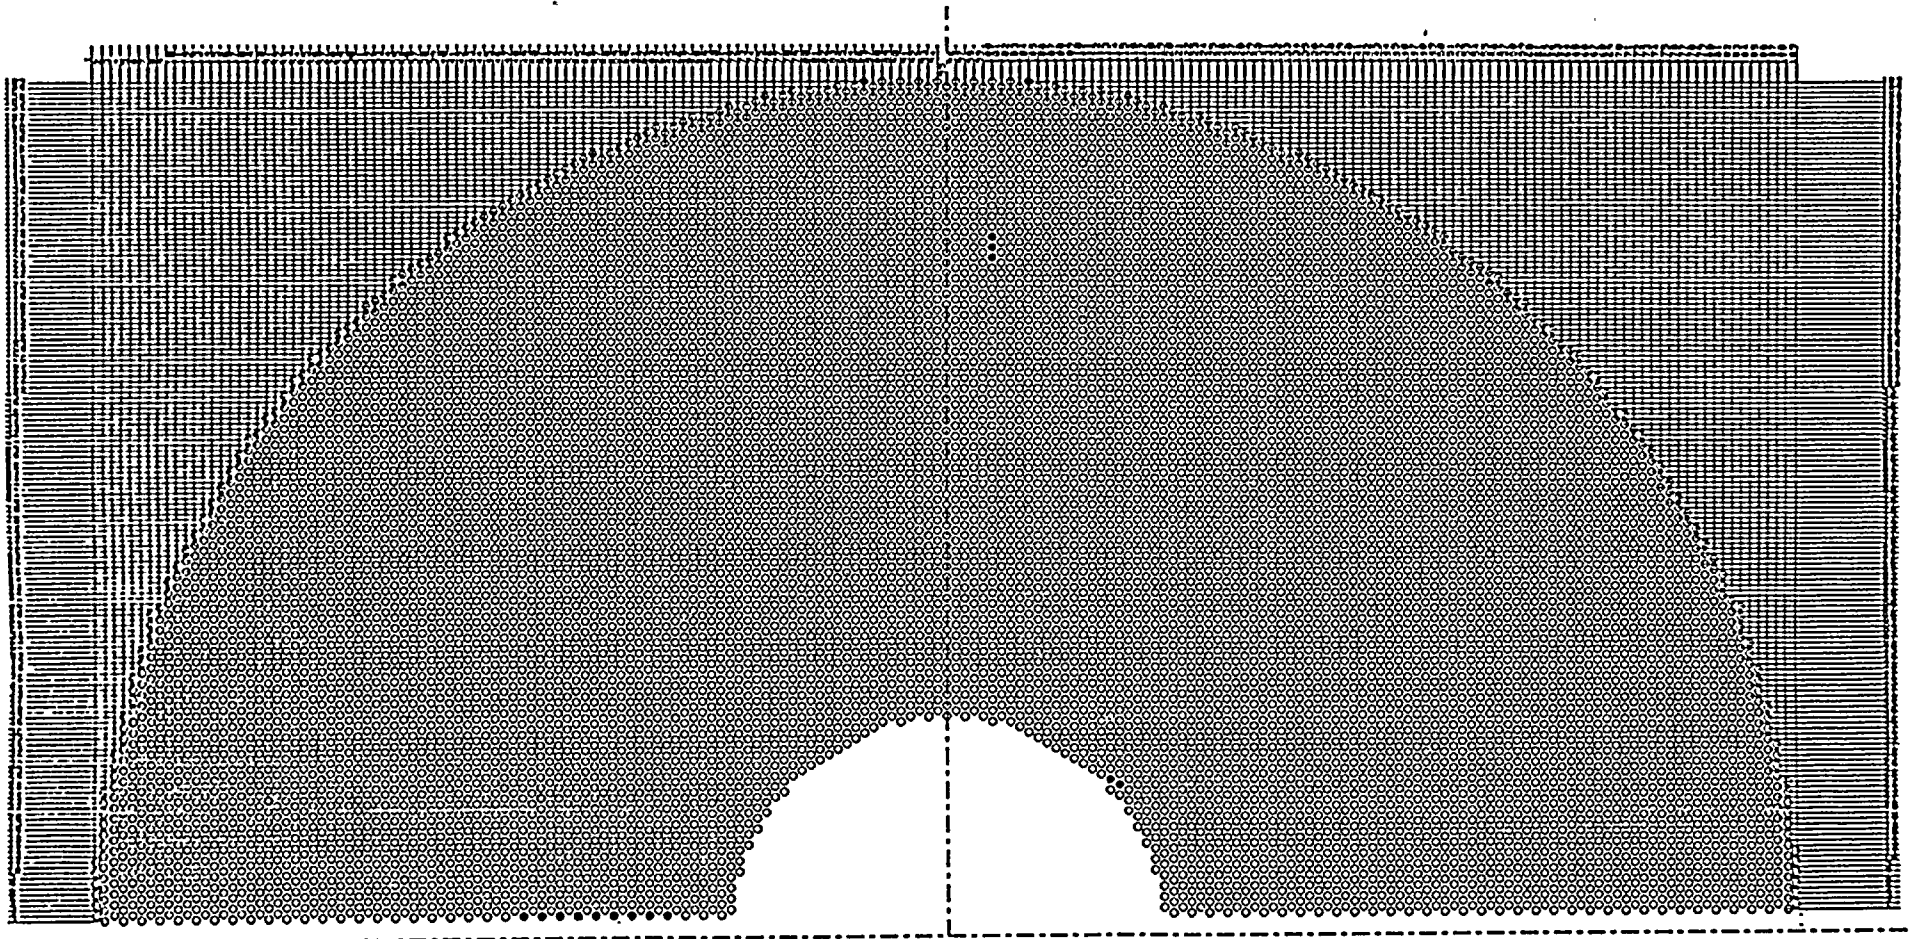
Figure 11

The use of a multi-frequency eddy current probe allows for the detection of potential loose parts or other anomalies when using the lower frequency range of the eddy current probe. As reported by our eddy current inspection team, potential loose part indications were found at the locations described in Table 2 and shown in Figures 11 and 12.

Unit 1, Steam Generator #1 Potential
Loose Parts Indications

Although the indications are too small to be well characterized, neither of the two tubes or any surrounding tubes show any sign of wear or tube wall degradation. Thus, the presence of these indications does not represent a safety concern.

The indication in Unit 1 steam generator #1 at rows 125 through 129 - column 100 and in steam generator #2 at row 39 - column 4 have been determined to be variations in the tubes themselves, such as the result of a permeability change in the tube. A multi-frequency mix of the eddy current signals indicates no tube wall degradation and no actual presence of foreign material. Therefore, these indications do not represent a significant safety concern.

The indications of a loose part at the row 1 - columns 48 through 64 location are discussed in Section III.B of this report. Two of the three remaining areas have been determined to be other than loose parts. The possible presence of a small foreign object at the remaining location cannot be positively ruled out. However, if one does exist, its size and location is such that no damage has occurred and no corrective action is necessary. These and other surrounding tubes will be monitored in a subsequent eddy current inspection.

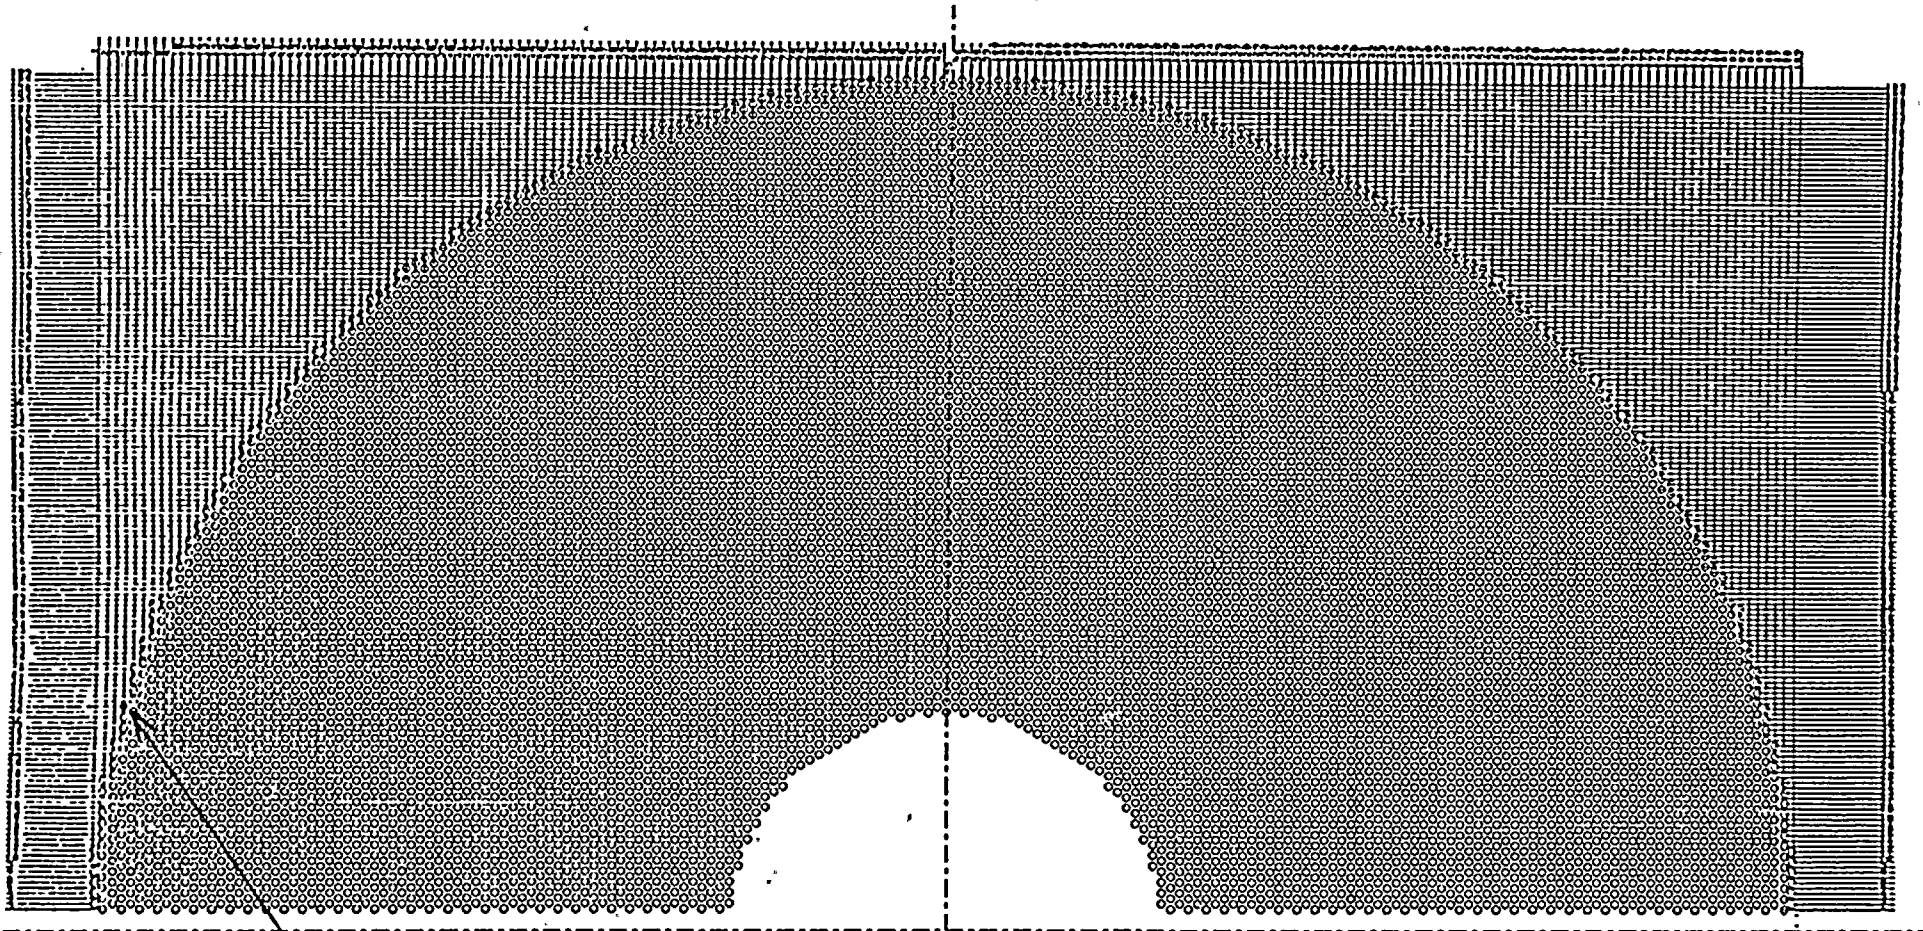
Figure 12

Unit 1, Steam Generator #2 Potential
Loose Parts Indications

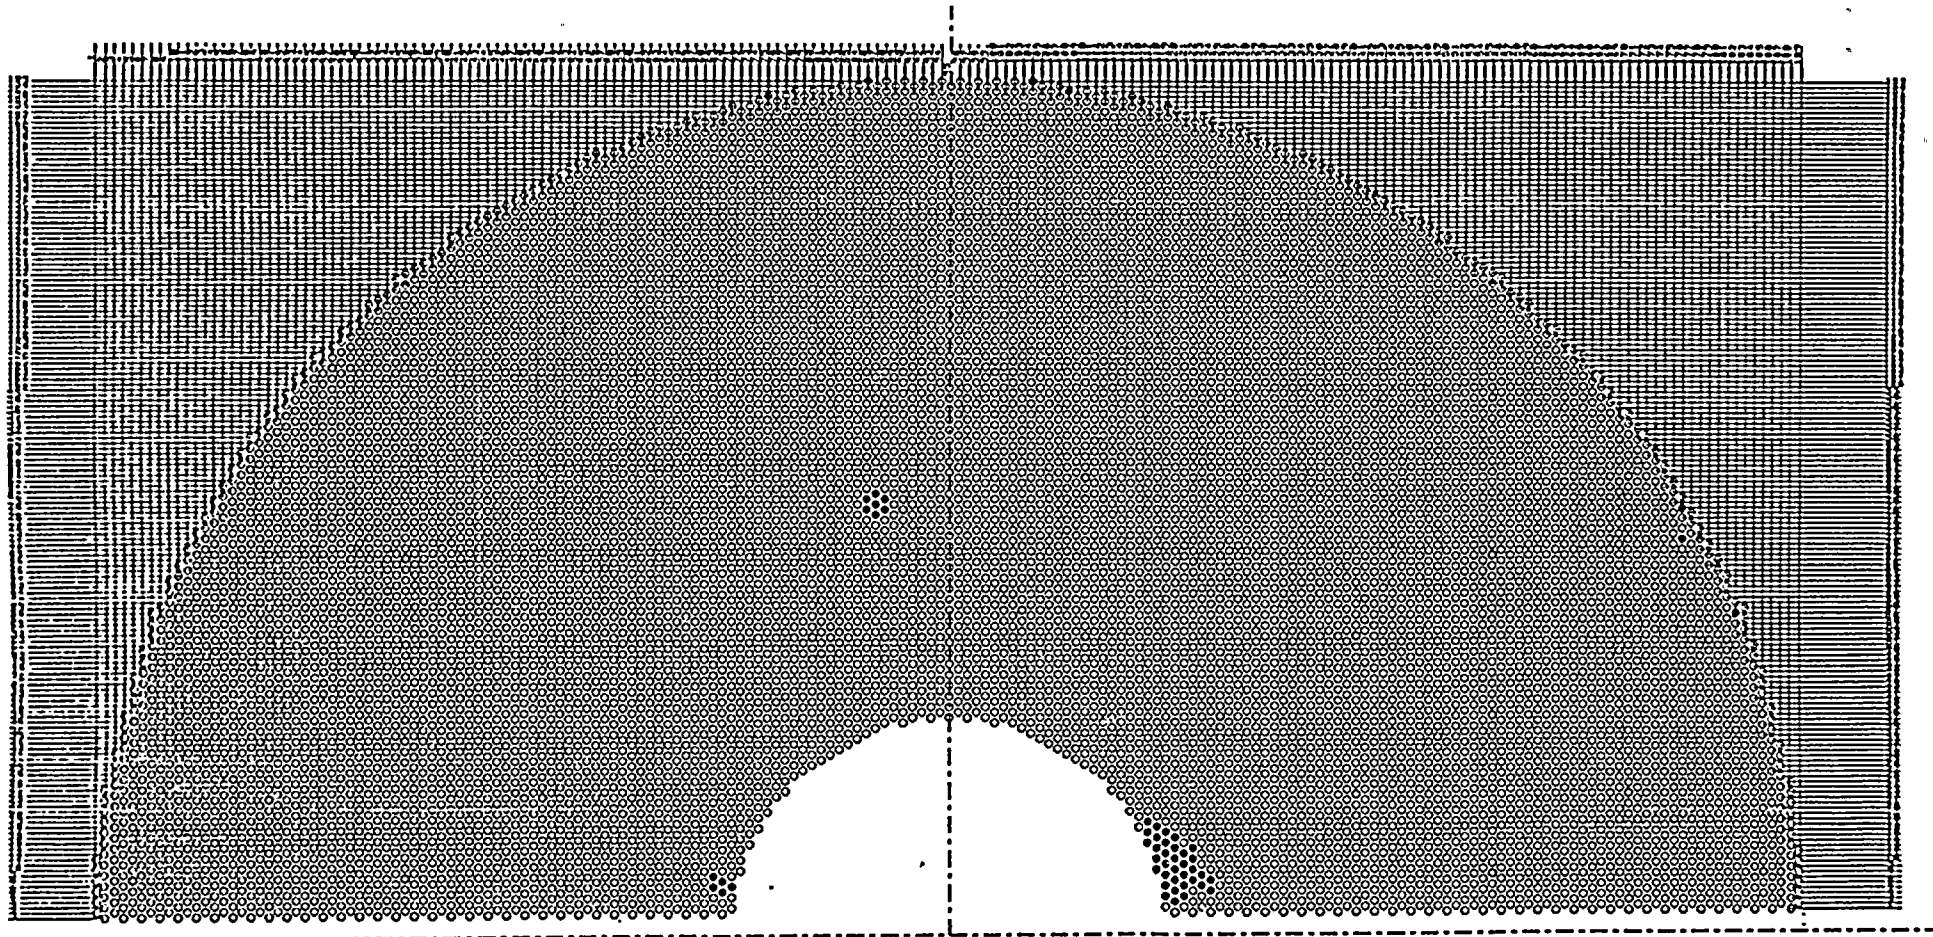
Figure 13

Unit 1, Steam Generator #1 Cold Leg
Side Sludge

The very small amount of sludge found in the Unit 1 steam generators indicates that secondary chemistry control has been good. The locations of the largest deposits of sludge indicate that the sludge is being swept across the tube sheet to the area of the blowdown ring. This indicates that the blowdown system is operating as designed to prevent sludge accumulations from forming in the center regions of the tube bundle which have been a concern in previous steam generator designs.

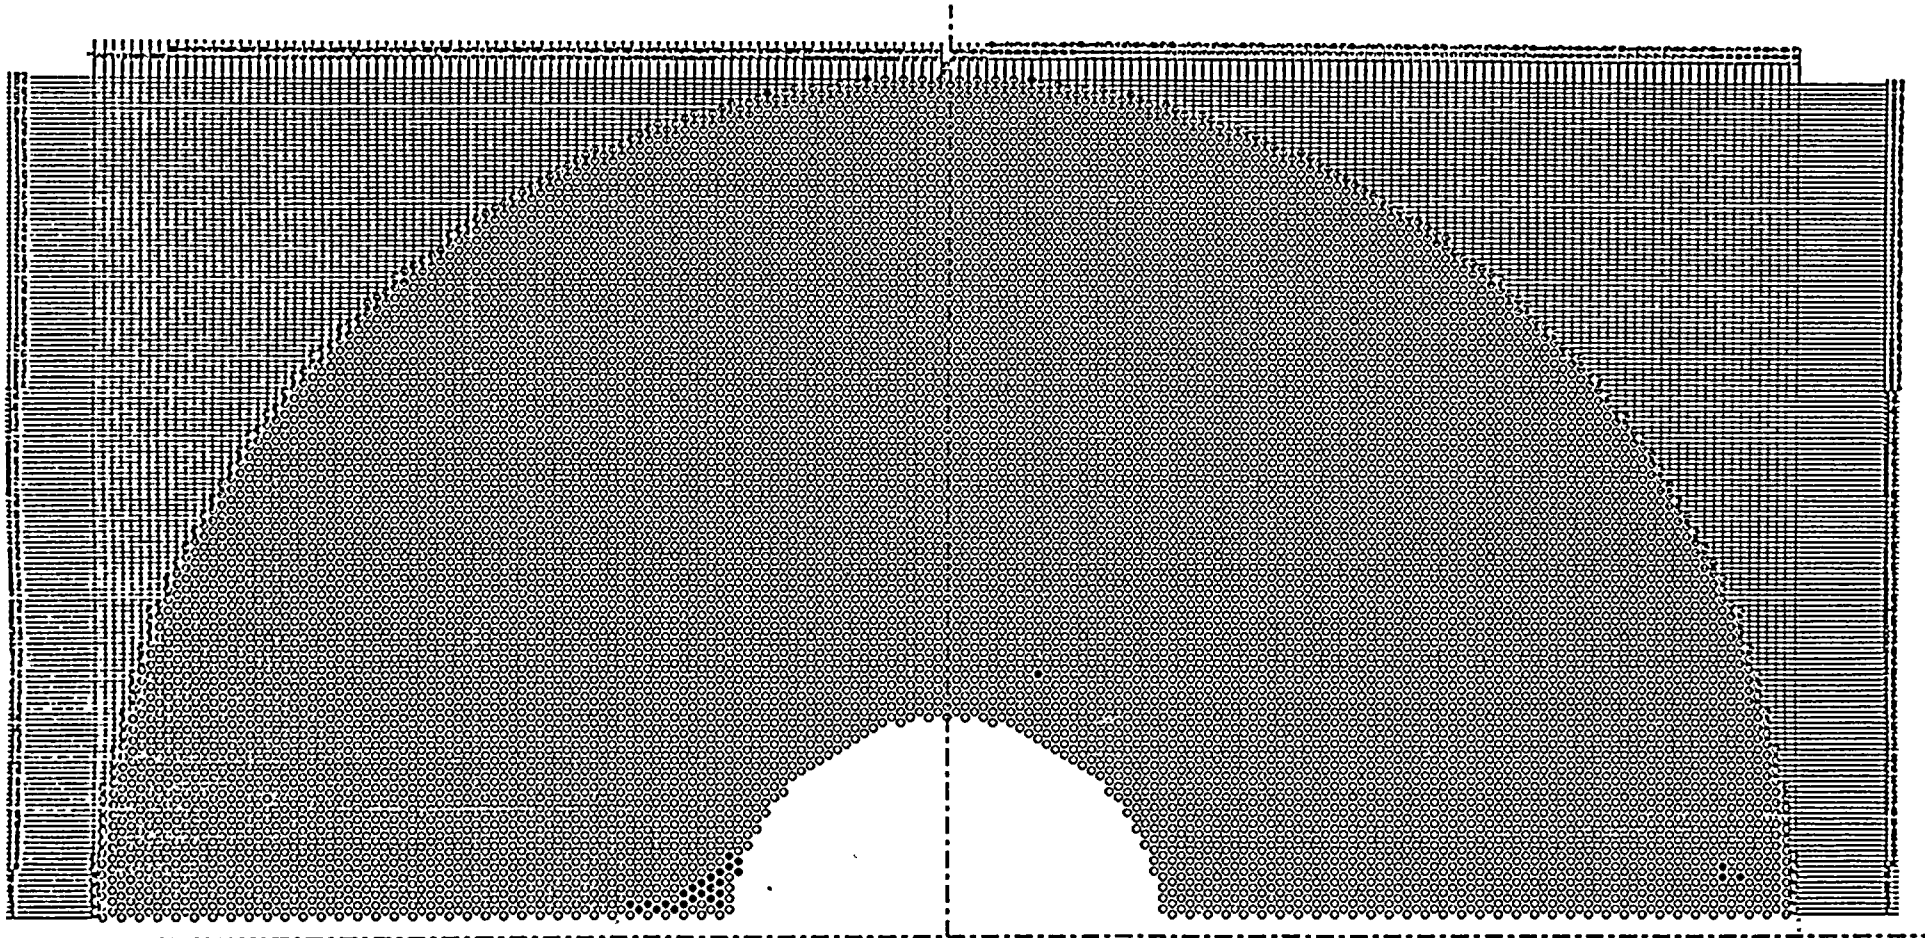
Figure 14

Unit 1, Steam Generator #2 Cold Leg
Side Sludge

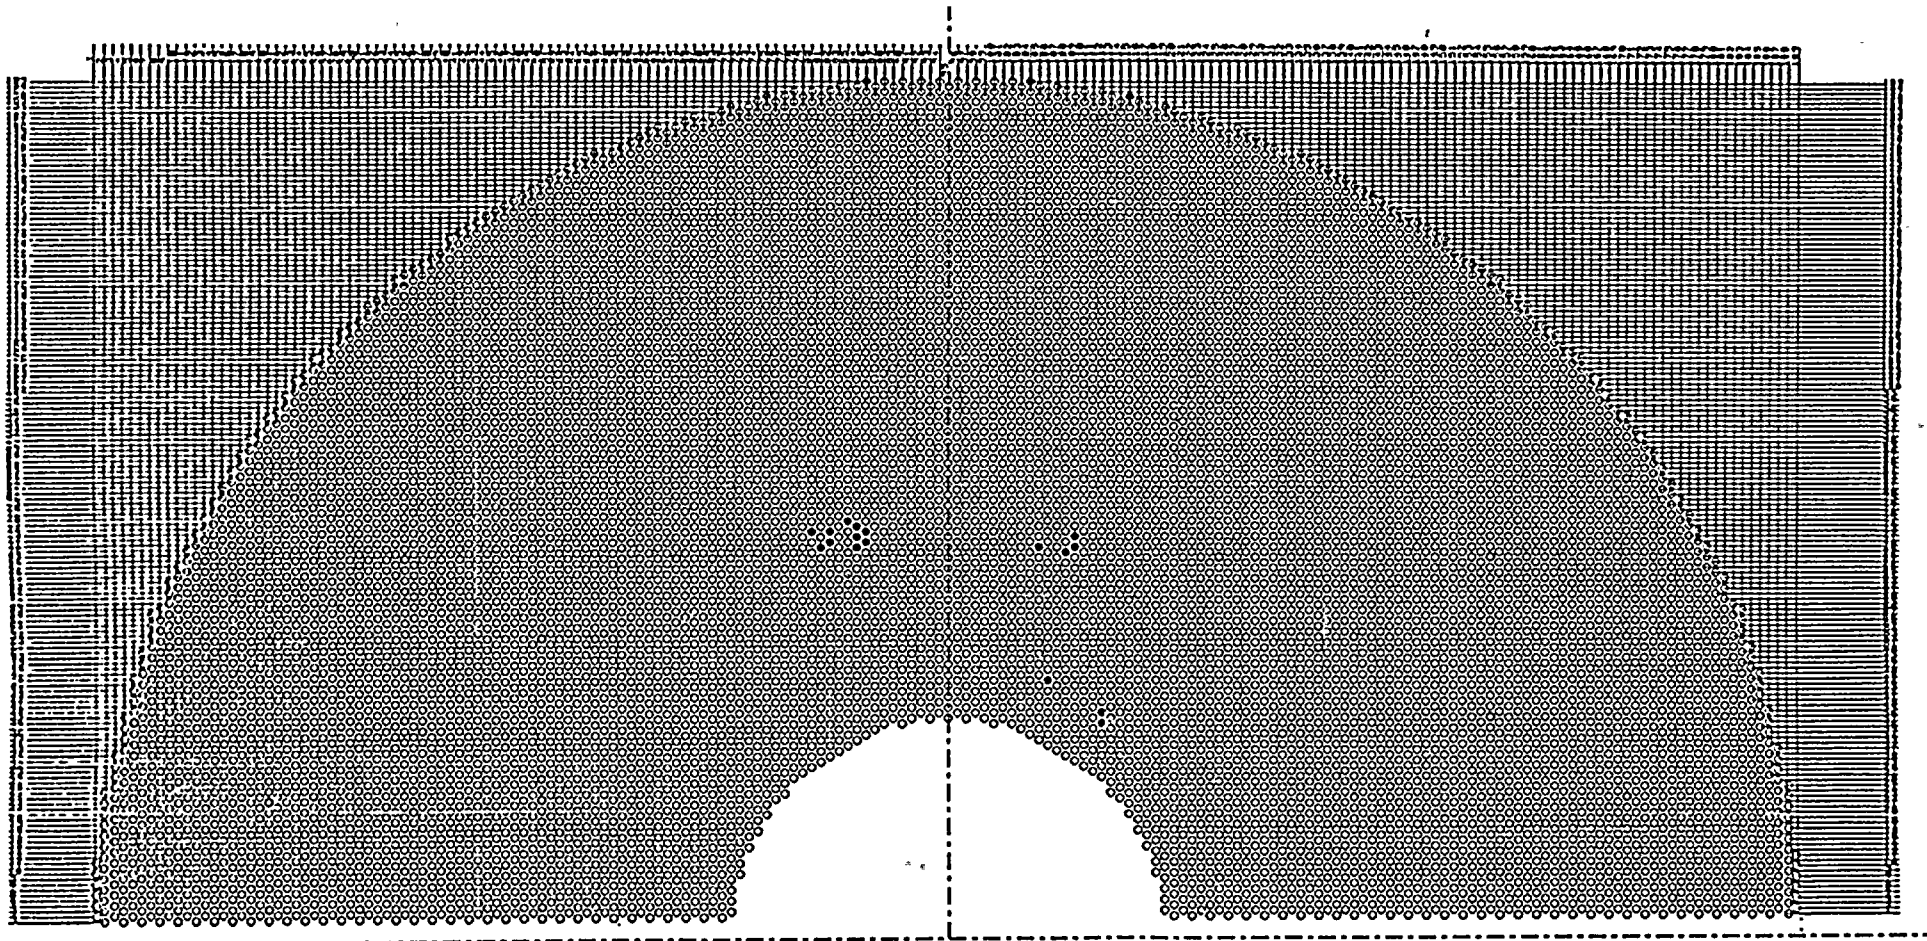
Figure 15

Unit 1, Steam Generator #2 Hot Leg
Side Sludge

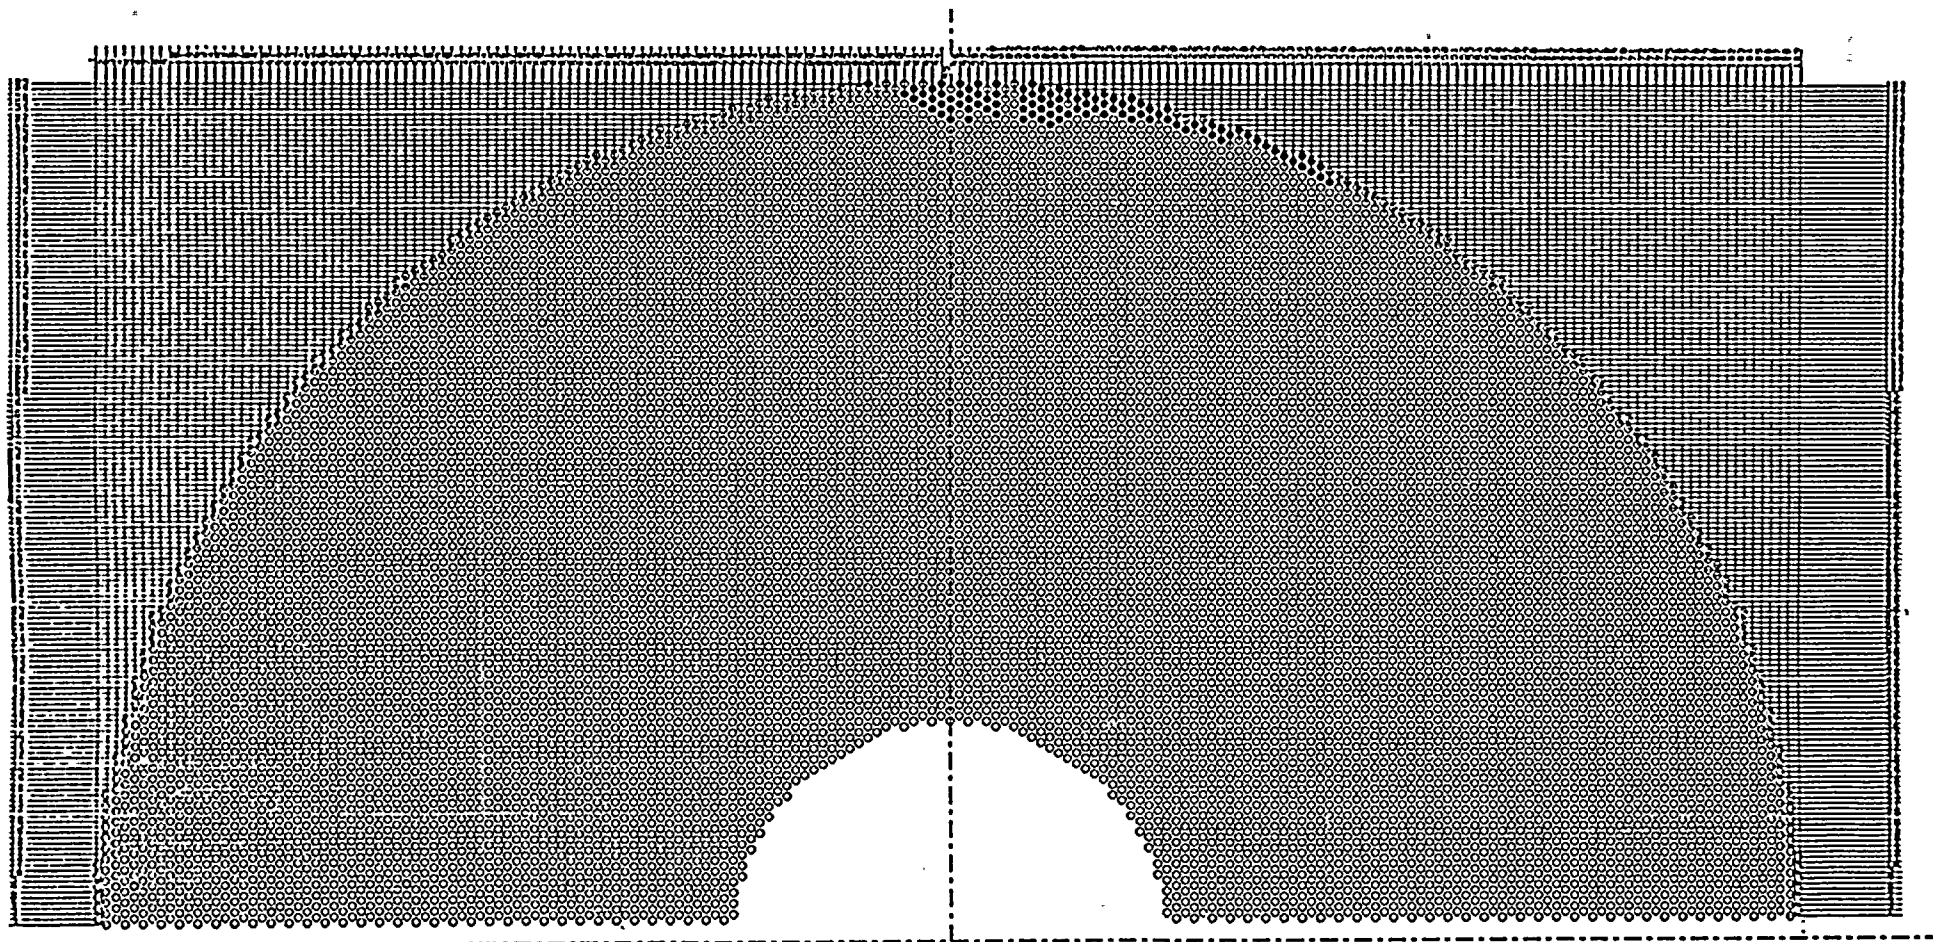
Figure 16

Unit 1, Steam Generator #1 Foreign
Material Locations
