SUBJECT: Forwards Rev 0 to "Rept on Steam Generator Tube Leak at Unit 1," per 870220 request. Rept provides requested info for Units 1 & 2 & discussion of alternatives considered for Unit 3.

Subject: Palo Verde Nuclear Generating Station (PVNGS)
Units 1, 2 and 3
Docket Numbers: STN 50-528 (License No. NPF-41)
STN 50-529 (License No. NPF-51)
STN 50-530
Report on the PVNGS Steam Generators
File: 87-E-056-026; 87-F-056-026

TUBE LEAK AT PVNGS UNIT 1

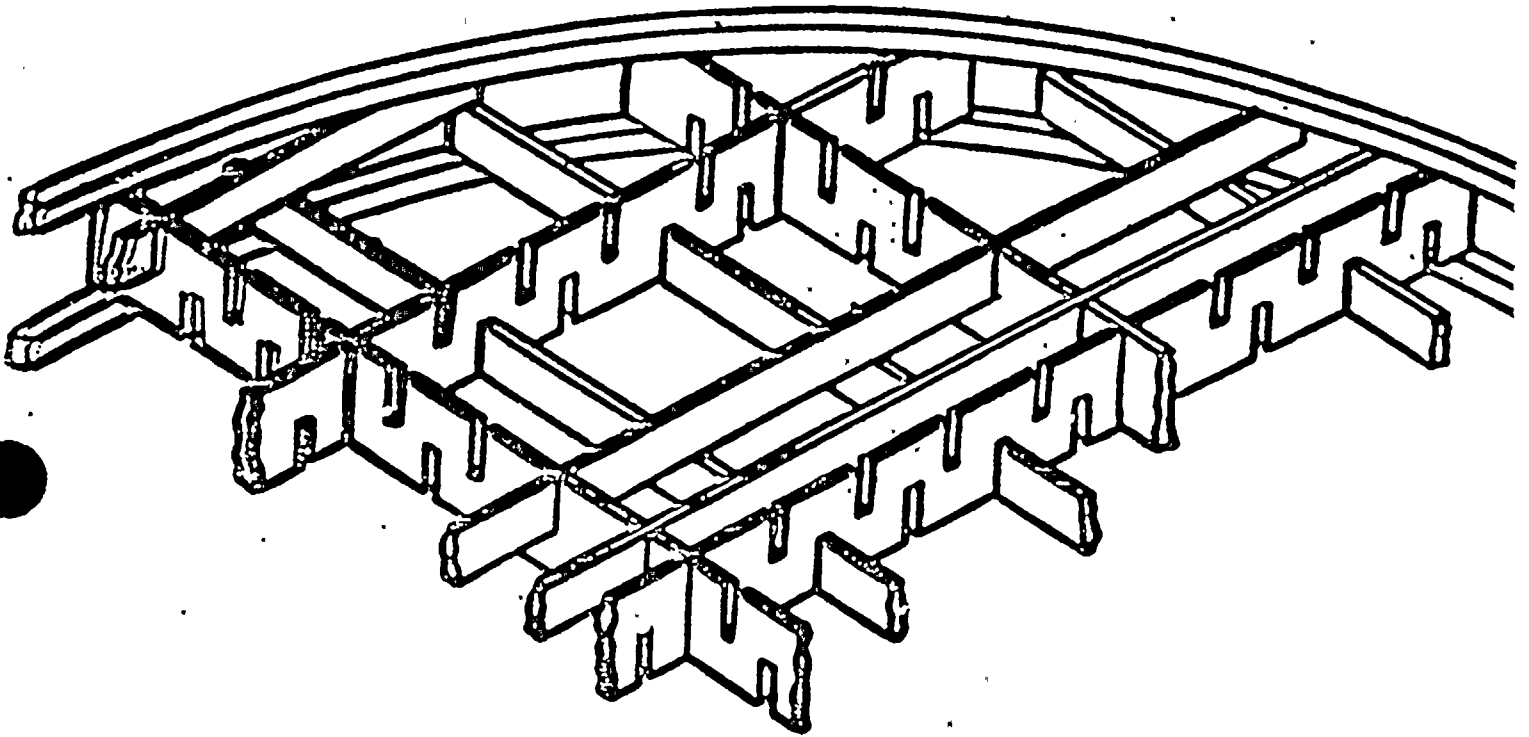
Figure 18

This condition can be further aggravated near the outer periphery where the eggcrates are welded to the shroud support bars (Figure 18), potentially resulting in slight distortion of individual eggcrate members. The tighter held tubes are sufficiently stiff to resist vibration and, thus, exhibit no wear. Therefore, both conditions, loosely held tubes and high radial cross flow velocity must exist to cause this tube wear phenomenon.
