SUBJECT: Forwards response to RJ Pate request for justification for continued operation of Unit 1 & inability of Control Element Assembly 56 to reliably drop during testing. Addl info solicited by C-E & followed.

Subject: Palo Verde Nuclear Generating Station (PVNGS)
Unit 1
Justification for Continued Operation - Inability
of CEA 56 to Drop
File: 88-A-056-026

ATTACHMENT A

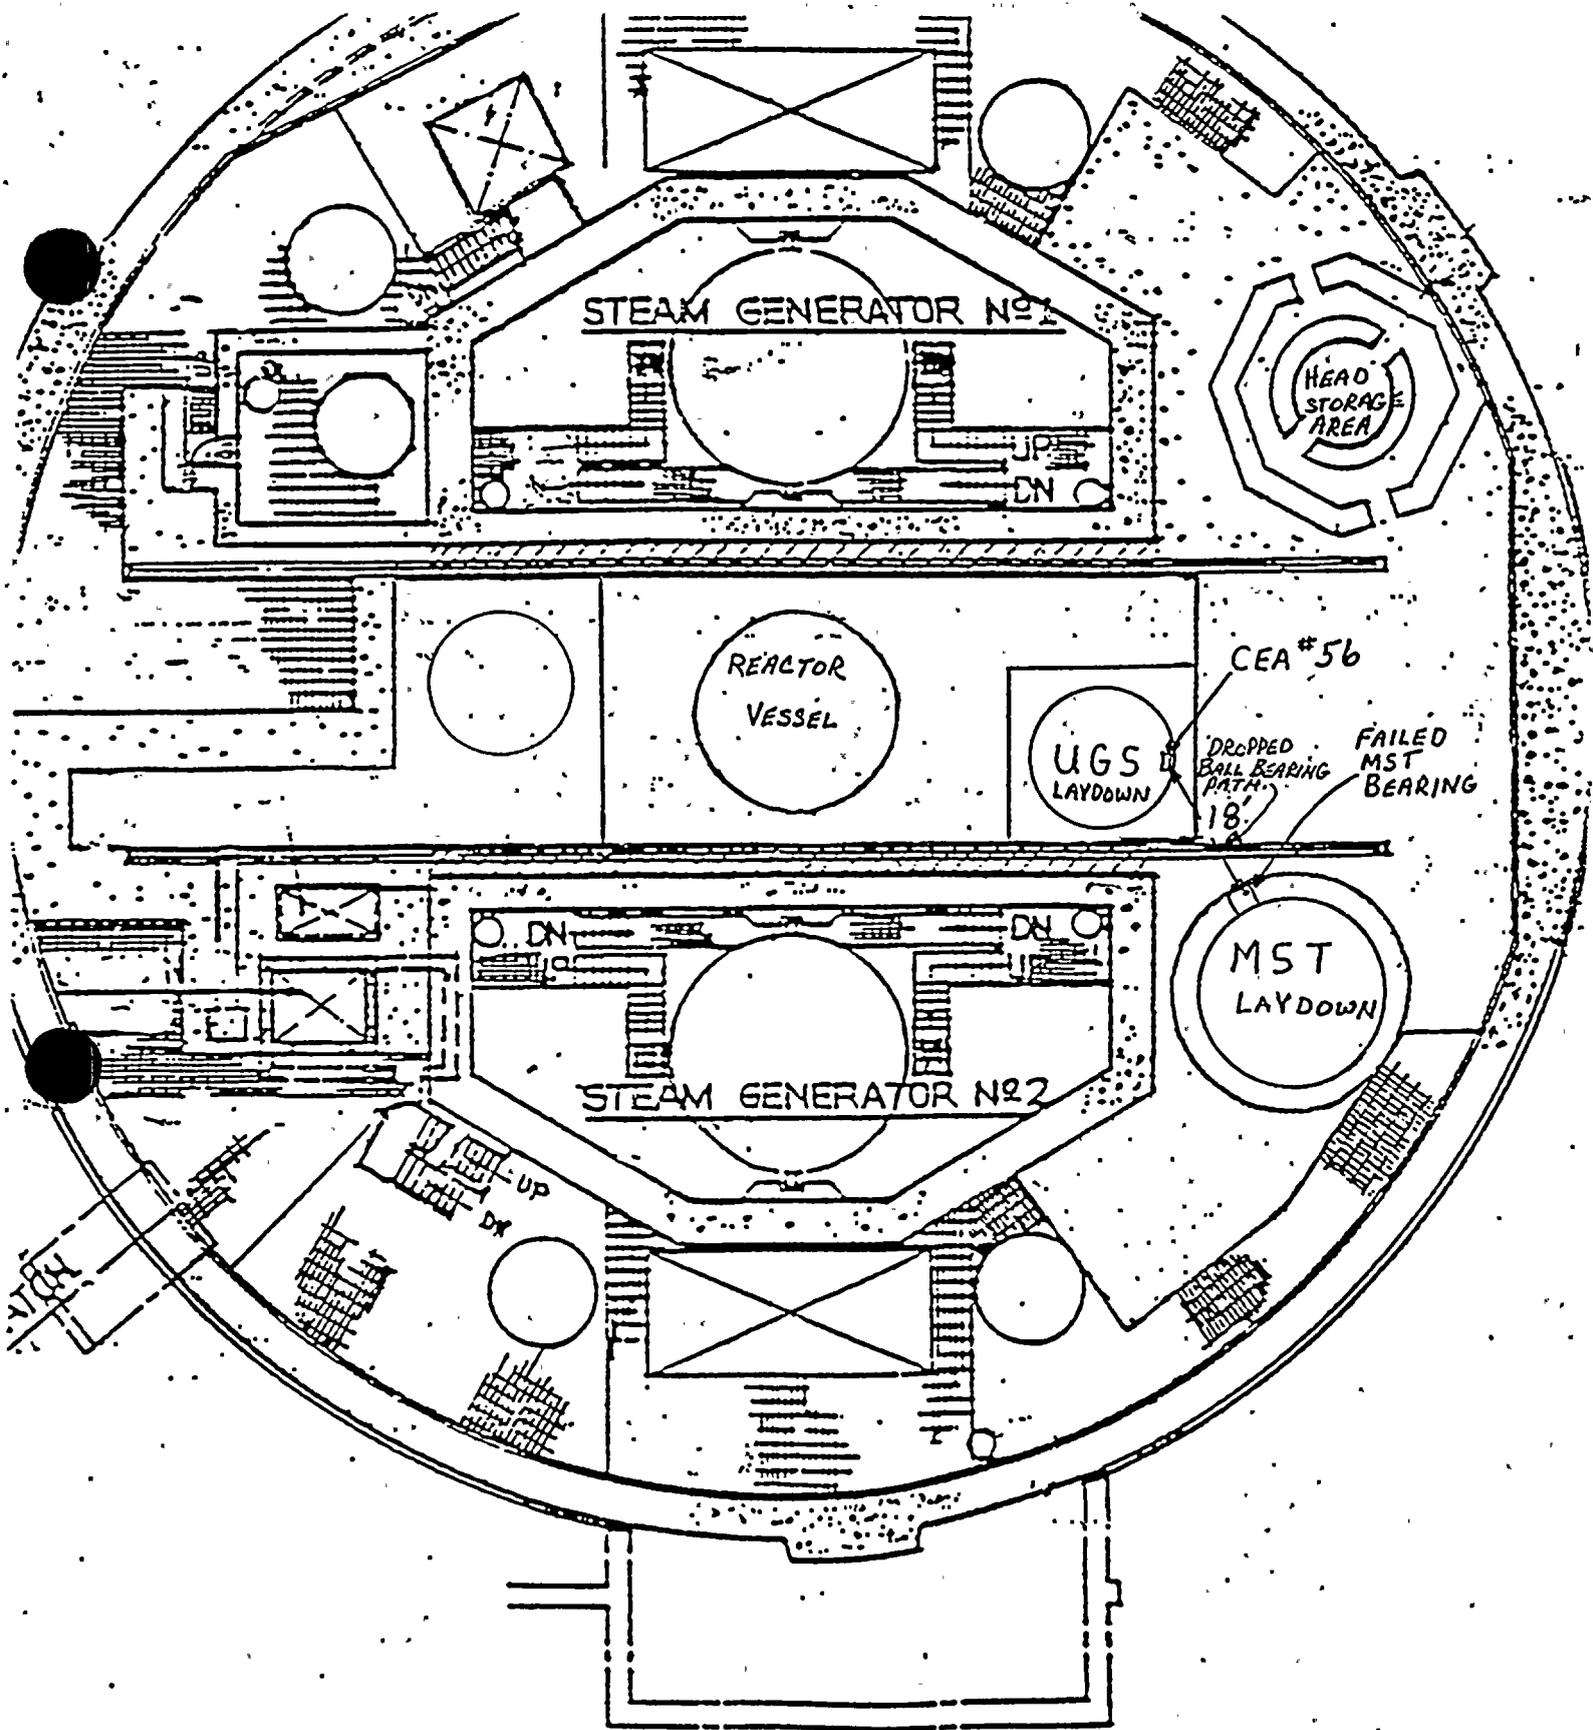
FIG 1

- a. The MST was removed from the reactor vessel head to the storage location with the studs stored in the MST (Fig. 1).
- b. The MST was being utilized for stud cleaning in the storage location (Fig. 1).

- c. While the stud cleaning was in progress, the reactor vessel head was removed to its storage location (Fig. 1).
- d. The UGS was then removed to the UGS storage pit (Figs. 1&2).

- e. The ball bearing was released from the MST (Fig. 1).
- f. During the course of work activities, the ball bearing fell into the UGS Storage Pit and onto the top of the UGS upper support plate (Figs. 1&2).

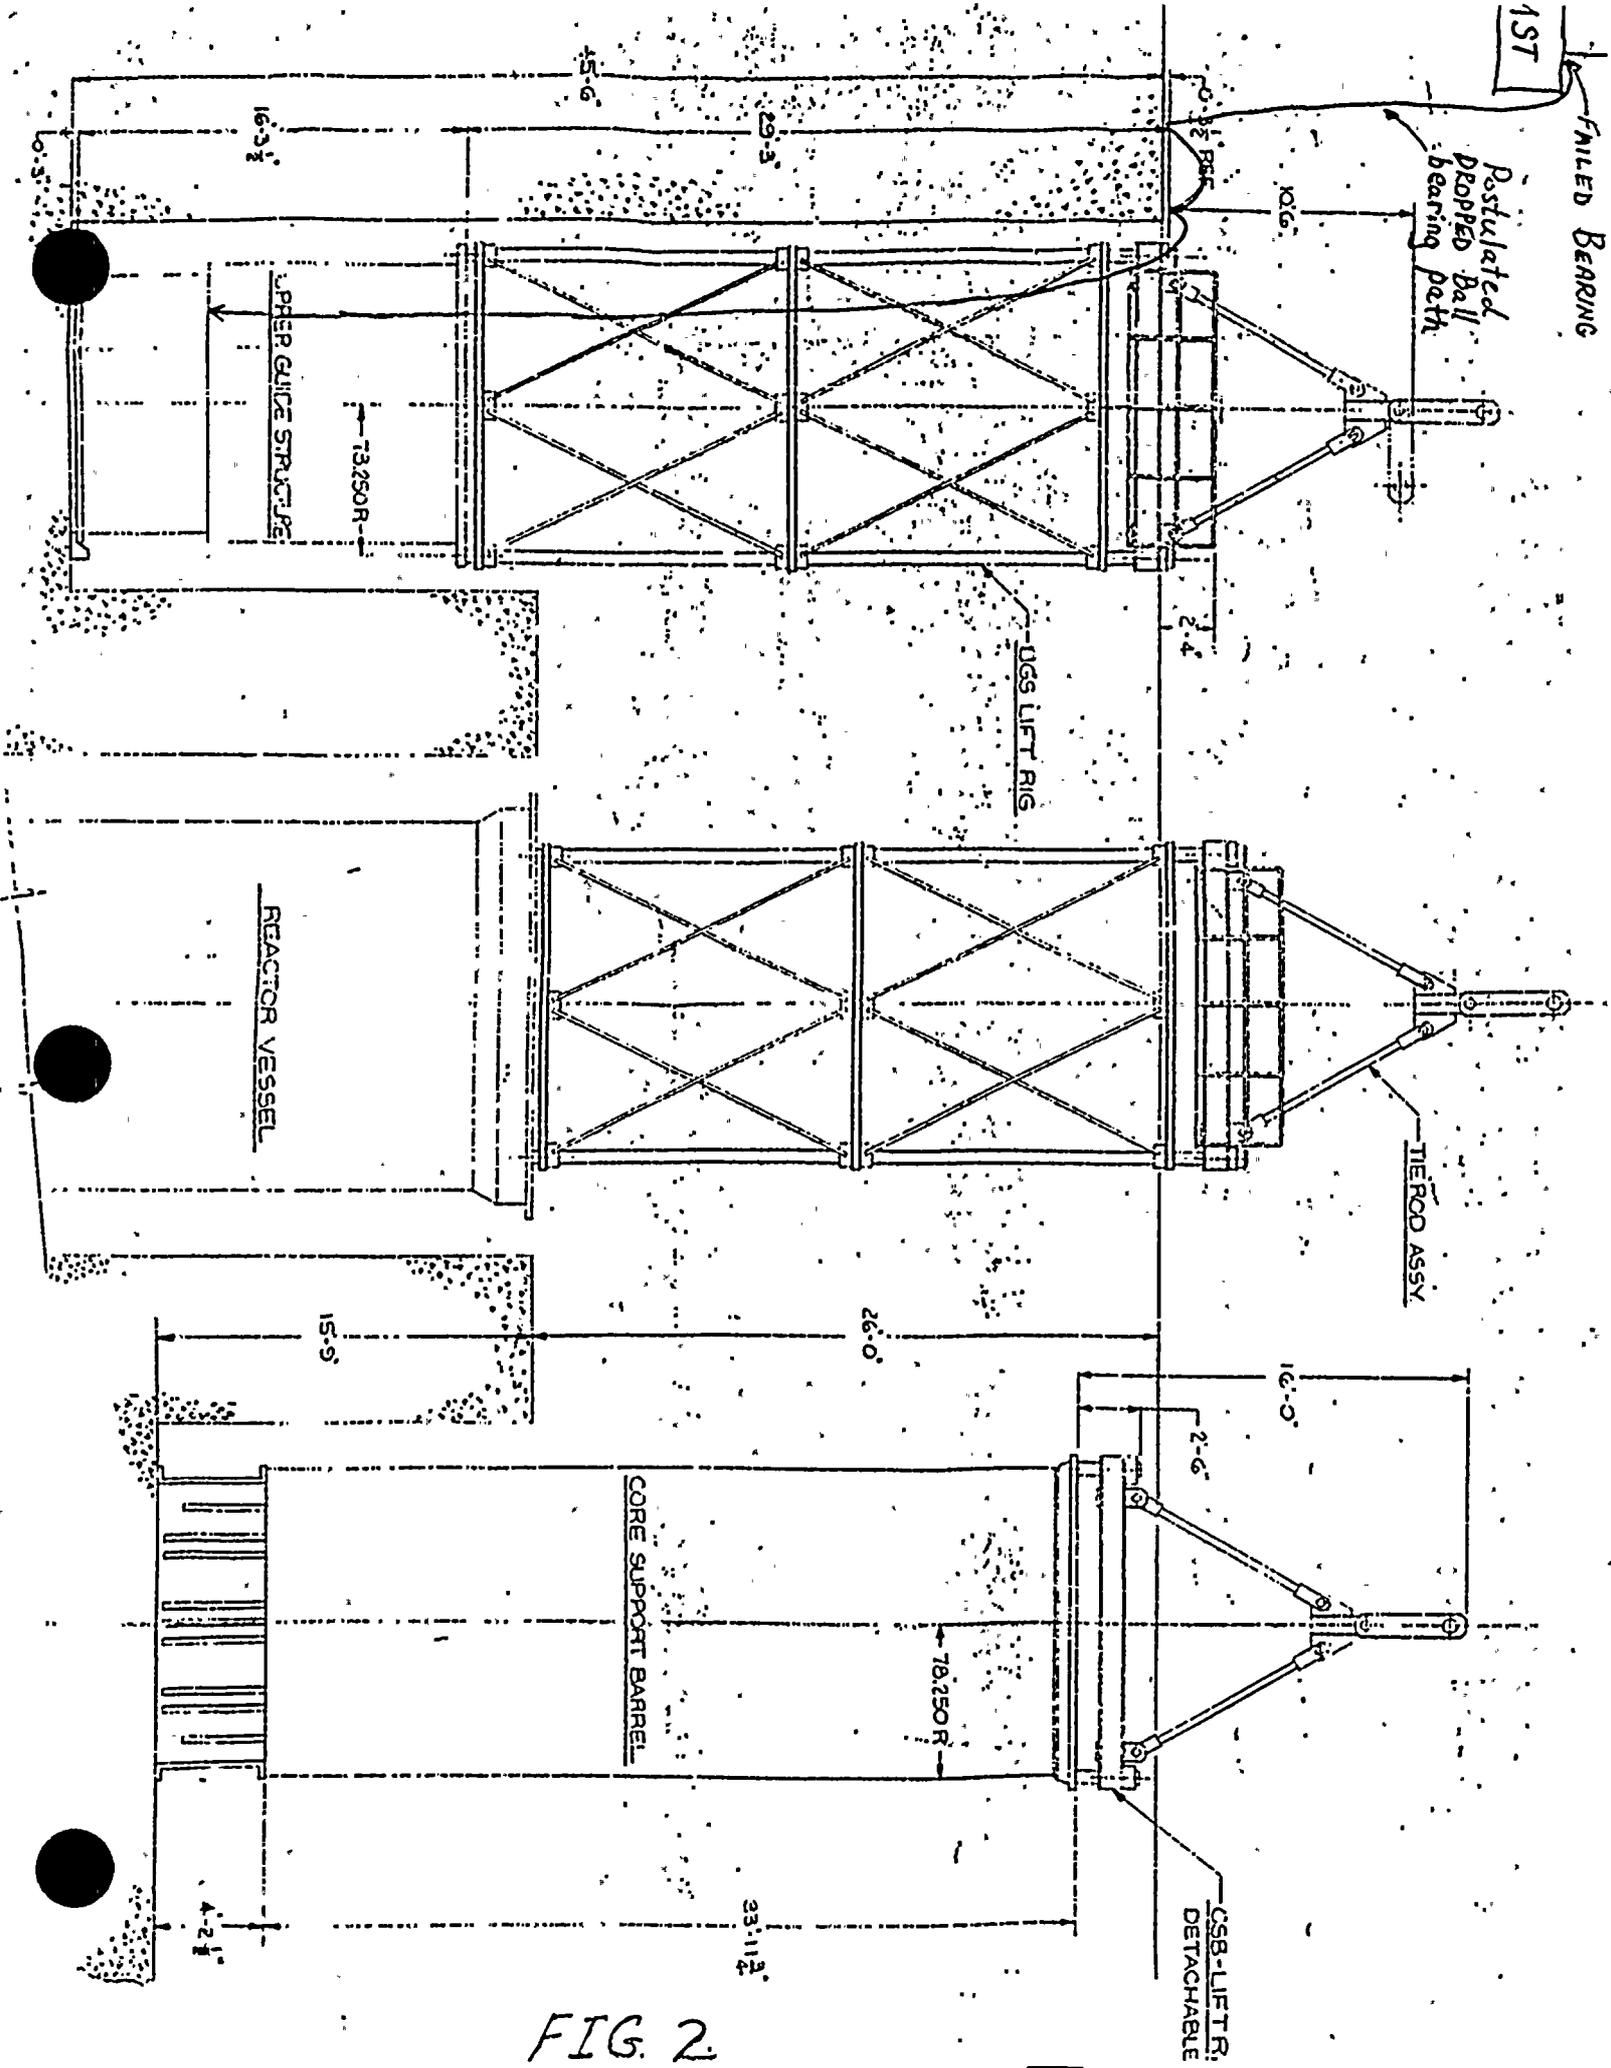
FIG. 2

- g. The UGS was reinstalled in the reactor vessel (Figs. 1&2).
- h. The reactor vessel head was reinstalled.
- i. During the course of heating up and running the RCPs, the ball bearing dropped between the UGS guide tube and the CEA finger (Figs. 3-12).

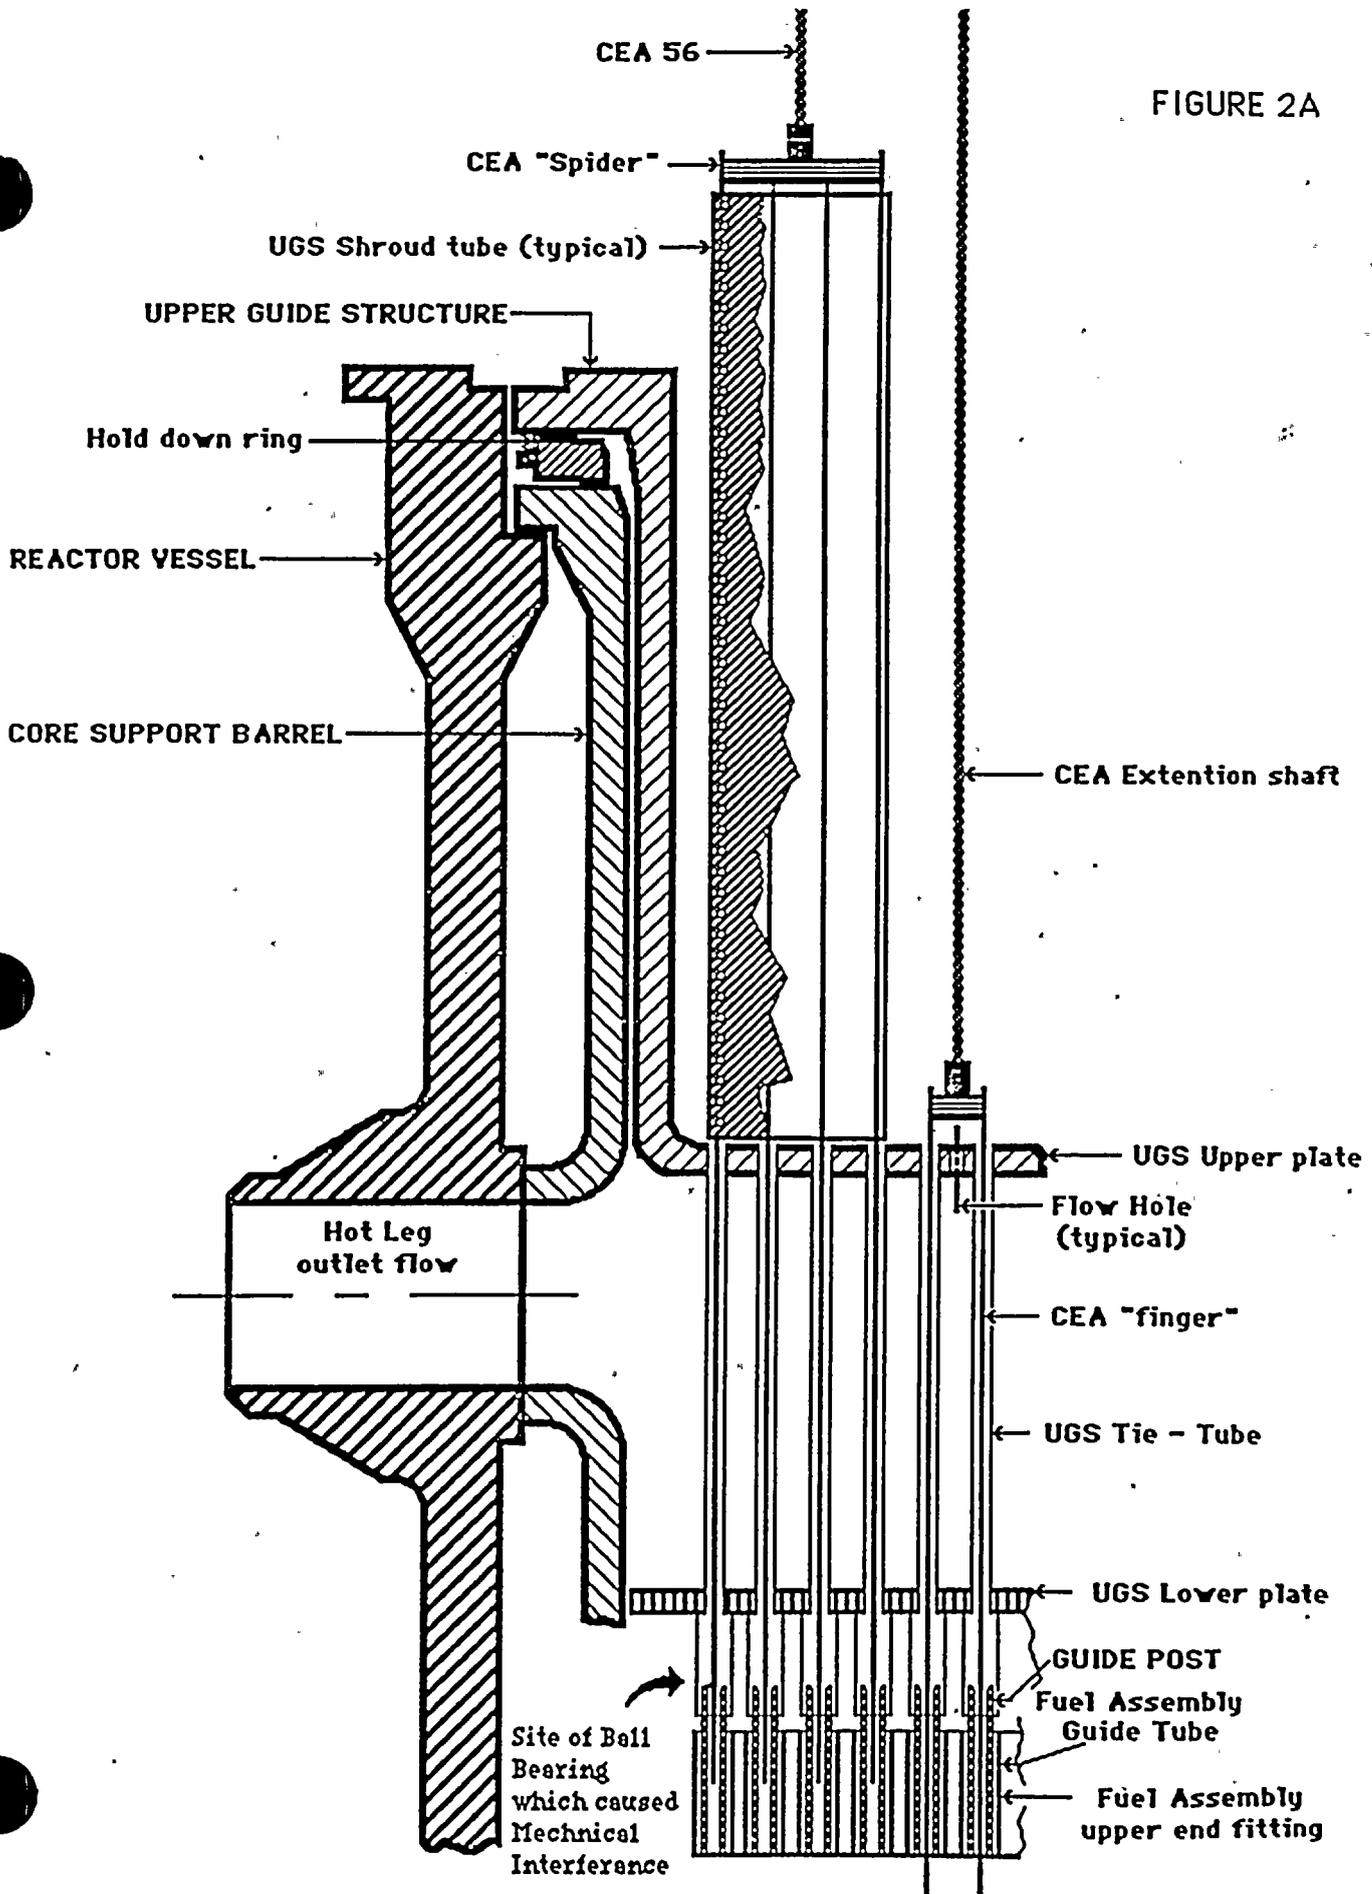
FIGURE 2A

Had a bearing assembly failed while the MST was positioned on the reactor vessel flange (during stud detensioning), the ball bearing could have fallen on to the floor of the refueling canal. As the level in the refueling pool was raised and lowered during the refueling evolution, it would be conceivable that the ball bearing could have been swept into the UGS while it was in the reactor vessel. This scenario is highly unlikely since a ball bearing traveling from the fuel transfer canal floor would fall into a gap between the reactor vessel and the flange (Fig. 2A).

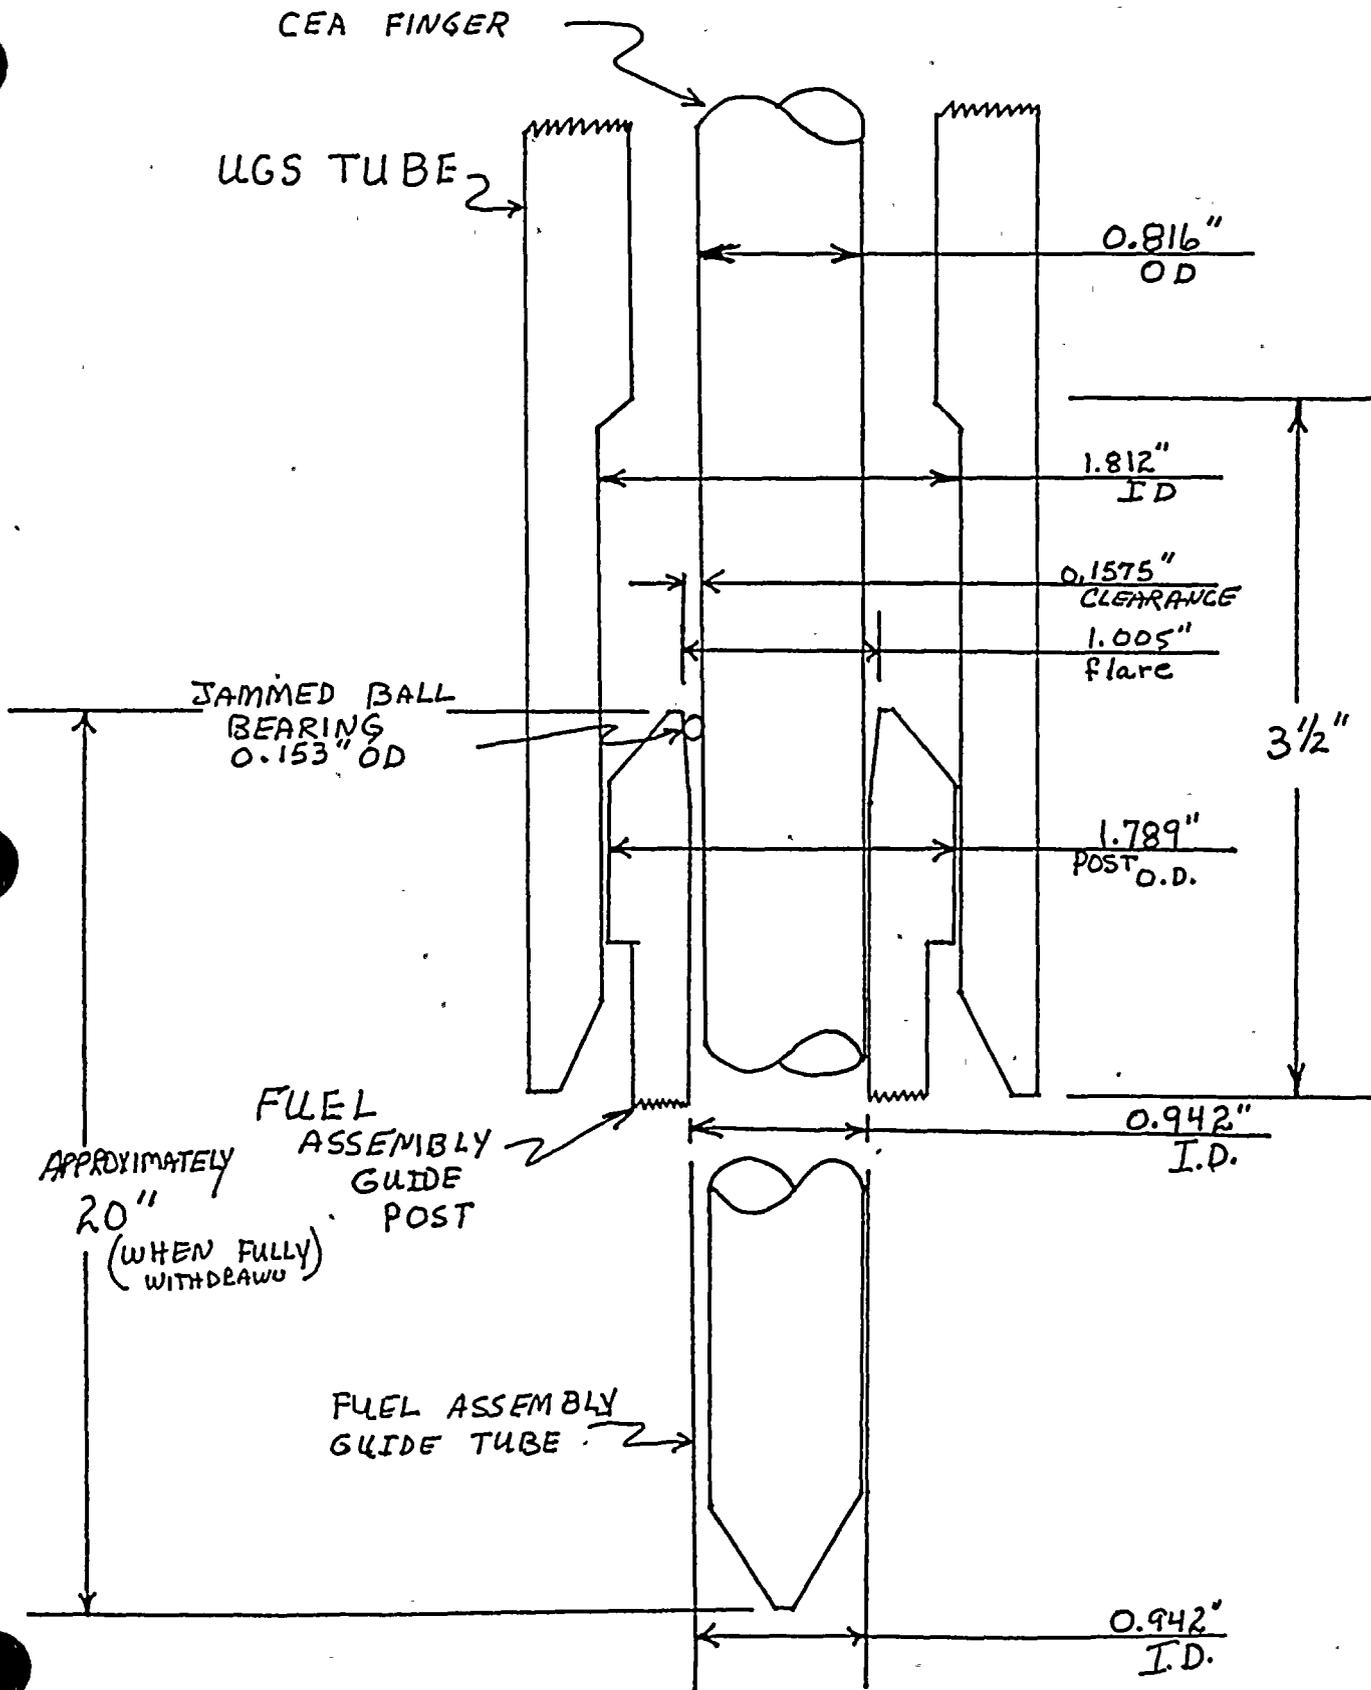
FIG. 12

As a result of these investigations, it was determined that the binding was due to the ball bearing lodging between the CEA finger and the fuel assembly guide post flare (Fig. 12). The occurrence of this phenomena is only possible if the ball bearing enters from the UGS support plate, travels down the UGS guide tube to the fuel assembly guide post flare area. This was further proven by taking a similar sized ball bearing, a dummy fuel assembly, and a dummy CEA finger (all dimensionally correct) and assembling them together in the same orientation as would have existed for CEA 56. The finger was free to move in the outward direction but it was discovered that the finger became lodged by the ball bearing when moved inward and further insertion of the finger was prohibited.

- j. The ball bearing became lodged between the CEA finger and the fuel assembly guide post (Fig. 12).

A review of the indications on the guide post confirmed that observed damage is confined to the guide post flare region of the guide tube (Fig. 12). No damage that could interfere with CEA travel was evident in the lower portion of the guide tube since the ball gauge traversed the full length of the guide tube without binding. In addition, there was no indication that the ball bearing traveled below the guide post flare region. Since no CEA guide post flare area contact is made during operation and no material which could become loose was observed in the damaged area the guide post is considered acceptable for unrestricted continued operation.
