ARIZONA NUCLEAR POWER PROJECT  
PALO VERDE NUCLEAR GENERATING STATION  
UNITS 1, 2, AND 3

JUSTIFICATION FOR CONTINUED OPERATION  
AUXILIARY FEEDWATER PUMPS

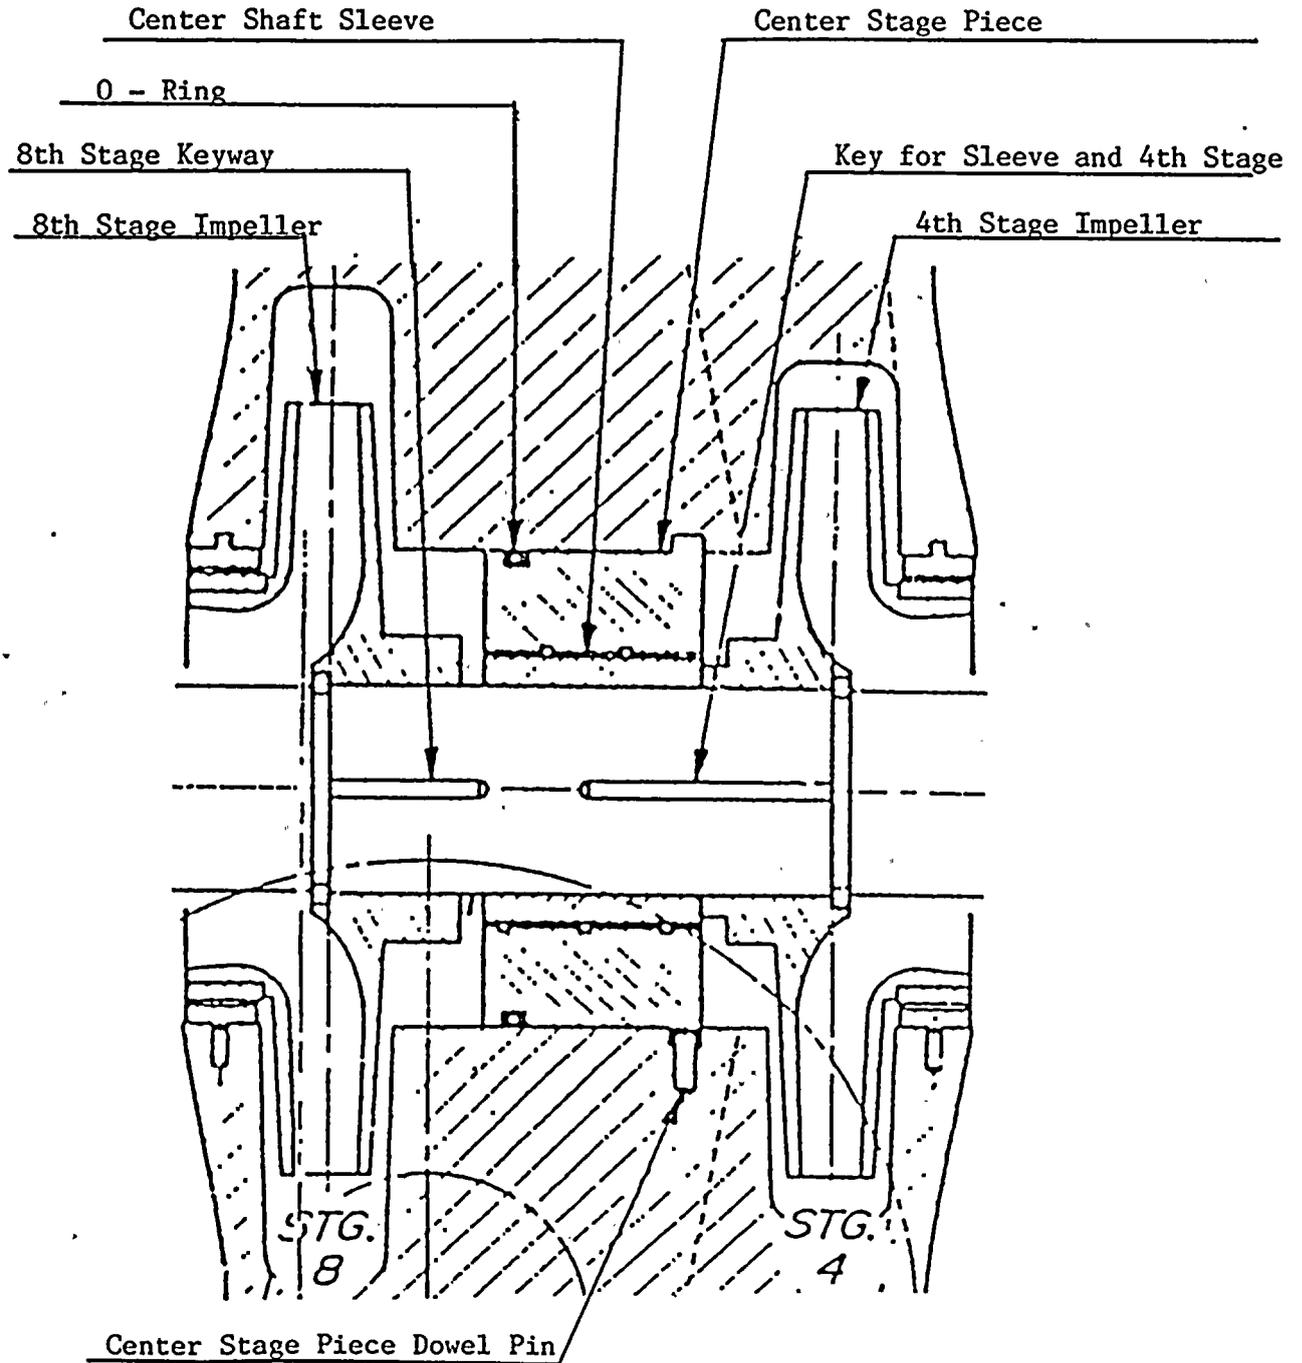
FIGURE 2 - CENTER STATE PIECE (ENLARGED)

The interstage bushing (center stage shaft sleeve) is approximately 3 inches long and 0.25 inches thick. It is manufactured from AISI 420 material, hardened to Rockwell C-50.5 hardness. The sleeve is shrunk-fit to the shaft to form a small interference fit of 2 mils or less. The sleeve is also keyed to the shaft by a key that is common with the fourth stage impeller. The sleeve is surrounded by a stage piece forming a hydrodynamic bearing. There is a groove within the center stage piece that spirals around the center stage sleeve for pumped fluid flow. While the pump is at rest, the center shaft sleeve is resting on the center stage piece. Upon startup, the rotating shaft is then supported by a film of pumped fluid that is forced through the annulus region between the center stage piece and the sleeve by the pressure differential between the eighth and fourth stages. Thus, upon startup, there is usually contact between the center stage shaft sleeve and the center stage piece. An enlarged view of the center stage piece is shown in Figure 2.

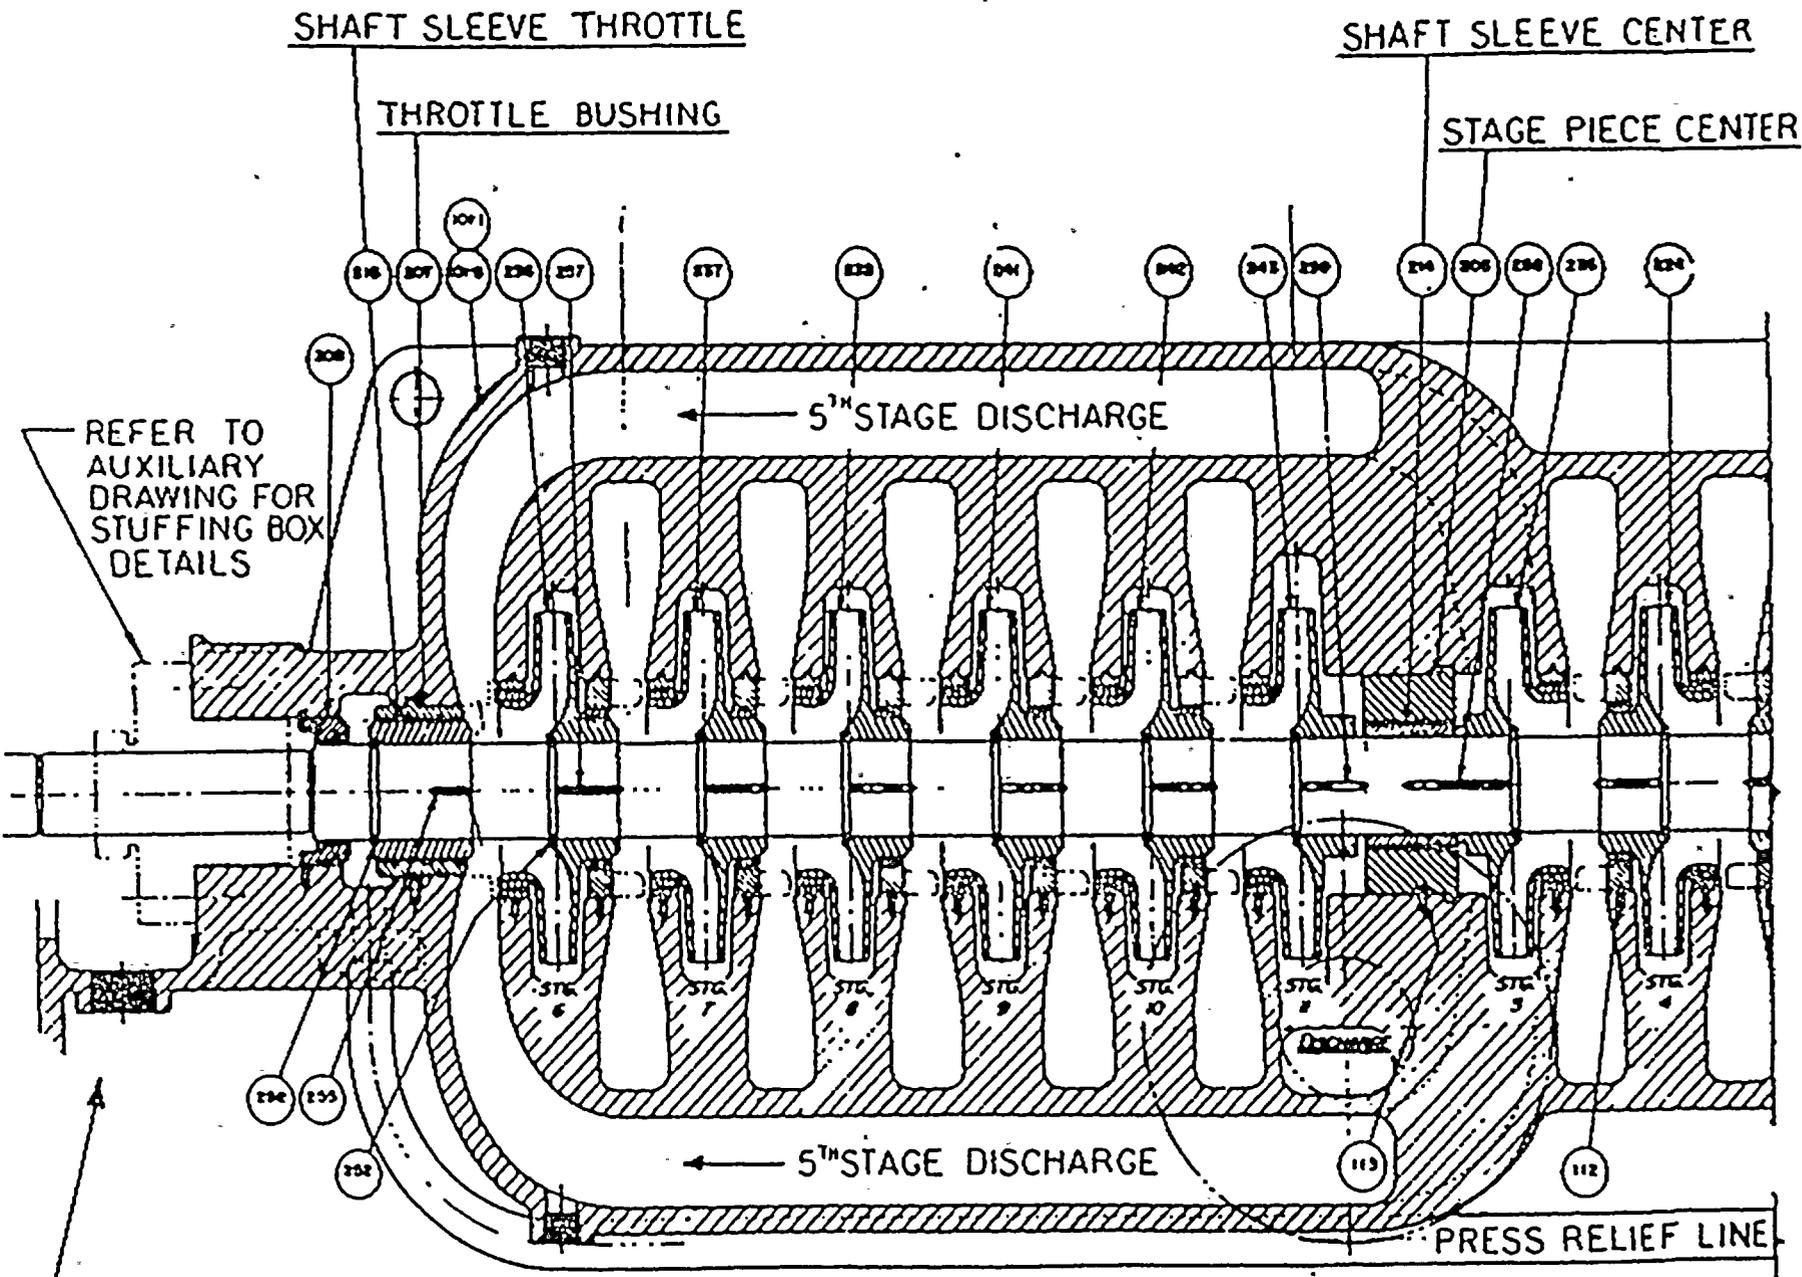
FIGURE 3 - SOUTH TEXAS AFW PUMP

The AFW pump at STP was inspected and damage to the throttle sleeve/bushing, the impeller and center stage shaft sleeve were observed. Bechtel and BW performed a detailed review to assess the extent of the damage. Their findings are as follows.

- i) The throttle bushing (normally stationary) had rotated in the pump case resulting in a plastic flow of the case metal in the upper half of the case. A blue discoloration was noted on the case surface in contact with the bushing indicating that tempering of the case material had occurred. The bushing's spiral trash groove (approximately 1/16" design depth) had been ground down by the sleeve outer surface rubbing on the inner surface of the bushing. Melted sleeve/bushing material was observed to have been extruded out to the high and low pressure ends of the sleeve/bushing pieces. The sleeve was found brazed to the bushing which was designed to have 0.004-0.006 inch radial clearance during normal operation of the pump. The remainder of the 3/8" anti-rotation pin associated with the bushing was found in place. The throttle bushing sleeve was reported to have cracked axially along the keyway, however, the key remained in place without incurring damage. It was noted that the sleeve retaining ring was not damaged and the pump shaft was not heat discolored where the shaft and sleeve are in contact.

- ii) The center stage shaft sleeve was found to have cracked axially through the keyway and the key was sheared at the intersection of the sleeve inner surface and the shaft outer surface. A portion of the key remained in the keyway half of the shaft under the shaft sleeve. Additionally, the portion of the key associated with the fifth stage impeller was found to be intact and in place. Sleeve movement toward the impeller hub was

estimated to be 5/16". The center sleeve and pump shaft had circumferential wear grooves (estimated depth of 1/64") at their interface. The sleeve was not found brazed to the center stage piece but similar circumferential wear grooves were observed at the interface of the sleeve and center stage piece where contact had occurred.

- iii) The fifth stage impeller hub was machined by the center stage shaft sleeve to a depth of 5/16". The worn end of the sleeve matched the indentation on the impeller hub. The portion of the key enclosed by the impeller hub was not sheared and functional loss of the impeller did not occur.

- i) Change the material of the stationary parts (case rings, center stage piece, throttle bushing and series stage pieces) to Ni-Resist #2.
- ii) Change the material of the rotating parts to AISI 410 with a hardness of 250/300 BHN.
- iii) Change the key material from 416 to 410 stainless steel.
