ELECTRICAL DISTRIBUTION SYSTEM
DESIGN ASSESSMENT

May 22, 1989

ELECTRICAL DISTRIBUTION SYSTEM DESIGN ASSESSMENT

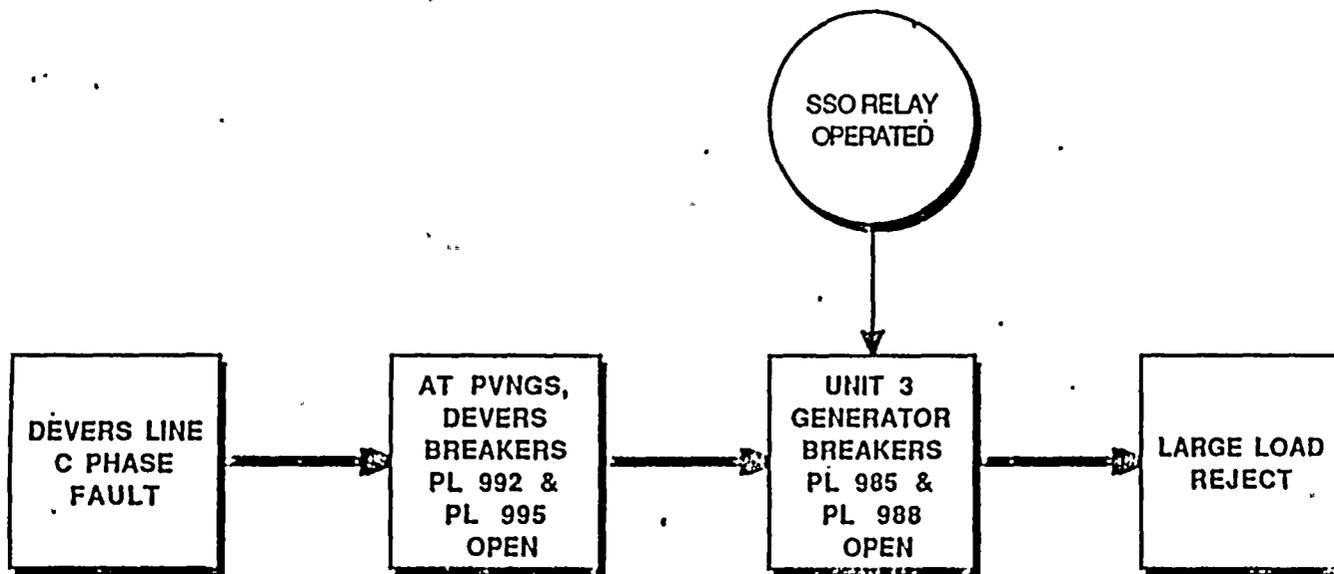
FIGURE 2
SSO RELAY
EVENTS AND CAUSAL FACTORS
CHART
I.I.R. 2-3-89-001

The second trip occurred on March 3, 1989, in Unit 3. Printouts from the Plant Monitoring System indicate that an SSO relay-initiated trip signal, opened the main generator 525-kV breakers. Initial investigation and analysis of a simulation of the condition on the 525-kV transmission system, at the time of the event, indicated that the SSO relay should not have operated. Functional tests performed on the SSO relays at PVNGS showed no apparent failure of either relay. Based on these findings, "bench" tests were performed on the SSO relay circuit boards. The results of these tests did not indicate component malfunction or failure.

Since test results of the Unit 3 SSO relays themselves have not identified the cause of the SSO relay/relays operation, APS investigated possible sources of erroneous signals to the SSO relays. The turbine-generator Power System Stabilizer (PSS) was reviewed as a possible source of erroneous input signals to the SSO relay. A malfunction of the PSS could generate a signal which could cause SSO relay operation; however, test results indicate that the PSS is not a likely source for the problem. Additionally, APS is testing the noisy generator
