PALO VERDE  
NUCLEAR GENERATING STATION

ATMOSPHERIC DUMP VALVE  
ENGINEERING ANALYSIS

March/April, 1989

REVISION 1

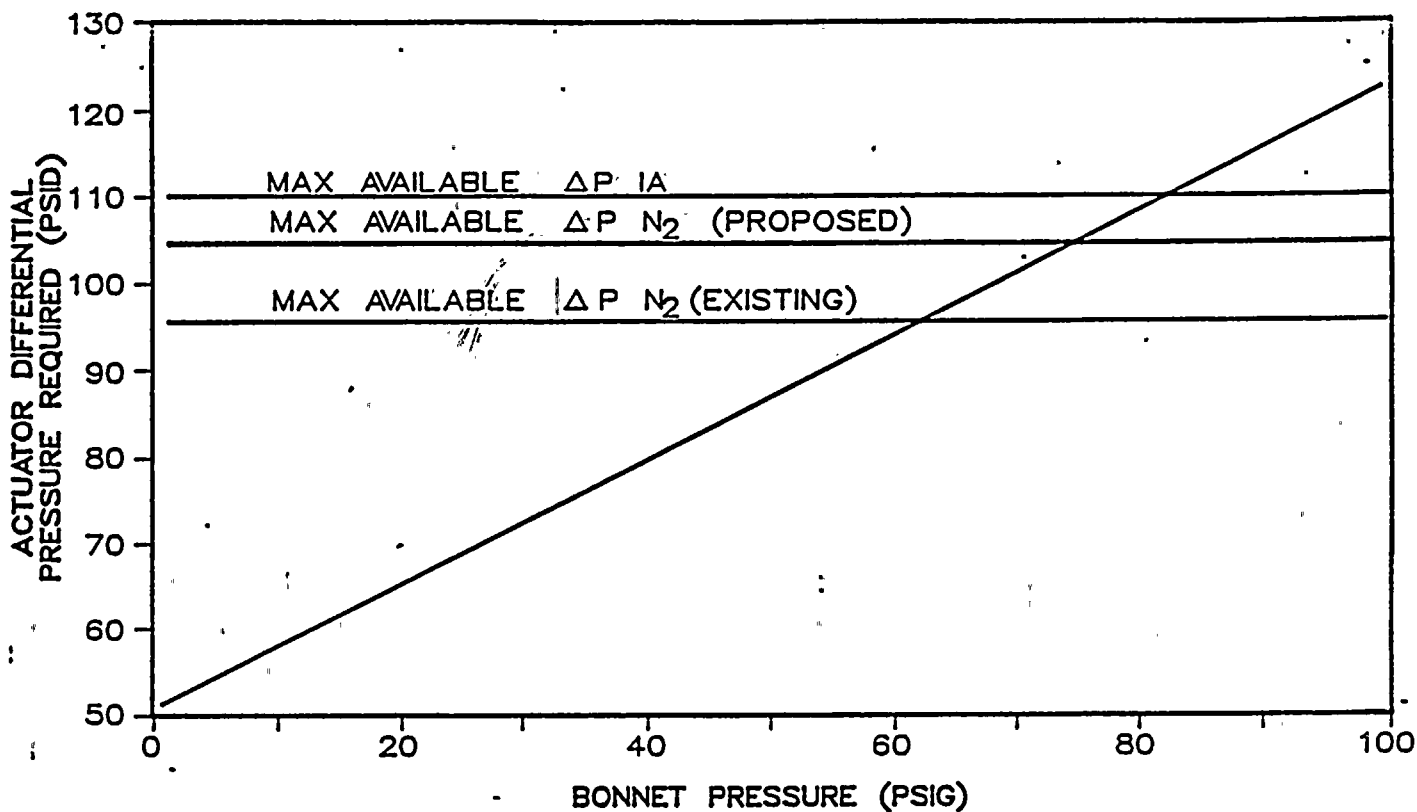
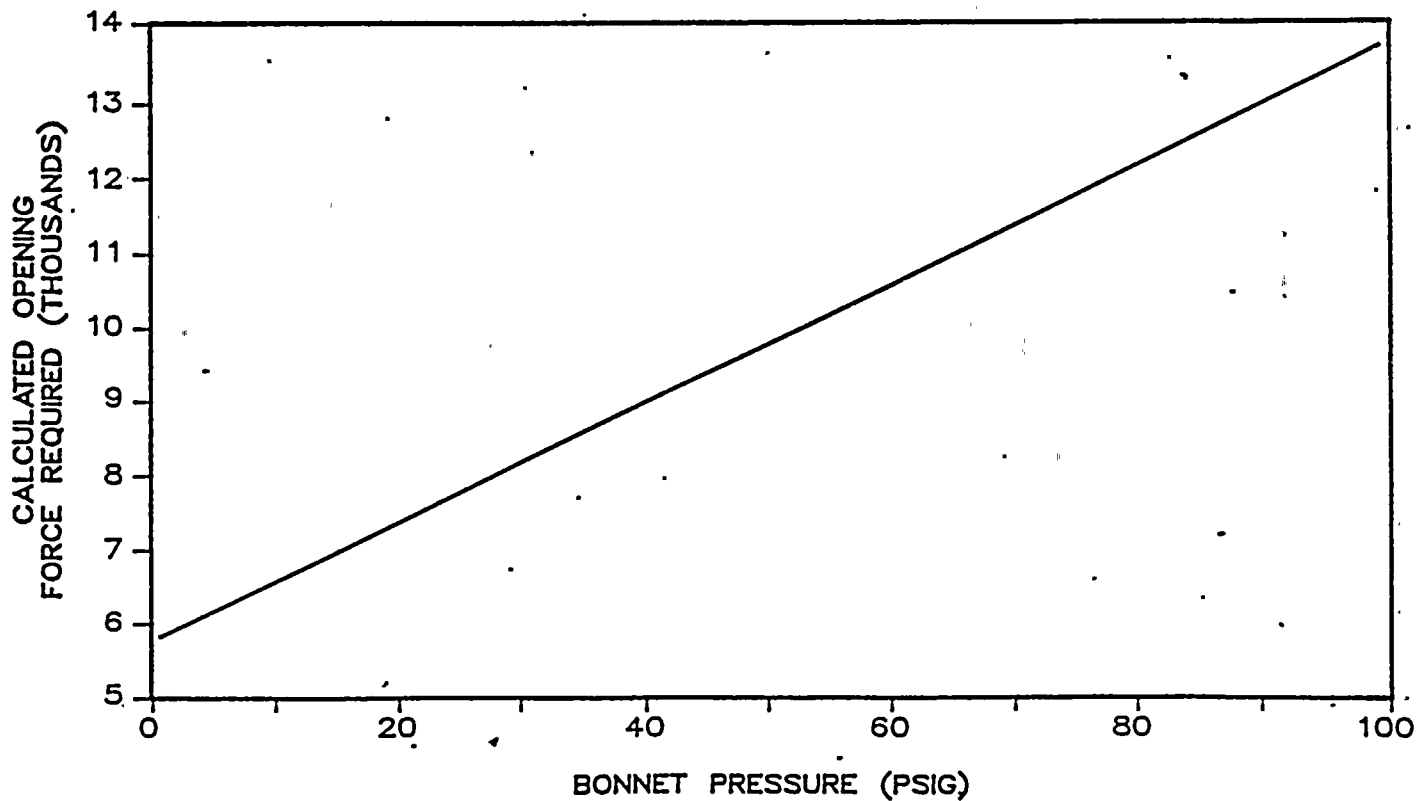
**FIGURE VI-2 & VI-3**

The failure of ADV-184 to open was due to an abnormally high bonnet pressure. High bonnet pressure may be caused by either the failure of the pilot valve to function or excessive leakage around the piston ring. Proper functioning of the pilot valve was verified by the opening of the pilot valve to the correct position. Thus, the cause of the high bonnet pressure is attributable to excessive leakage around the piston ring. The ring design utilized in this ADV is a self-energizing piston ring. This means the force to seat the ring is a result of the differential pressure across the piston ring. When the ring is energized, it is held tightly against the plug and upper portion of the bonnet, forming a seal. If anything interferes with the ring moving up into position against its sealing surfaces, a high bonnet pressure may result. Two scenarios have been proposed whereby this can happen:

**Calculated Force and Actuator D/P  
Required to Open a Typical  
ADV vs. Bonnet Pressure**

- 1) Failure to Open due to High Valve Bonnet Pressure - APS and the vendor, Control Components Inc. (CCI), have determined that excessive piston ring leakage combined with inadequate pilot valve relieving capacity create high forces in the valve bonnet, (also called balance chamber), that cannot be overcome by the forces exerted by the actuator. The vendor recommends installing a larger pilot valve and new style piston rings. APS and CCI have also determined that periodic stroking of the valve helps to keep the piston ring seated thus minimizing excessive leakage into the bonnet area of the valve.

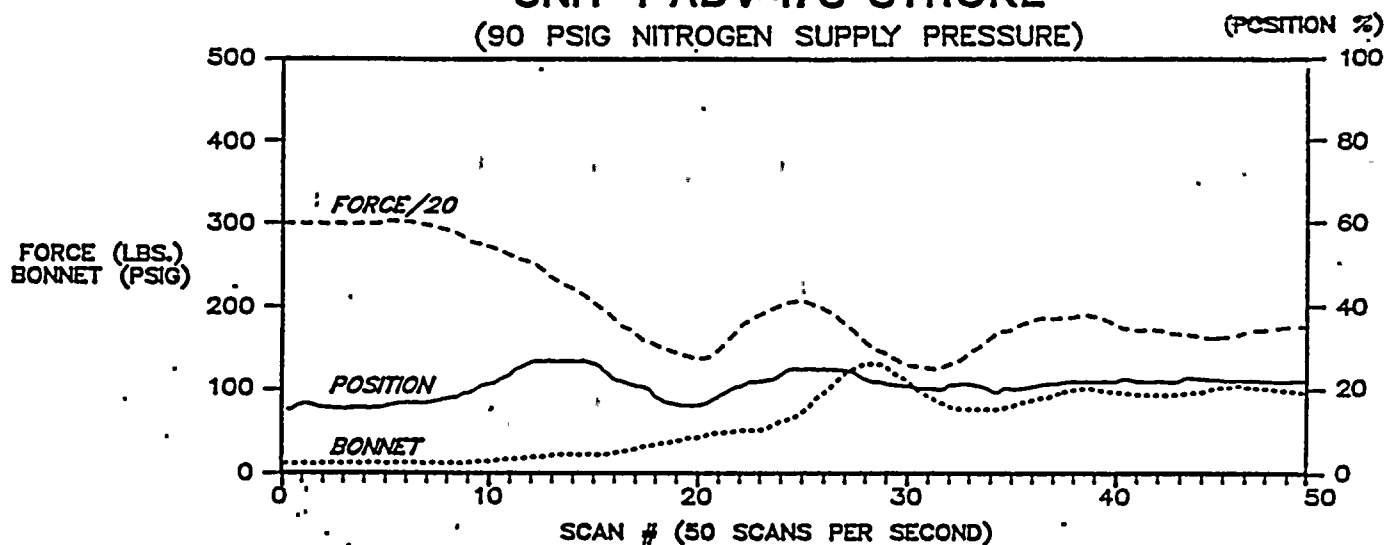
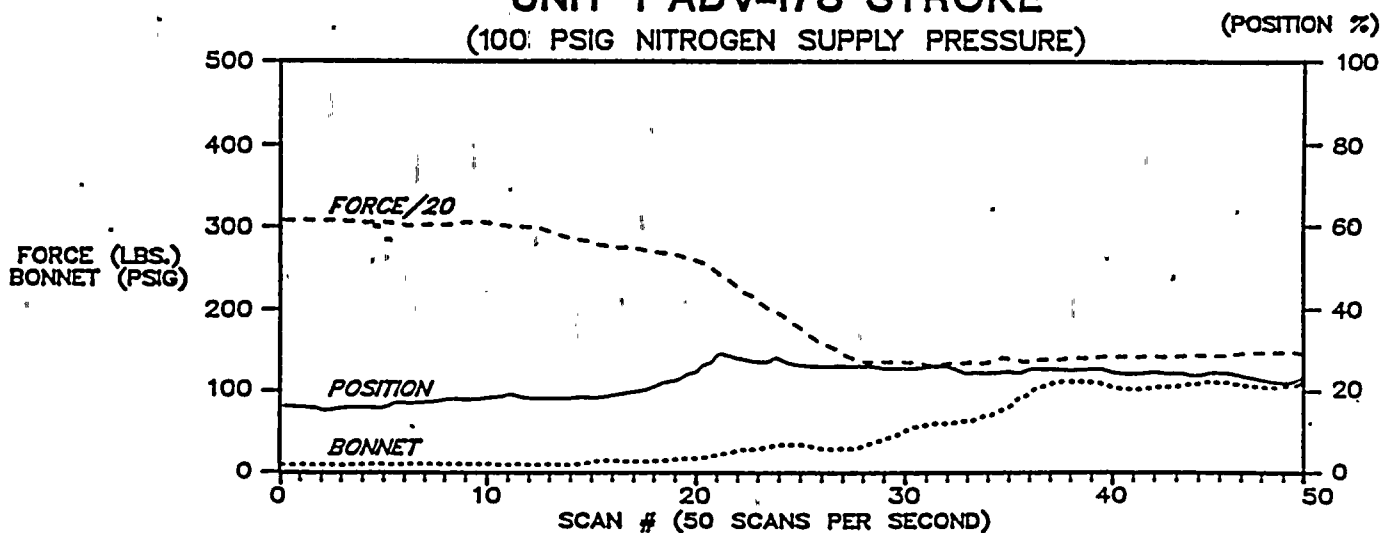
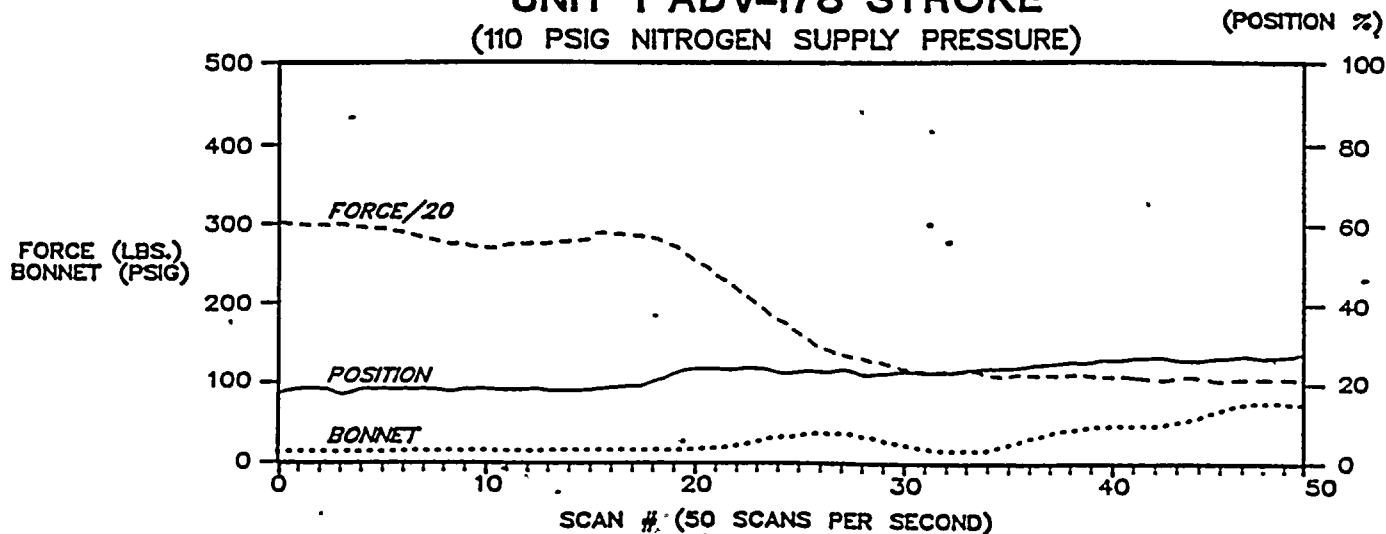
**FIGURE VI-4, VI-5, and VI-6**

On March 18, 1989, ADV-178 was given both incremental and step demand signals, initially using nitrogen at  $\approx 95$  psig. As the valve opened through the disk stack transition region, (approximately 15% to 20% open), it exhibited an oscillation lasting several seconds. The maximum amplitude of the oscillation was between  $\approx 20\%$  and  $\approx 60\%$ . Because of the oscillation, the valve was closed. Similar damped oscillations had been observed during startup testing.

1. Stroking or exercising of the valves aids in reducing upper bonnet pressures allowing the valve to open and stroke more reliably.
2. Significant oscillations only occur when pneumatic supply pressure is  $\leq 95$  psig.
3. A total of 44 tests were performed in which the ADVs were stroked to at least 20% open. Oscillations were observed on 13 of these tests. Except for ADV-184, on nitrogen at approximately 95 psig supply pressure, all valves opened when given a sufficient, (e.g.  $\geq 30\%$ ) demand signal.

**Unit 1 ADV-178 - 30% Step Demand  
at Various Nitrogen Supply Pressures**

The force on the valve plug changes rapidly as the plug passes approximately 15% open. This transition point (referred to as the  $C_v$  transition point), is caused by a change in the configuration of the disk stack at that region. (Refer to Section II for details on the valve construction and operation.) The change in forces on the plug as it passes the disk stack  $C_v$  transition point causes the oscillations to start. The greatest single contributing factor to preventing oscillations is the stiffness of the actuator. This is a function of the pressures in the upper and lower actuator cylinders. The stiffness of the actuator can be increased by increasing the pneumatic supply pressure to the valve positioner. Testing has shown that when the supplied pressure was at least 100 psig, no significant oscillations occurred. Modifications have been developed to increase the pressure supplied by the nitrogen accumulator to 105 psig and to rework the disk stack to smooth the  $C_v$  transition. The normal instrument air is already supplied at a pressure greater than 100 psig. The nitrogen supply pressure will be increased to 105 psig and the modification to smooth the  $C_v$  transition in the disk stack will be accomplished prior to the startup of any unit from the current outages.
