PALO VERDE NUCLEAR GENERATING STATION  
UNITS 1, 2, AND 3

JUSTIFICATION FOR CONTINUED OPERATION  
GEA DROP EVENTS

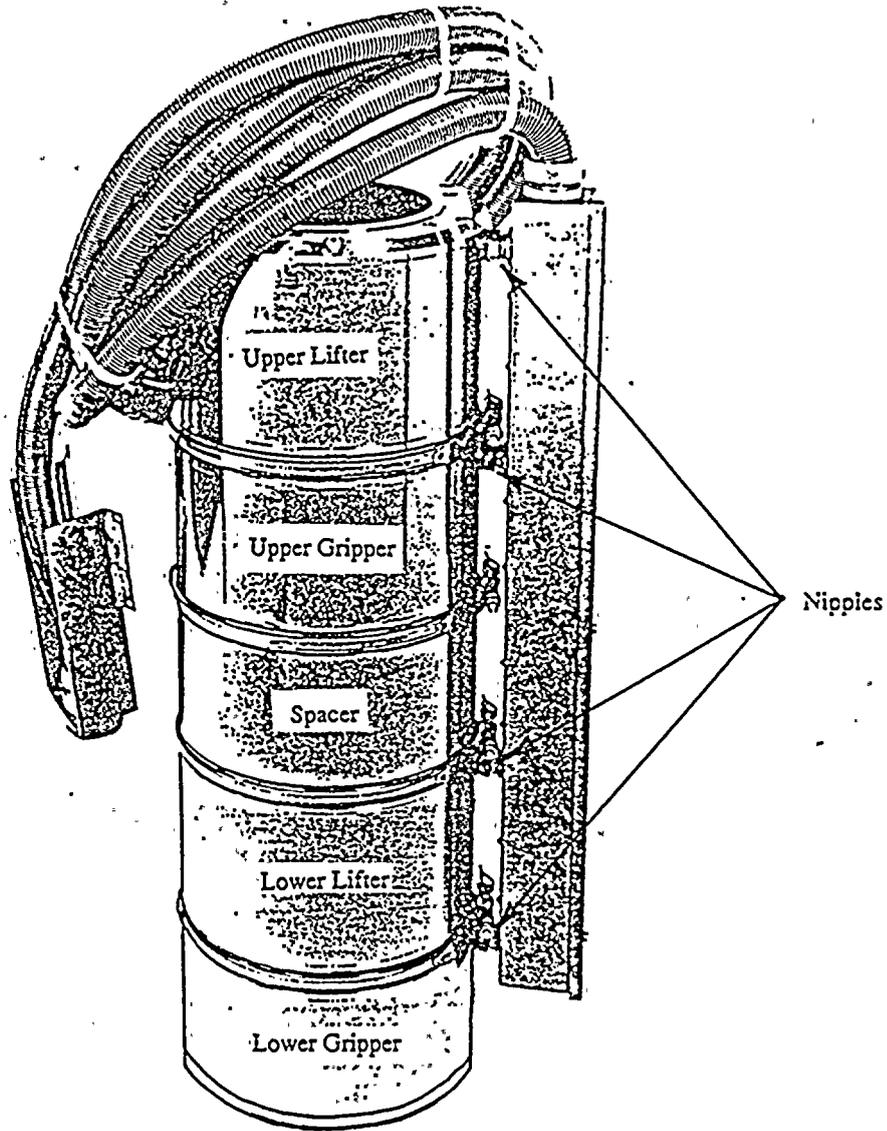
FIGURE 2 - COIL STACK ASSEMBLY

The coil stack for CEDM No. 33 was disassembled, examined, and evaluated at PVNGS by representatives of the Engineering Evaluations Department. During the examination, substantial damage was found in the area of the lower lift coil where the coil lead wires pass through the nipple assembly. The evaluation concluded that the ground fault associated with CEA No. 33 was the result of damage to the coil lead wires which was later found to have occurred during the assembly process (a manufacturing deficiency).

The coil stack for CEDM No. 19 was sent to C-E for an independent evaluation. During the evaluation, C-E identified damaged fiberglass sheathing and insulation on the coil leads. This was determined to be a manufacturing deficiency that occurred during the coil stack assembly process.

Two factors are believed to have contributed to the manufacturing deficiency becoming a pathway for a short to ground. The two factors were the observed motion of the lower lift coil leads and the orientation of the coil within its housing. These conditions combined to narrow the gap between the bare wire and the housing which allowed an intermittent ground fault, subsequent insulation deterioration over time, and subsequent arcing to the housing (nipple) assembly.

- 2) All known defective coil stacks, identified during testing, will be replaced prior to restart of the affected unit. This is expected to eliminate the source of CEA slippage problems associated with ground faults.
