CONDENSATE PIPING
OVERPRESSURE
EVALUATION

AUGUST 16, 1989

NUCLEAR
ENGINEERING

Condensate Overpressure Eval.

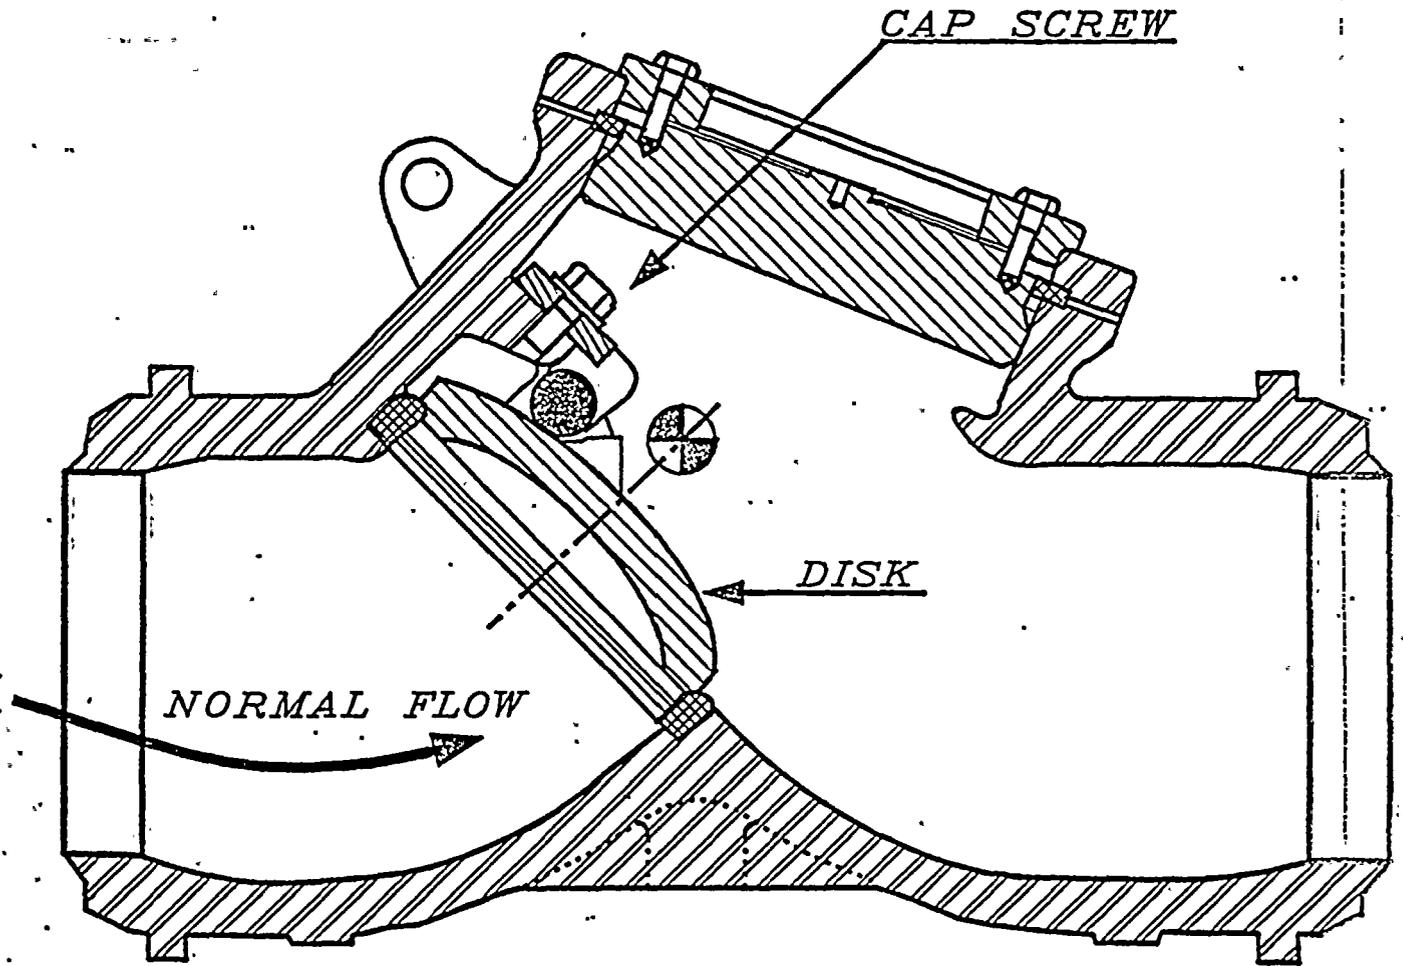
(2PSGNV431)

Following the trip on July 13, EED tested check valve SGN-V431, Figure 1.2-2, verified that it allowed backleakage, and requested rework of the valve, which was performed to work order 00369951. The rate of the backleakage through the check valve was unknown, and the operator did hear an unusual noise when cracking open the FWP bypass valve, FWN-V013, to initiate long path recirculation. The system lineup, Figure 1.2-1, has been reconstructed from the operators logs and interviews. The system engineer was able to redevelop the scenario of the system alignments and identified the following system piping that experienced the overpressurization;
