PALO VERDE  
NUCLEAR GENERATING STATION

ATMOSPHERIC DUMP VALVE  
ENGINEERING ANALYSIS

March/April, 1989

REVISION 2

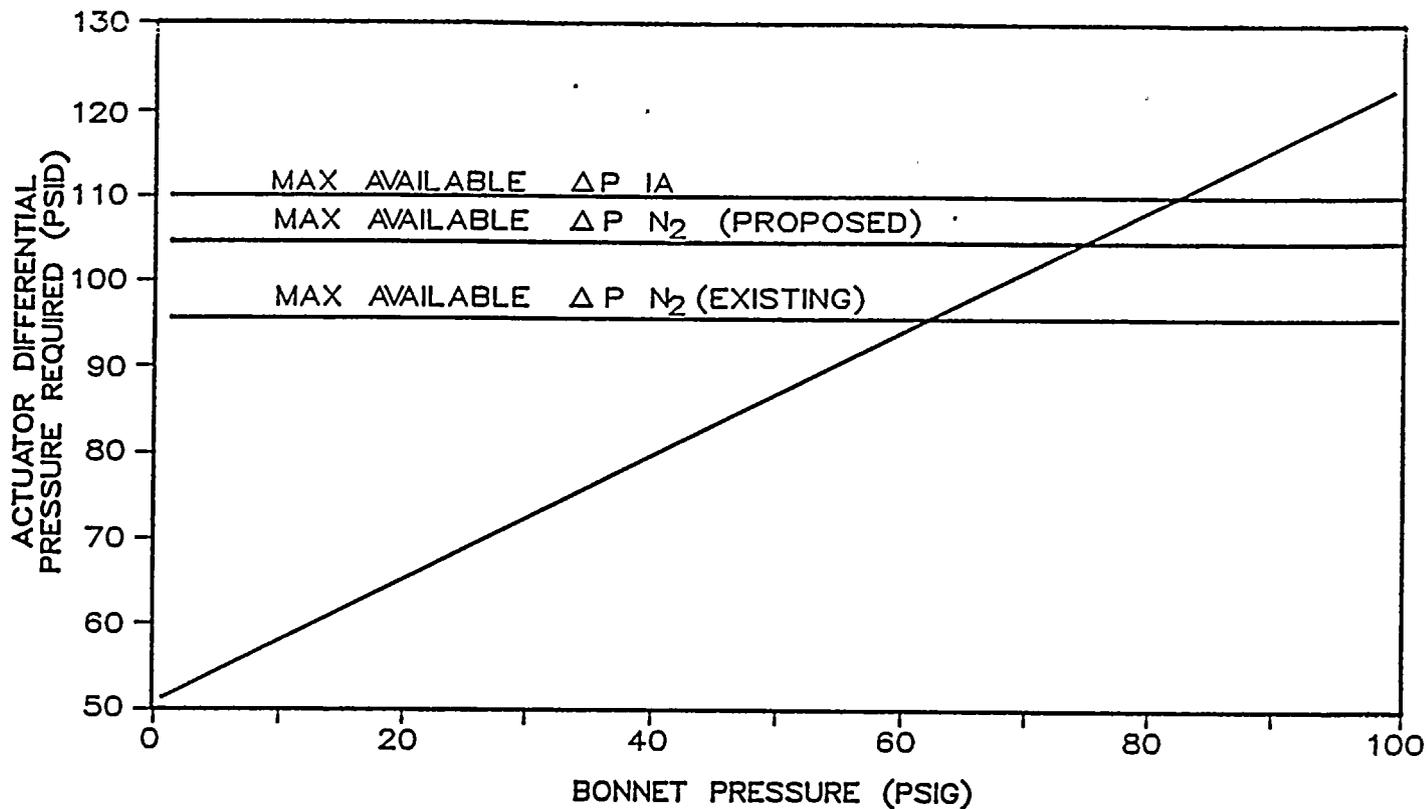
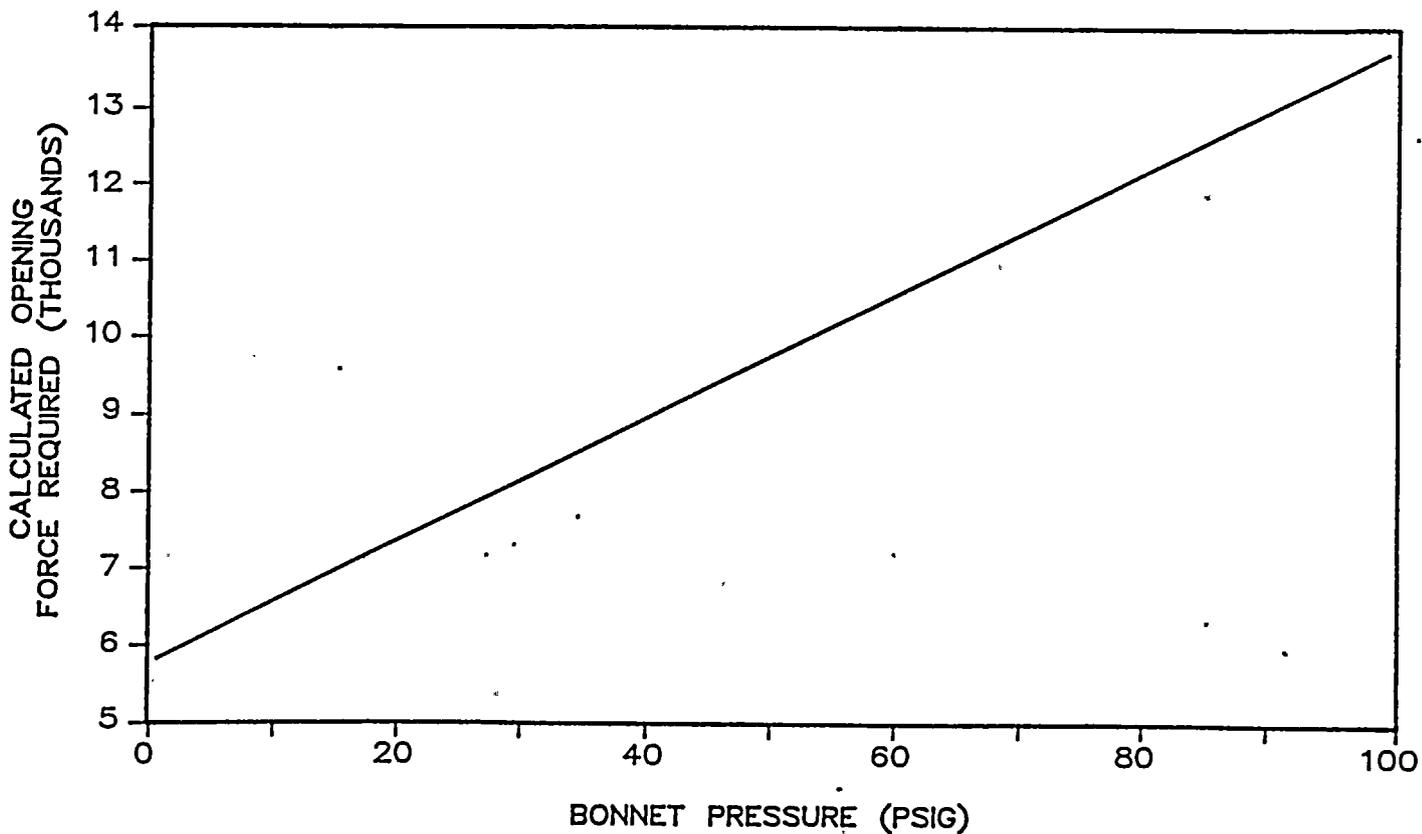
**FIGURE VI-2 & VI-3**

TABLE VI-2 shows the forces acting on ADV-184 during the tests. The first tests performed on nitrogen assume that the bonnet pressure was the same as that measured after installation of the bonnet pressure tap. The table shows that until the bonnet pressure was reduced by exercising the valve with the instrument air system, there was not enough force available from the positioner to open the valve. This transition occurred during Test 8 on the table where the bonnet pressure reduced to a value where the actuator was able to lift the plug. This reduction in bonnet pressure was momentary and when the plug lifted the bonnet pressure increased to 110 psig and the valve was forced shut. During Test 9, the bonnet pressure decreased to 44.6 psig and the actuator was able to stroke the valve. Subsequent tests had bonnet pressures of approximately 4.5 to 6.9 psig and the valve stroked normally.

FIGURE VI-2 shows the calculated force required to open a typical ADV with varying bonnet pressures. The pressure measured on ADV-184 initially was 110 psig which would require approximately 14,000 pounds of force to open the valve. FIGURE VI-3 shows the actuator differential pressure required to open an ADV with varying bonnet pressures. The maximum differential pressure available from the IA system and nitrogen accumulators are also shown. These figures show that unless the bonnet pressure is less than approximately 80 psig the IA system will not provide enough force to open the valve and unless the bonnet pressure decreases below approximately 60 psig, the nitrogen accumulator, (with the nitrogen regulator set at 95 psig), will not provide adequate force to open the valve. Thus, with the 110 psig bonnet pressure measured during the testing of ADV-184, neither system could provide enough force to open the valve. Therefore, it was concluded that the bonnet pressure in ADV-184 was preventing the operation of the valve. This fact was also demonstrated during testing of the other ADVs, which all opened

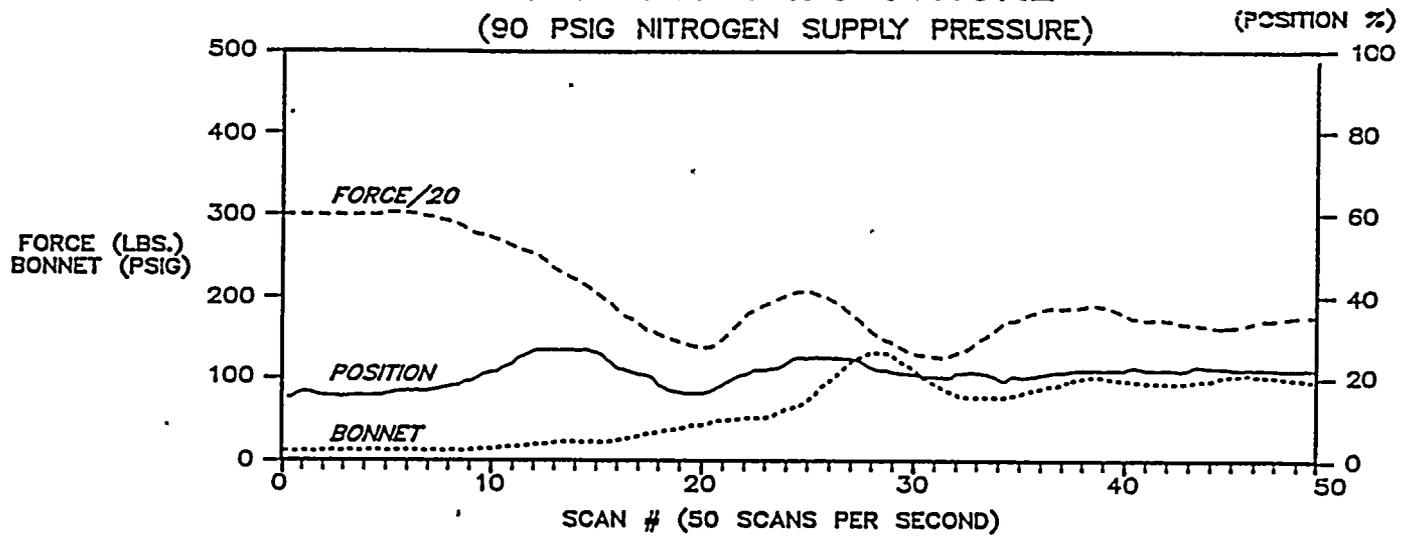
**FIGURE VI-4**  
**UNIT 1 ADV-178 STROKE**

On March 18, 1989, ADV-178 was given both incremental and step demand signals, initially using nitrogen at  $\approx 95$  psig. As the valve opened through the disk stack transition region, (approximately 15% to 20% open), it exhibited an oscillation lasting several seconds. The maximum amplitude of the oscillation was between  $\approx 20\%$  and  $\approx 60\%$ . Because of the oscillation, the valve was closed. Similar damped oscillations had been observed during startup testing.

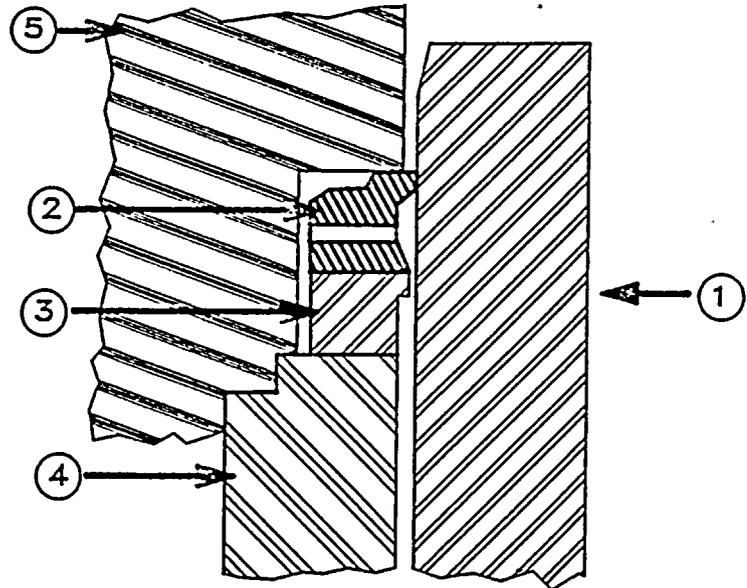
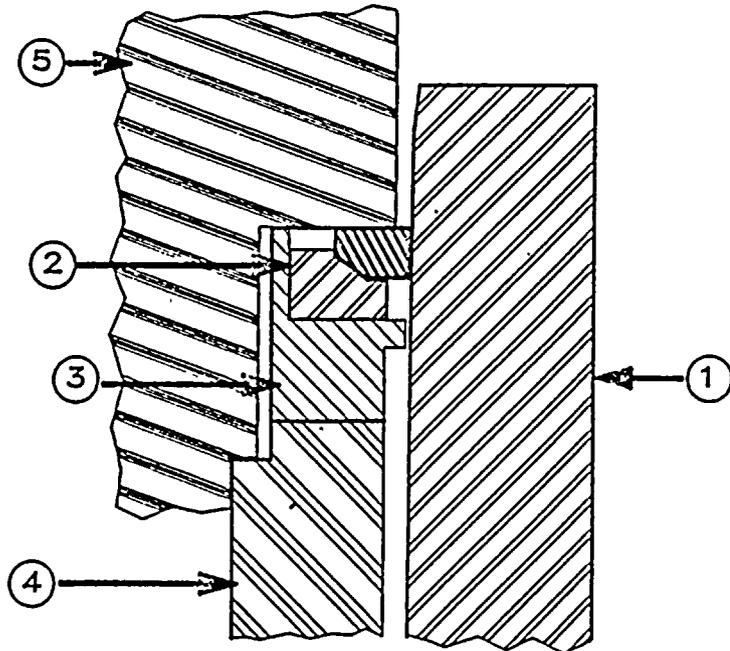
FIGURE IX-2

- 2) The vertical clearance of the piston ring in the valve is approximately 5 mils. It is possible that when a valve is opened, flow around the outside and across the top of the piston ring produces a dynamic loading which prevents it from energizing and forming a tight seal against the top sealing surface. This scenario was addressed by CCI with the addition of a wave-spring underneath the piston ring. The purpose of this spring was to hold the piston ring against the top sealing surface when the valve was shut and no differential pressure was available to hold the ring in position. This solution was not successful and CCI is no longer recommending this modification.
