PALO VERDE NUCLEAR GENERATING STATION
UNITS 1, 2, AND 3

JUSTIFICATION FOR CONTINUED OPERATION
CONTROL ELEMENT ASSEMBLY (CEA) DROP EVENTS

REV. 3

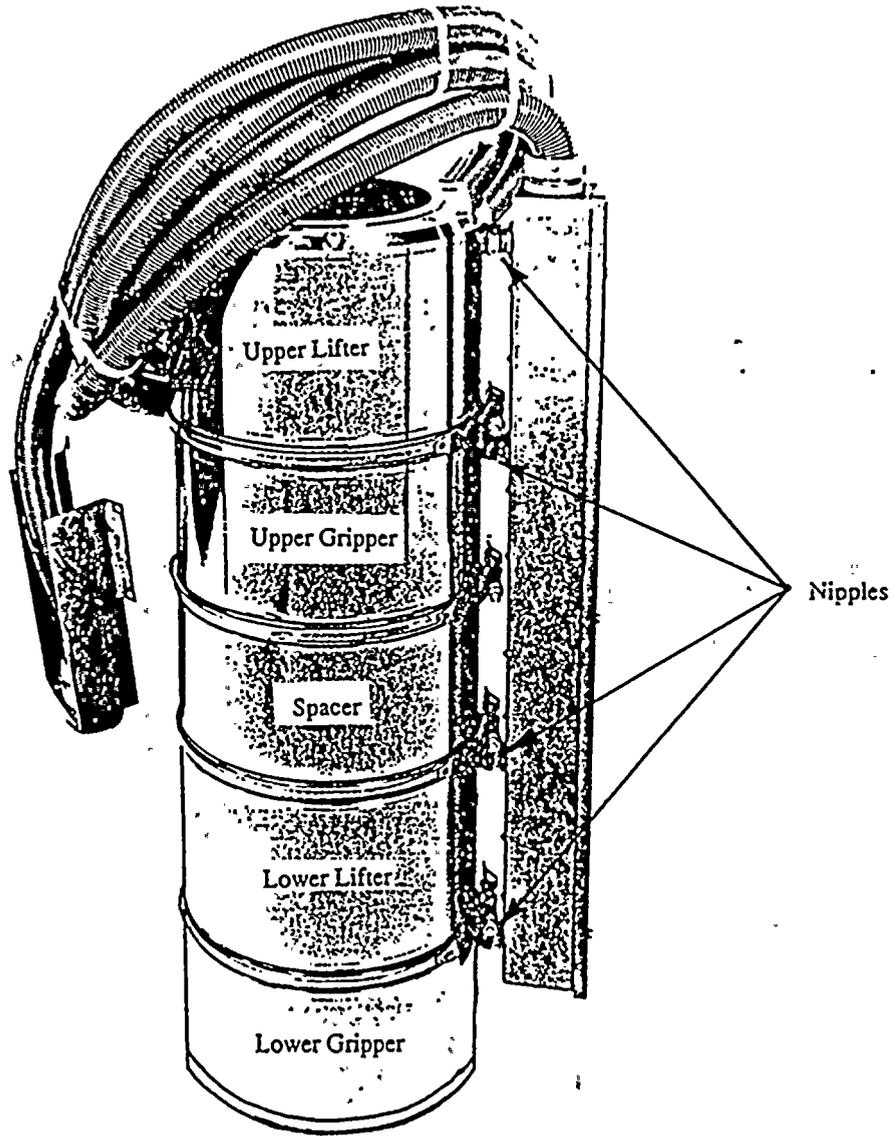
FIGURE 2 - COIL STACK ASSEMBLY

The coil stack for CEDM No. 33 was disassembled, examined, and evaluated at PVNGS by representatives of the Engineering Evaluations Department. During the examination, substantial damage was found in the area of the lower lift coil where the coil lead wires pass through the nipple assembly. The evaluation concluded that the ground fault associated with CEA No. 33 was the result of damage to the coil lead wires which was later found to have occurred during the assembly process (a manufacturing deficiency).

Two factors are believed to have contributed to the manufacturing deficiency becoming a pathway for a short to ground. The two factors are the observed motion of the lower lift coil leads and the orientation of the coil within its housing. These conditions combined to narrow the gap between the bare wire and the housing which allowed an intermittent ground fault, subsequent insulation deterioration over time, and subsequent arcing to the housing (nipple) assembly.

The coil stack for CEDM No. 19 was sent to C-E for an independent evaluation. During the evaluation, C-E identified damaged fiberglass sheathing and insulation on the coil leads. This was determined to be a manufacturing deficiency that occurred during the coil stack assembly process and the contributing factors outlined above.

- 2) All known defective coil stacks, identified during the previous cycle or refueling shutdown will be replaced prior to restart from refueling of the affected unit. This is expected to minimize potential sources of CEA slippage problems associated with ground faults.

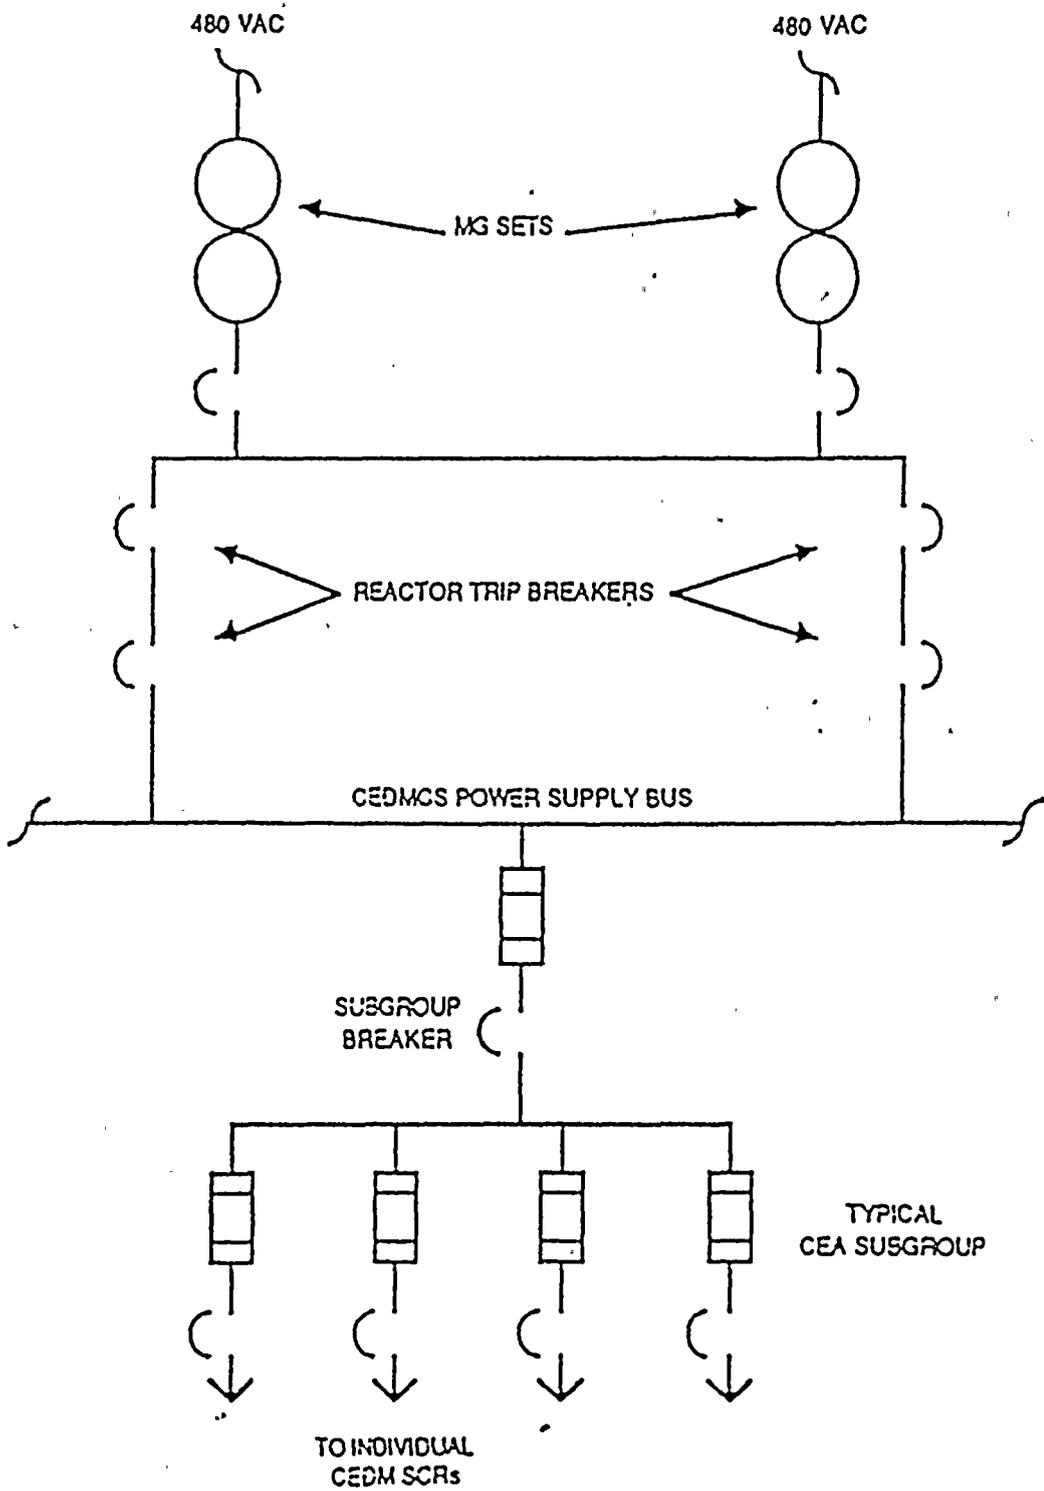
FIGURE 1 - CEDMCS POWER SUPPLY

The purpose of the CEMDCS is to provide the drive signals to the coils of the magnetic-jack Control Element Drive Mechanisms (CEDMs) which position and hold the individual Control Element Assemblies (CEAs). The CEMDCS controls the direction, rate, and duration of CEA motion in response to automatic or manual demands. The CEMDCS is a non-safety related control system. The safety function of the CEAs is to drop into the core when power is removed from the CEDMs. Power is removed from the CEDMs when the reactor trip breakers open in response to valid reactor protection signals. Refer to Appendix A, Figure 1 for a schematic of the power supply arrangement to the PVNGS CEMDCS.
