SUBJECT: LER 89-004-03:on 890104,emergency diesel generator rocker  
 arm failure/ESF actuation.

Subject: Palo Verde Nuclear Generating Station (PVNGS)  
Unit 3  
Docket No. STN 50-530 (License No. NPF-74)  
Licensee Event Report 89-004-03  
File: 89-020-404

Emergency Diesel Generator Rocker Arm Failure/ESF Actuation

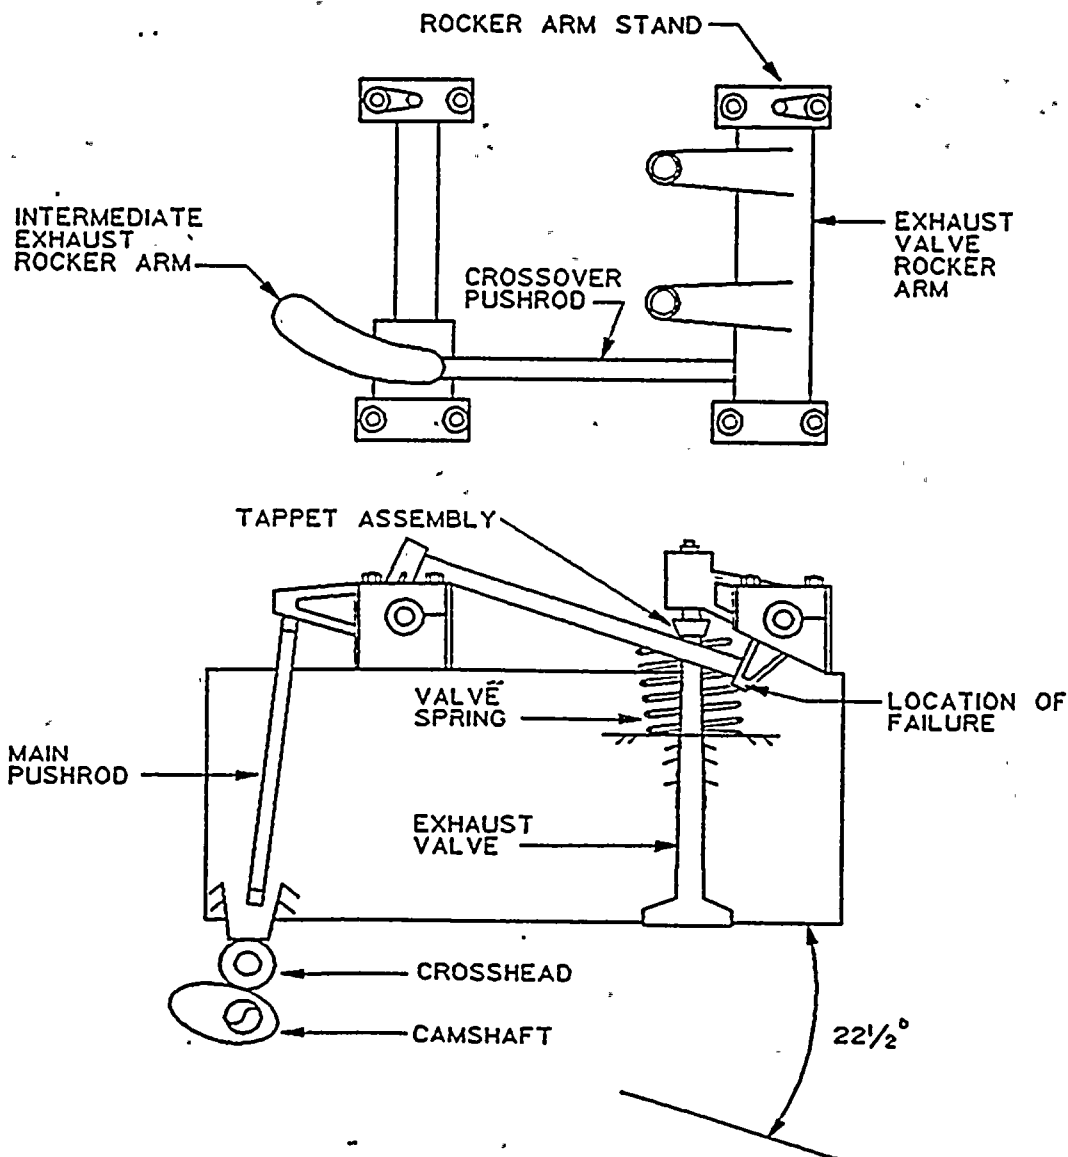
Figure 1

the end of the push rod arm fractured and separated from the main exhaust valve rocker arm (Figure 1). The push rod arm casting is machined to accept a round insert which comprises the push rod seat. The fracture occurred at the rocker arm wall on both sides of this insert and down through the base of the push rod arm. Subsequent inspection of the fractured piece revealed evidence of paint on the fracture face. This indicates a crack had occurred prior to painting the rocker arm and the paint seeped into the crack. ANPP received the rocker arm painted from the factory. ANPP sent the failed rocker arm to Cooper-Bessemer for inspection and analysis. On January 11, 1989, discussions with Cooper-Bessemer confirmed that the rocker arm failure resulted from an original defect prior to delivery to ANPP. The cause of the rocker arm failure has been determined to be an inadequate original design coupled with insufficient inspection of the rocker arm for cracks in the material around the push rod seat insert. As designed the rocker arm casting was not sufficiently strong to withstand the stress incurred when the push rod seat insert was press-fit into place. This excessive stress resulted in the cracks which then went undetected during post-manufacturing inspections.

On January 11, 1989, ANPP removed the inspection covers and visually inspected the remaining intake and exhaust rocker arms on the "A" Emergency Diesel Generator. This inspection revealed a cracked exhaust rocker arm for the 9R cylinder. An inspection of the fracture revealed evidence of paint on the fracture face. This rocker arm remained functional. The rocker arm had been cracked prior to receipt from the factory.

## EXHAUST ROCKER ARM ASSEMBLY

The failed rocker arm and damaged turbocharger components were replaced. The remaining rocker arms on the "A" Emergency Diesel Generator (EDG) have been inspected and one was replaced. These corrective actions were completed by January 12, 1989. Following the return of the "A" EDG to service, the "B" EDG rocker arms were inspected. No other failed rocker arms were identified. This action was completed by January 14, 1989.

Replacement rocker arms received from Cooper-Bessemer are being inspected by APS utilizing non-destructive examination techniques prior to installation. The non-destructive examination provides assurance that the replacement rocker arms utilized at Palo Verde are free from cracks in the press fitted area. Cooper-Bessemer has re-designed the rocker arm used in nuclear applications. The new design utilizes an adhesive to affix the push rod insert in place vice the press-fit previously used. Also, Cooper-Bessemer has instituted additional quality controls to ensure that the rocker arms are properly inspected.
