Subject: Palo Verde Nuclear Generating Station (PVNGS)  
Units 1, 2 and 3  
Emergency Lighting - Exide Power Supplies  
File: 90-019-026; 90-056-026

EXIDE UNINTERRUPTIBLE POWER SUPPLY RELIABILITY EVALUATION  
PVNGS UNITS 1, 2, AND 3

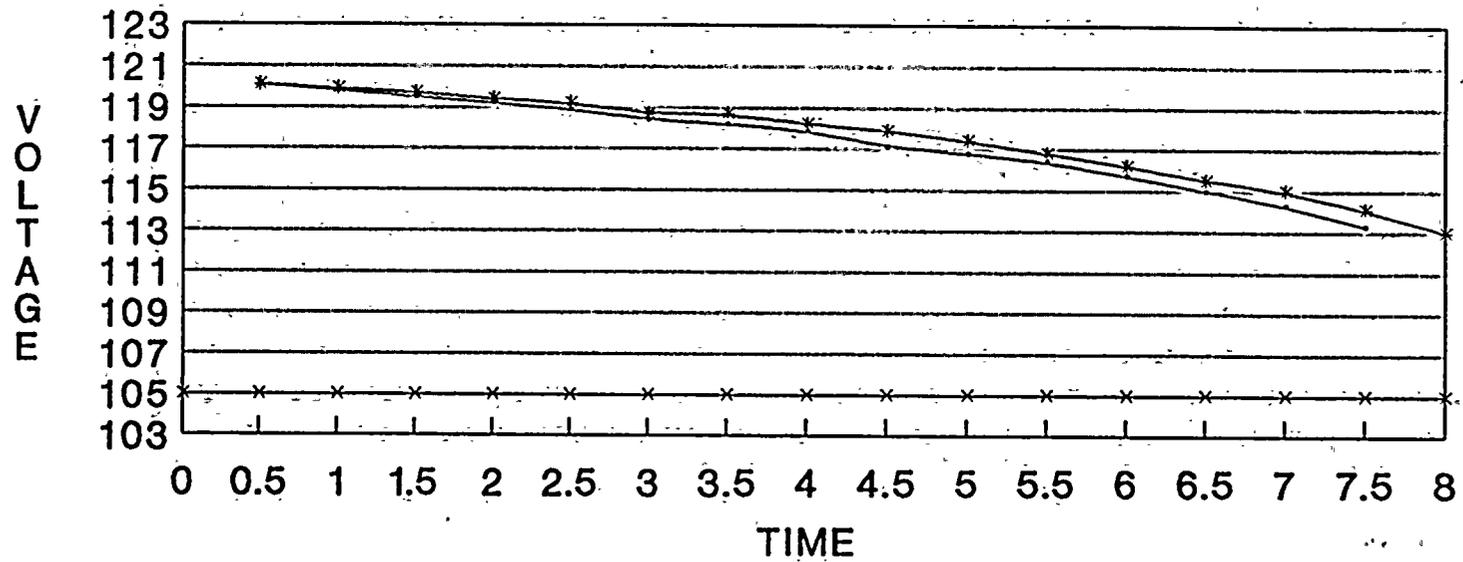
## FIGURE 1A

The data presented for battery bank 1EQDN-F01 in Unit 1 (Figure 1A) shows only seven and one-half hours of data even though the written comments by the technician indicate that the battery bank and inverter did supply power for the full eight hours before the minimum voltage disconnect relay actuated. Subsequent examination has indicated that the setpoint for this relay was high. This relay will be reset and the eight hour burn PM repeated prior to entry into Mode 2. Unit 1 battery bank 1EQDN-F02 successfully passed its discharge test. Both Unit 2 battery banks successfully passed their discharge tests.

\*\* NOTE: TEST WAS TERMINATED PRIOR TO  
ILLUMINATION READING BEING TAKEN

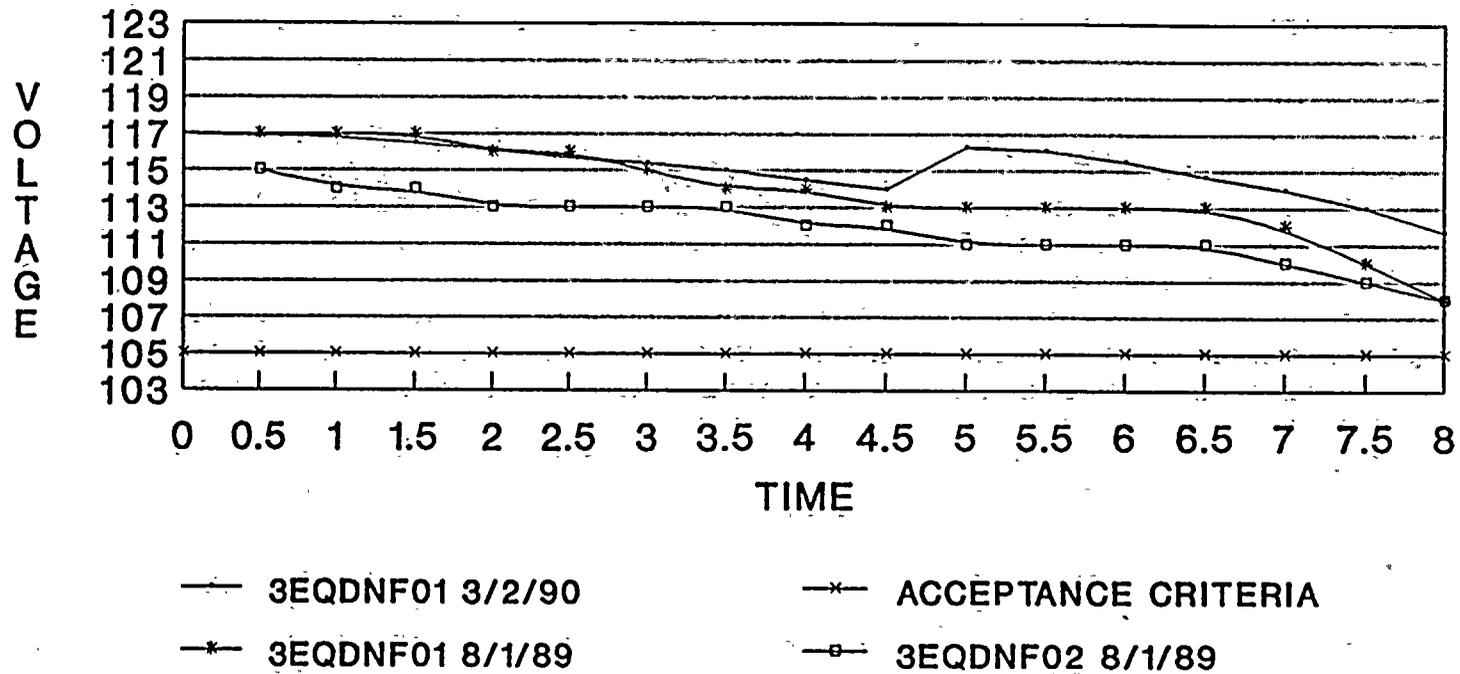
FIGURE 1C

The discharge curves for the Unit 3 battery banks show a voltage two to four volts lower than the Unit 1 and 2 battery banks when compared at the start of the discharge test. This is explained by the difference in voltage drops caused by different lengths of cable runs in each Unit between the UPS and its batteries as well as different locations for measuring voltage as explained below. Other indicators of battery condition such as the monthly specific gravity tests and cell voltage measurements of pilot cells indicate no problems. A review of the previous eight hour burn test on 3EQDN-F01 performed six months earlier indicated a similar initial voltage, indicating little degradation of the battery bank over time. The upward deflection in the discharge voltage curve between four and one-half and five hours occurred at a shift change, with a change in personnel. The deflection could be explained by taking voltage readings at different locations, i.e., the battery or the inverter. The PM task does not specify the location for taking voltage readings.

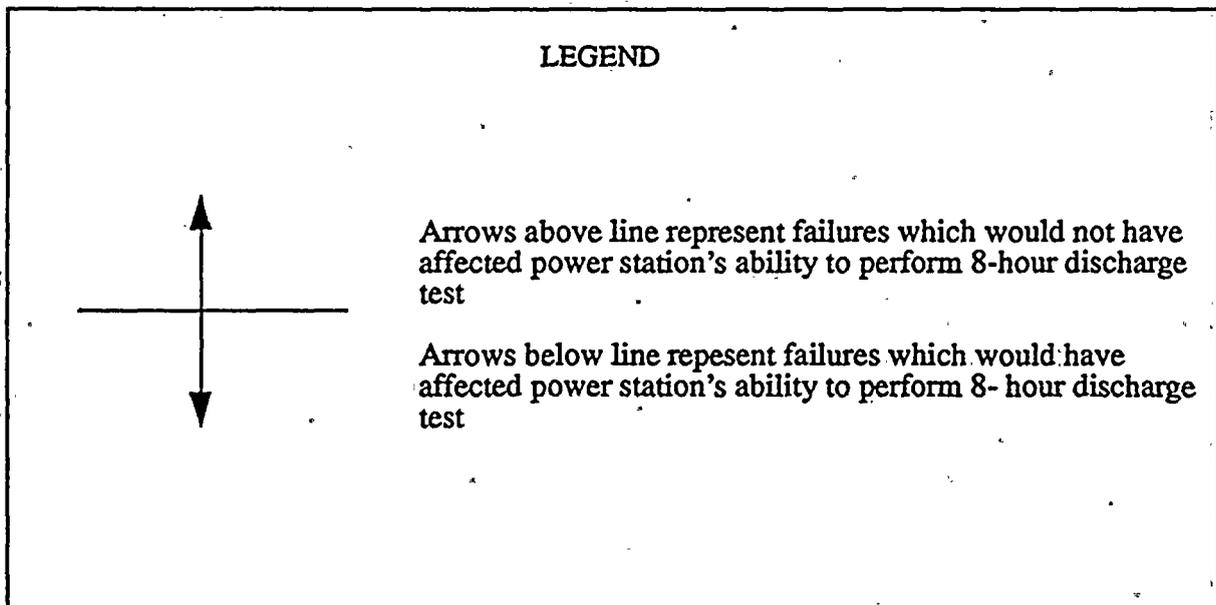
Figure 2

A total of 21 component failures were reported in the six UPSs during the period of June 1987 through March 1990. These were reviewed to determine if the specific component failure would have resulted in loss of capability of the lights to illuminate for eight hours following loss of 1E bus voltage. Of the 21 component failures, seven resulted in actual loss of lighting capability. This data is presented in a timeline for each of the six UPSs (Figure 2).

The attached timeline graphically depicts component failures from June 1987 to March 1990. The timeline also shows whether the indicated component failure would have affected the ability of the UPS to meet its eight hour discharge requirement.

The seven failures experienced may be divided into two groups, battery failures and inverter failures. Four of the failures were battery failures, three in Unit 1 and one in Unit 3. In all cases, the entire battery bank has been replaced since the failures, and no failures have occurred since which would have prevented the batteries from lasting eight hours. The remaining three failures were all failures of the battery low voltage cutout relay. The cause of these relay failures is under investigation. A summary of each of the failures evaluated is provided in Appendix A.

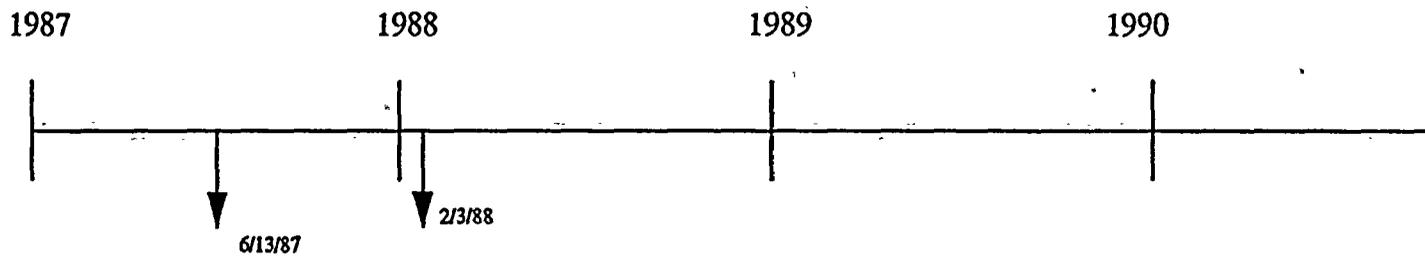
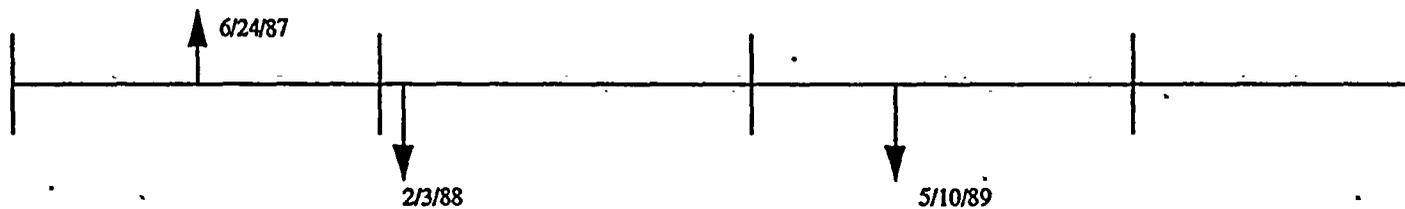
Figure 2a

Two cells had low electrolyte specific gravity. Insufficient information was available to determine whether lights would have burned for 8 hours. Therefore, this is considered a failure.

Low electrolyte specific gravity was found for the complete bank. The bank was replaced. This condition would have prevented the lights from burning for eight hours.

DATE	EVALUATION SUMMARY
06/24/87	Low electrolyte specific gravity was found in one cell, one cell had a broken flame arrestor and one cell had a broken case. Two cells and the flame arrestor were replaced. These conditions would not have prevented the lights from burning 8 hours.
02/03/88 (OPENED)	Battery would not hold charge and specific gravity was low. The complete battery bank was replaced. These conditions would have prevented the lights from burning 8 hours. *
10/03/88 (CLOSED)	
05/10/89	The inverter input breaker tripped. This condition would have prevented the lights from burning for 8 hours. The breaker was replaced.

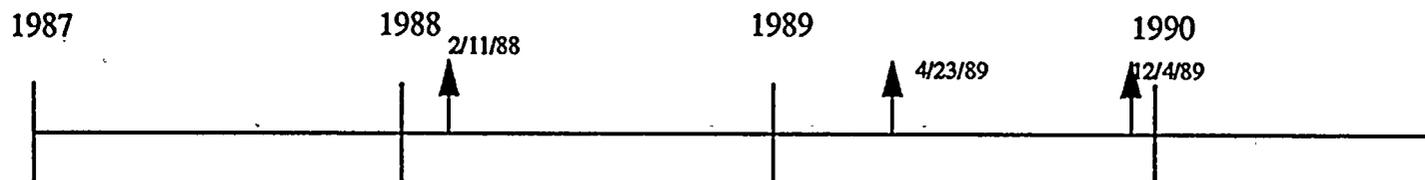
Figure 2b

DATE	EVALUATION SUMMARY
02/11/88	The low battery warning lamp was burned out. This condition would not have prevented the lights from burning for 8 hours. The lamp was replaced.
04/23/89	Low electrolyte specific gravity was found in cell 53. This condition would not have prevented the lights from burning for 8 hours. The battery was replaced.
12/04/89	Wrong lamps were installed and failed to meet illumination criteria. This condition would not have prevented the lights from burning for 8 hours. Lamps were replaced with correct lamps and the test was successfully reperformed.

DATE	EVALUATION SUMMARY
03/14/88	Corrosion was found on intercell connections. This condition would not have prevented the lights from burning for 8 hours. The intercell connections were cleaned and reinstalled.
06/18/88 (OPENED) 09/23/88 (CLOSED)	A cracked post on one battery. This condition would not have prevented the lights from burning for 8 hours. The battery was replaced. *
08/29/89	Float/equalize charge switch was performing intermittently. This condition would not have prevented the light from burning for 8 hours. Switch was replaced.

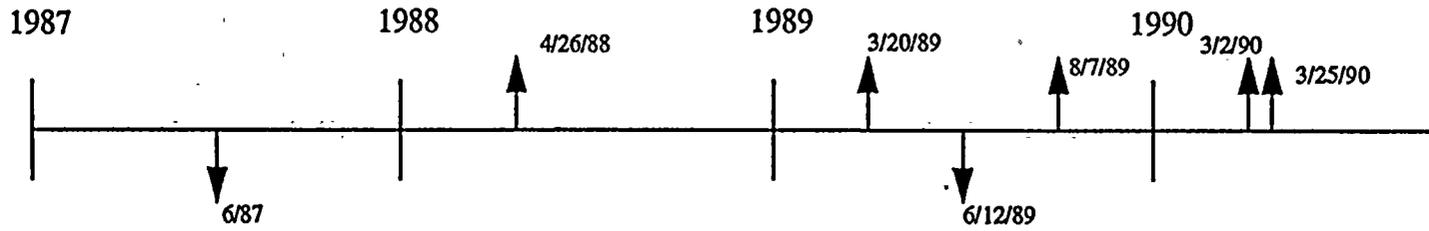
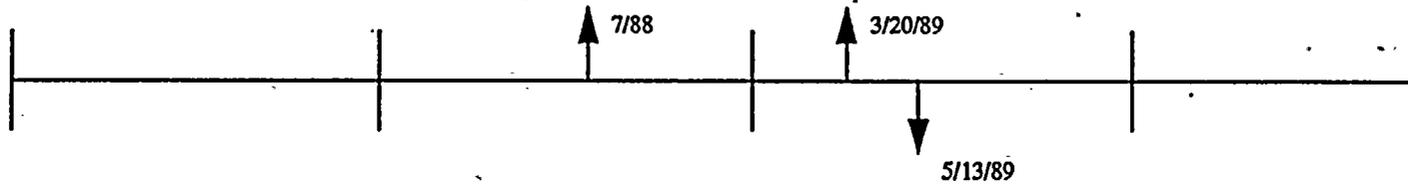
Figure 2c

DATE	EVALUATION SUMMARY
06/87	Batteries had low electrolyte specific gravity. The battery bank was replaced. This condition would have prevented the UPS from burning for 8 hours.
04/26/88	The flame arrestor was defective. This condition would not have prevented the UPS from burning for 8 hours. The flame arrestor was replaced.
03/20/89	The charger voltage sensing circuit failed. The UPS was operable. This condition would not have prevented the UPS from burning for 8 hrs.
06/12/89	The inverter input breaker tripped. The UPS was repaired. This condition would have prevented the UPS from burning for 8 hours.
08/07/89	Low electrolyte specific gravity was found. A successful 8 hour discharge test was performed six days earlier. Batteries were put on equalize charge and all electrolyte specific gravities were found acceptable.
03/02/90	UPS passed the 8 hour discharge test but electricians did not take final illumination reading, therefore was recorded as a failure. The lights burned for 8 hours.

03/25/90	Charger failure light did not illuminate. This would not have prevented the UPS from burning for 8 hours.

DATE	EVALUATION SUMMARY
07/88	The flame arrestor was broken. This condition would not have prevented the lights from burning for 8 hours. The flame arrestor was replaced.
03/20/89	The battery charger indication was not illuminated. The sensing circuit was incorrectly adjusted. The battery voltage sensing potentiometer was adjusted. This condition would not have prevented the charger or inverter from performing properly.
05/13/89	Failure of the input breaker. This is a failure of the UPS. This condition would have prevented lights from burning for 8 hours. The inverter logic card was replaced.
