SUBJECT: MEETING WITH ARIZONA PUBLIC SERVICE

TRIP REPORT
MEETING WITH ARIZONA PUBLIC SERVICE
MAY 13, 1991

APS Vendor Quality Assurance Engineering Major Vendor Audits and Significant Events (1986 - 1991)

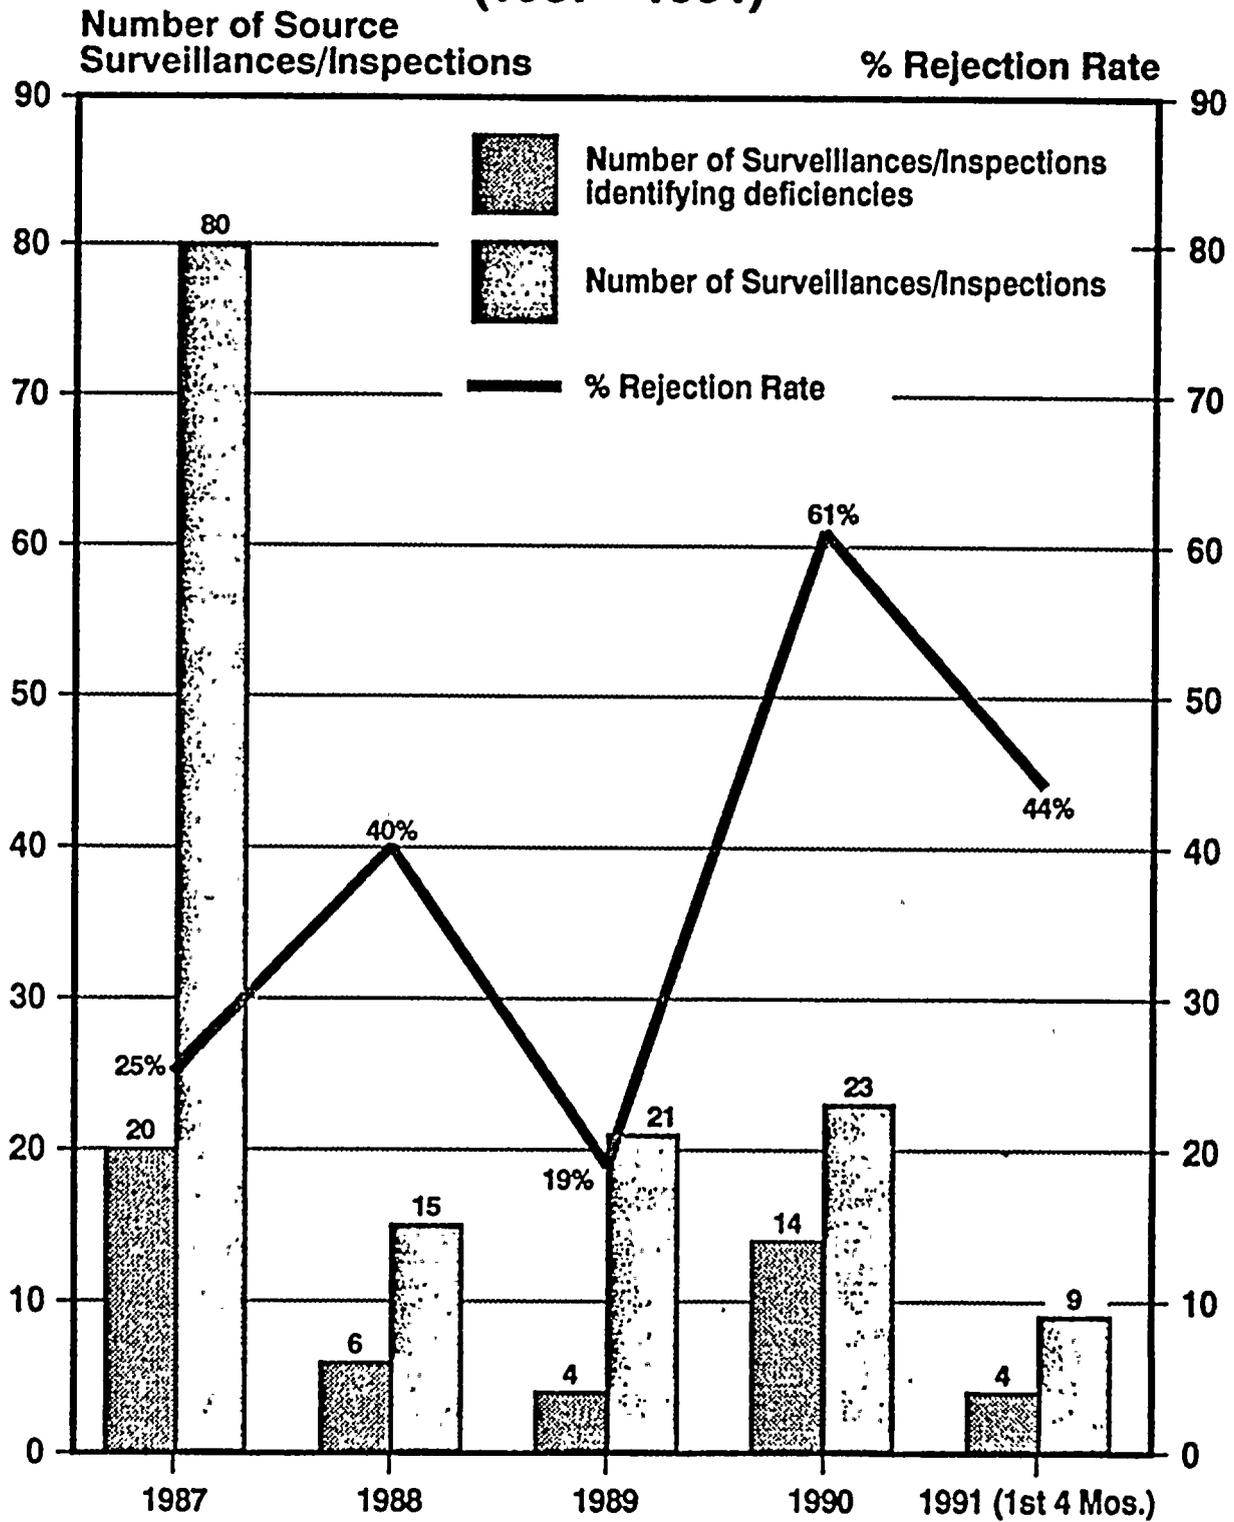
ESG Supplier Performance Trend (1987 - 1991)

As of April 30, 1991 seven safety-related purchase orders were subjected to source surveillance by APS. Approximately nine trips were taken to support the project. Rejection statistics are reflected on the performance trend.

Our surveillances to date have indicated a downward trend in parts acceptability. APS has re-imposed 100% surveillance.
