U.S. NUCLEAR REGULATORY COMMISSION

AUGMENTED INSPECTION TEAM (AIT) REPORT

Facility Name: Palo Verde Nuclear Generating Station
Units 1, 2, and 3

Areas Inspected: Augmented Inspection Team (AIT) review of a partial loss of offsite power event at Unit 3 due to an unattended, ungrounded mobile crane boom striking one of two offsite 13.8 kV power transmission lines.

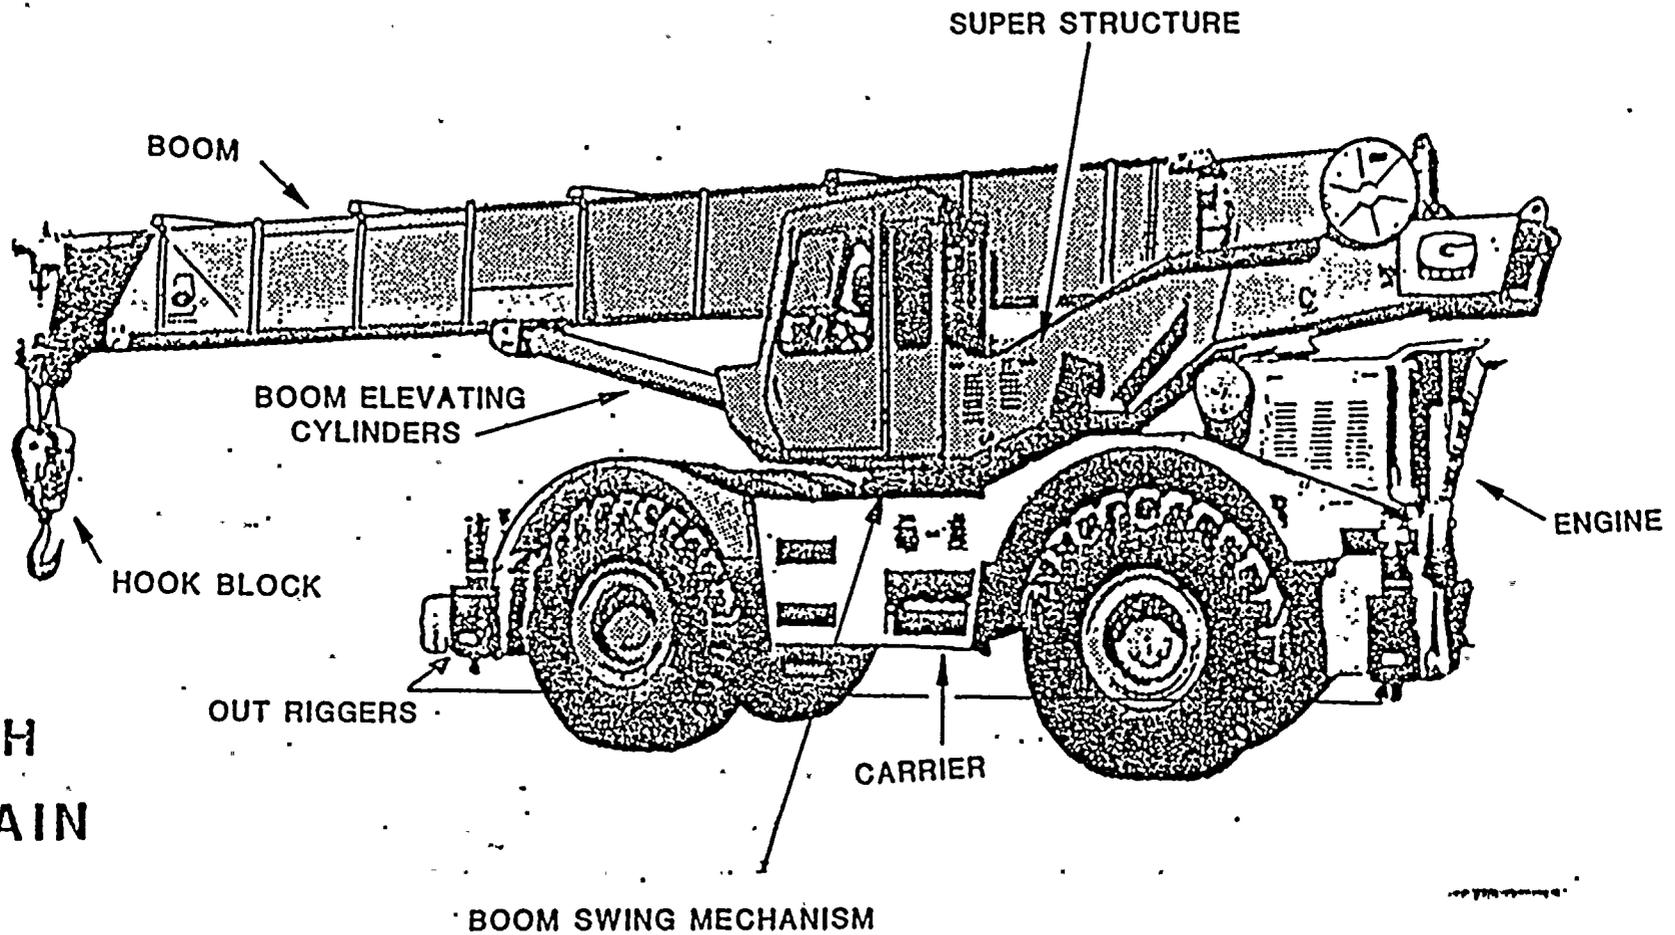
FIGURE 3
GROVE MODEL RT 65S CRANE

"Lifting on rubber" is operation of the crane with no outriggers out. In that configuration, the handbook and load charts required that the boom swing lock must be engaged. Also, the boom must not be extended over 56 feet, according to the load charts for the crane located in the crane cab. As noted above, the crane was extended about 66 feet at the time of the event.

The AIT concluded that the crane operator had improperly operated the crane when he failed to level it or to extend all outriggers.
