SUBJECT: LER 92-008-00:on 920508, discovered that surveillance requirement for nonessential auxiliary feedwater pump not performed. Caused by personnel error. Instruction change request submitted. W/920608 ltr.

Palo Verde Nuclear Generating Station (PVNGS)

Unit 1

Licensee Event Report 92-008-00

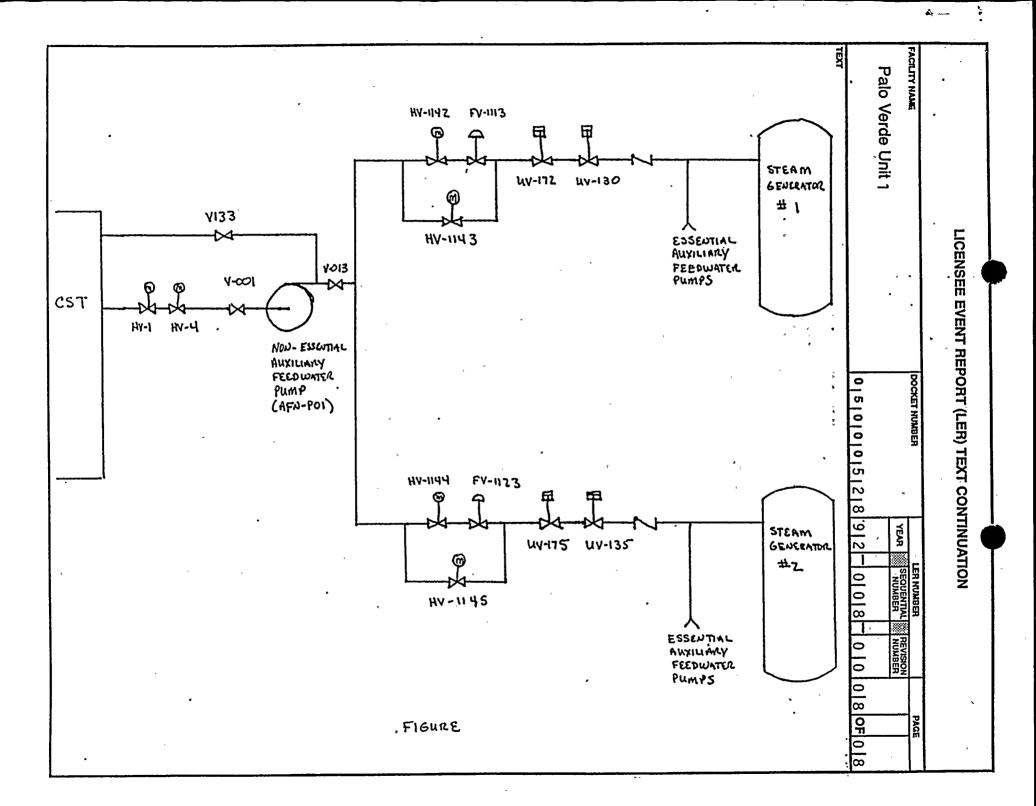
The nonessential AFWP flowpath and associated valves are as described below (see attached Figure):

The nonessential AFWP (AFN-P01) takes suction from the Condensate Storage Tank (CST) through two redundant, motoroperated valves (CTA-HV-1 and CTA-HV-4). Upstream of AFN-P01 is the suction isolation valve (AFN-V001) and downstream of AFN-P01 are the discharge isolation valve (AFN-V013) and the recirculation isolation valve to the CST (AFN-V133). The flowpath continues to both steam generators via the main feedwater supply lines (i.e., through the downcomer feedwater regulating valves and into the upper nozzles of the steam generators). The nonessential auxiliary feedwater supply lines join main feedwater upstream of the main feedwater downcomer control valves. The valves in this flowpath are the steam generator feedwater isolation block

valves (SGN-HV-1142 and SGN-HV-1144), steam generator downcomer feedwater control valves (SGN-FV-1113 and SGN-FV-1123), and the steam generator downcomer isolation valves (SGA-UV-172, SGA-UV-175, SGB-UV-130 and SGB-UV-135). An additional bypass flowpath around SGN-FV-1113, SGN-FV-1123, SGN-FV-1142, and SGN-FV-1144 exists and contains the steam generator feedwater isolation bypass valves (SGN-HV-1143 and SGN-HV-1145).

Of the fifteen manual, power-operated, or automatic valves located in the flowpath of the nonessential AFWP, five (CTA-HV-1, CTA-HV-4, AFN-V001, AFN-V013, and AFN-V133) were surveillance tested in accordance with existing surveillance procedures. Three of the five valves (AFN-V001, AFN-V013, and AFN-V133) are required to be locked in their desired position. The ten valves that were not surveillance tested are in the flowpath from the discharge isolation valve (AFN-VO13) of the nonessential AFWP to the steam generators. Therefore, the operability requirements of TS LCO 3.7.1.2 and the associated ACTIONs have not been met since issuance of the operating licenses for Units 1, 2, and 3 (Unit 1 on June 1, 1985, Unit 2 on April 24, 1986, and Unit 3 on November 25, 1987). Disabling selected valves in the nonessential AFWP flowpath from the CST to the steam generators could cause an entry into an applicable TS LCO 3.7.1.2 ACTION statement since a flowpath from the CST to the steam generator would not be available using the nonessential AFWP. The requirements of TS LCO 3.0.4 and TS SR 4.0.4 also were not met.

Units 1, 2, and 3 Operations personnel verified that each valve (manual, power-operated, or automatic) in the flowpath from the nonessential AFWP to the steam generators that is not locked, sealed, or otherwise secured in position, was in its correct position to satisfy the TS SR 4.7.1.2.a.2.

An instruction change request for the auxiliary feedwater monthly alignment surveillance testing procedure was submitted to verify

the position of the valves in the flowpath from the nonessential AFWP to the steam generators. The corresponding procedure change became effective on May 26, 1992. In the interim, a night order was issued to all three units to notify Operations personnel of the ten additional valves to be included in verifying the flowpath for the nonessential AFWP.
