U. S. NUCLEAR REGULATORY COMMISSION

Report Nos. 50-528/92-23, 50-529/92-23, and 50-530/92-23

Facility Name Palo Verde Nuclear Generating Station
Units 1, 2, and 3

Areas Inspected: Special inspection of the circumstances surrounding a Unit 1 containment isolation check valve found improperly assembled on March 18, 1992. This condition was documented by Unit 1 Licensee Event Report 92-005. Inspection Procedure 92700 was used as guidance during this inspection.

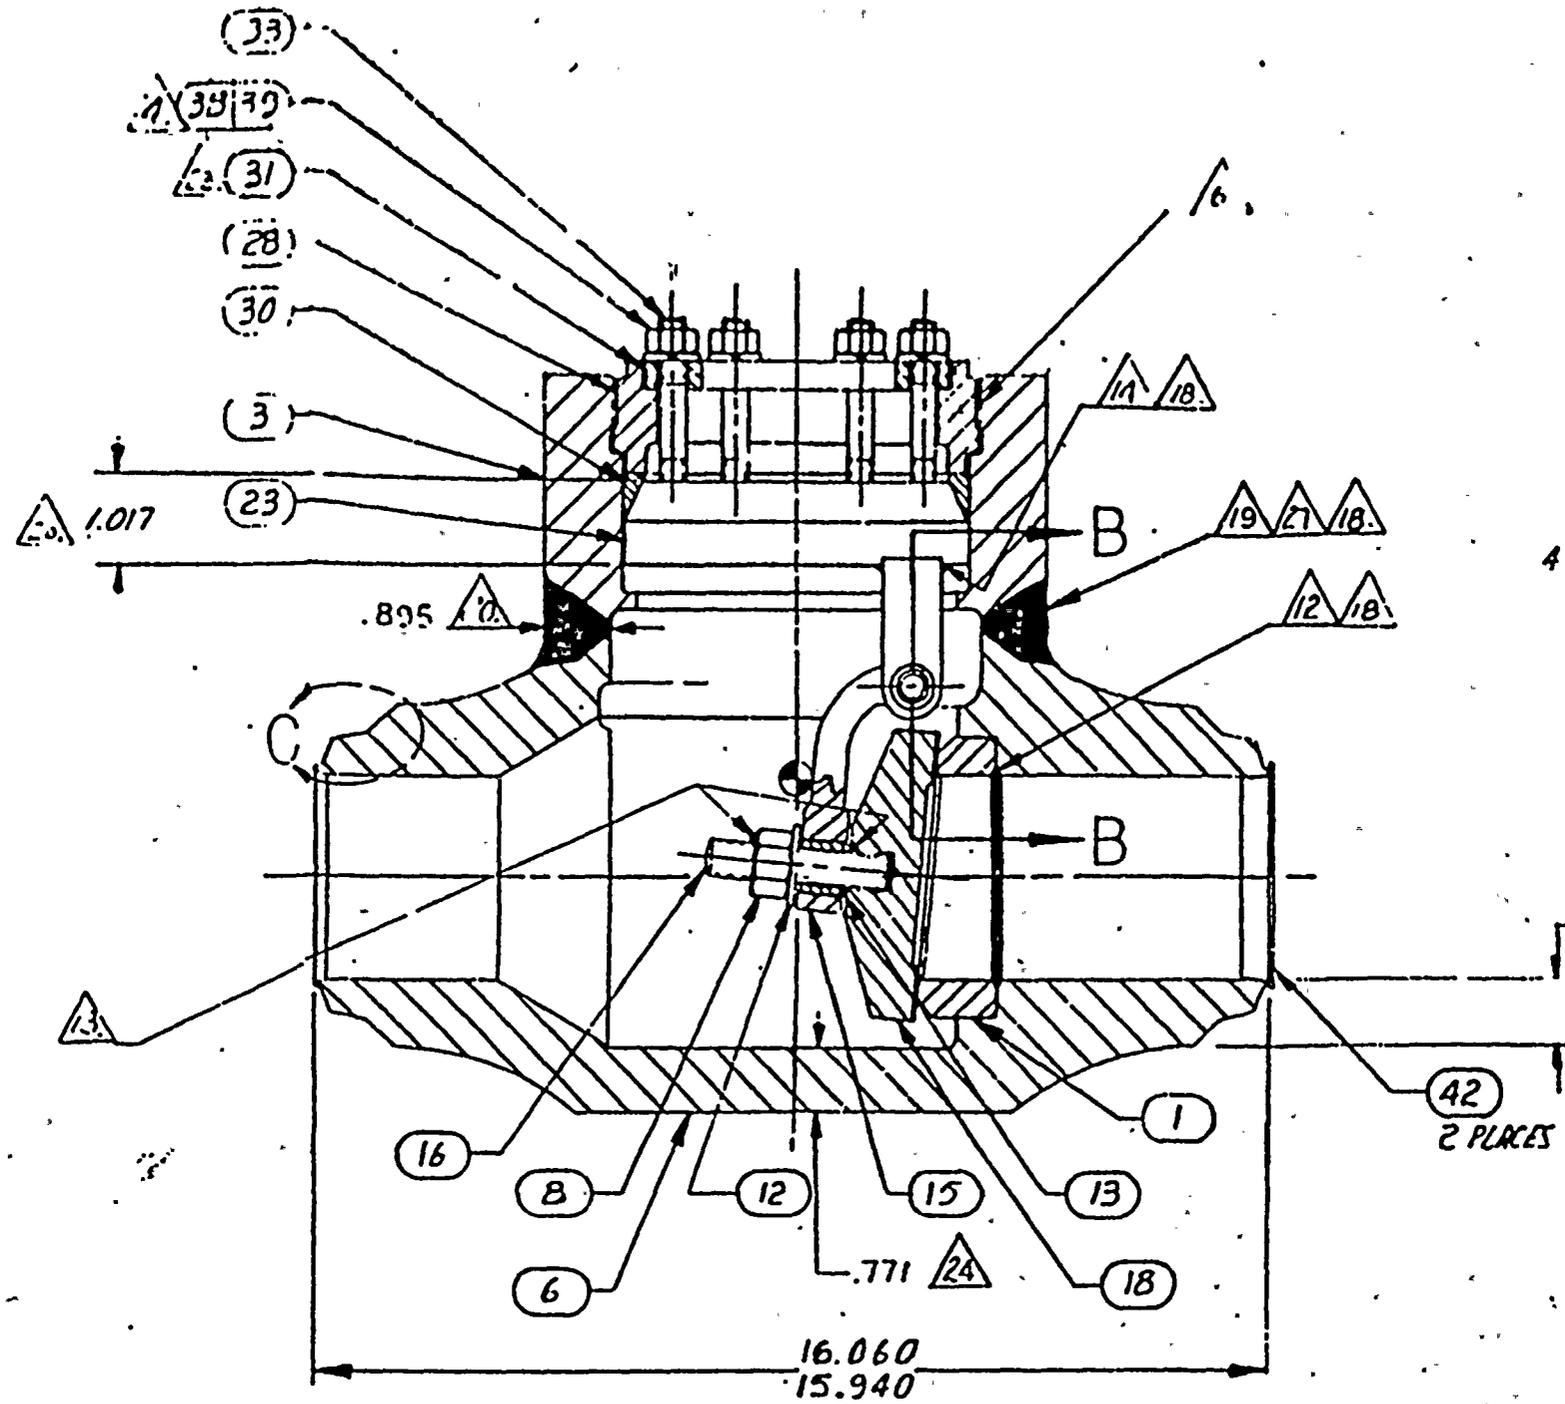
ATTACHMENT 1

Unit 1 valve SIE-V133 was found to have its bonnet assembly installed approximately 160 degrees from normal alignment. The valve was manufactured by Borg-Warner and is a three inch swing check, model 77700. The bonnet assembly includes the attached valve disc, and the bonnet assembly is secured to the valve body with a bonnet retainer held by studs, nuts, and washers. A silver plated seal between the bonnet and valve body provides leakage protection. The valve design allows the bonnet assembly to be rotated in the valve body when the retainer and seal are not present. Attachment 1 depicts the valve assembly.

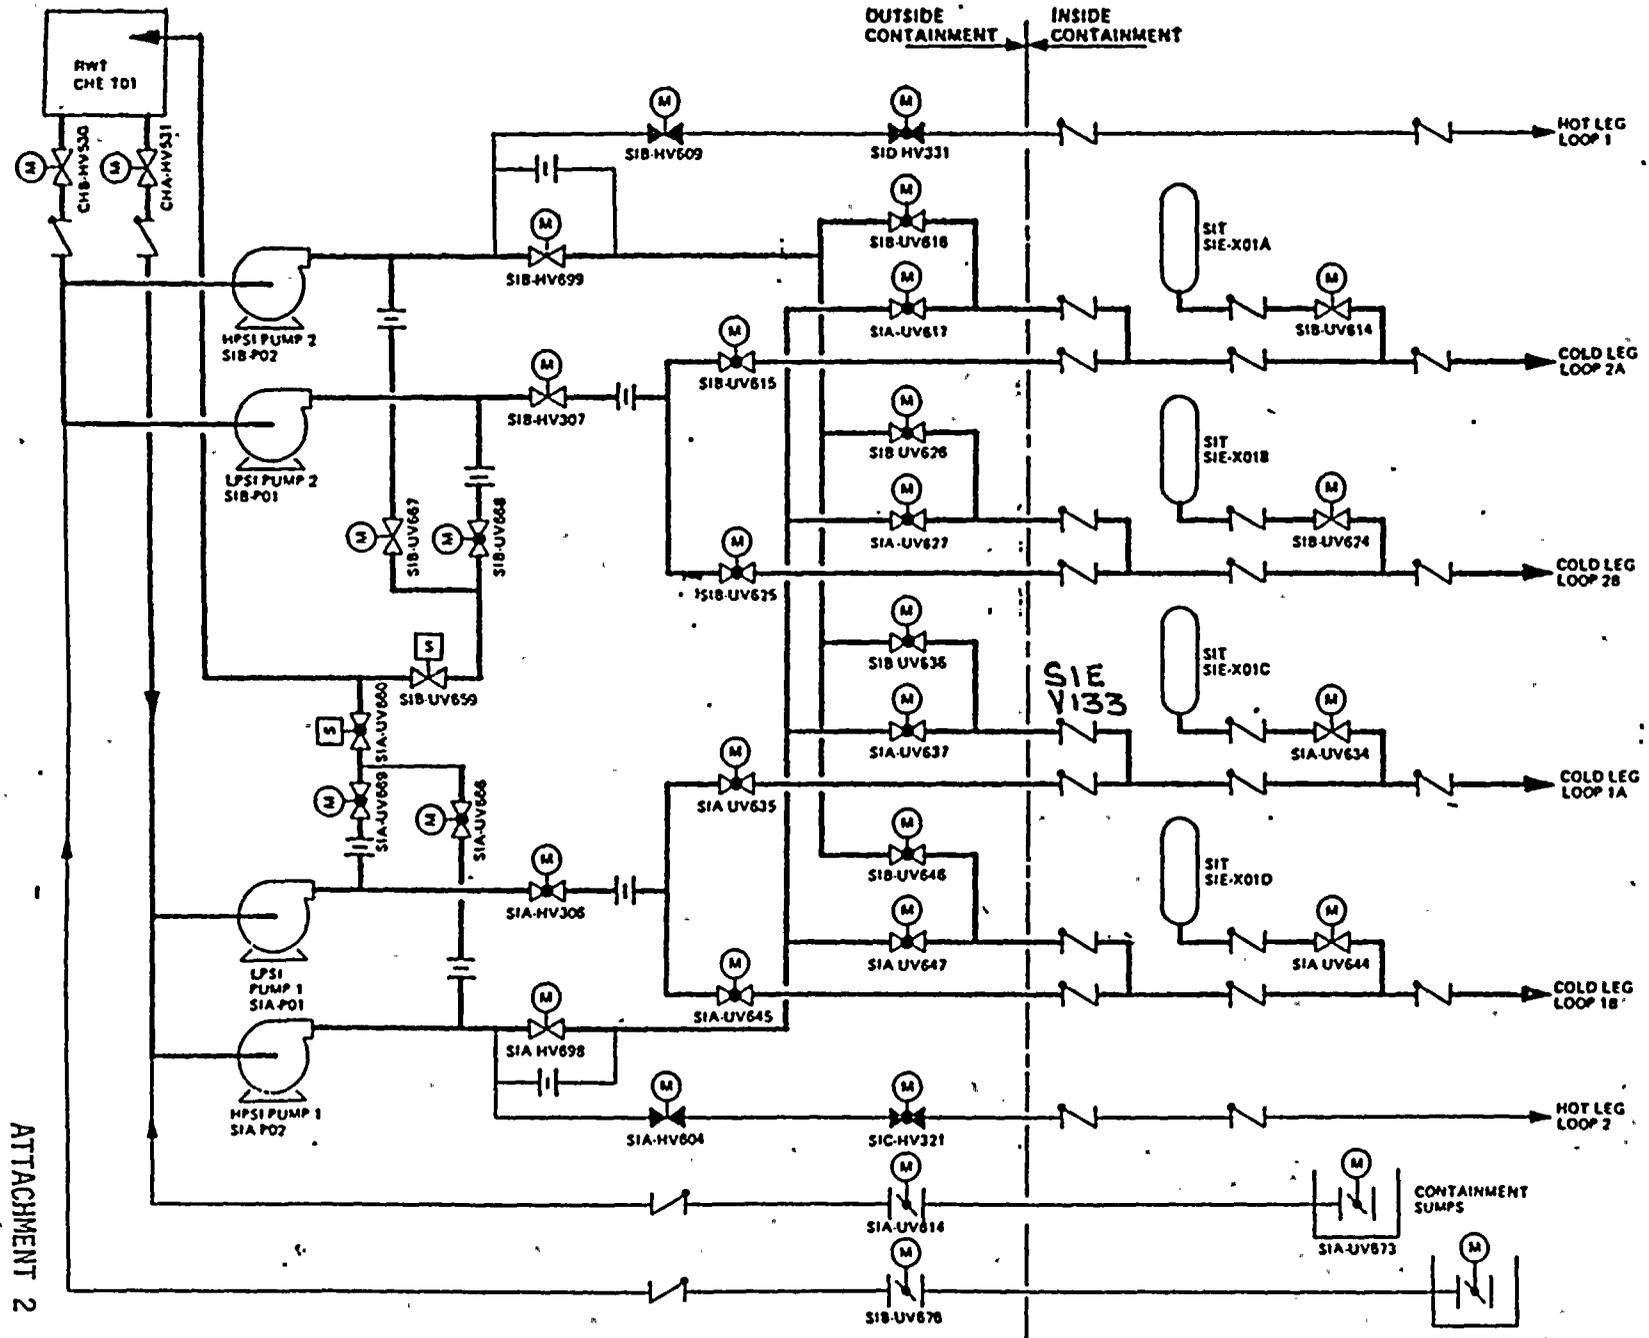
FIGURE 1

SIE-V133 is located in the high pressure safety injection (HPSI) system leading to reactor coolant system loop 1A. The valve is located inside of containment, within five feet of the containment wall. Upstream of the valve, and outside of containment, the two HPSI trains join to form one line. A motor operated valve (MOV) is located outside of containment in each of the HPSI trains. Downstream of SIE-V133, the low pressure safety injection (LPSI) system connects to the injection piping. Attachment 2 depicts the location of the check valve in the safety injection system.
