UNITED STATES
NUCLEAR REGULATORY COMMISSION
REGION II
101 MARIETTA STREET, N.W.
ATLANTA, GEORGIA 30323

Report Nos.: 50-335/85-31 and 50-389/85-31

Facility Name: St. Lucie 1 and 2

Inspection Conducted: December 2-6, 1985

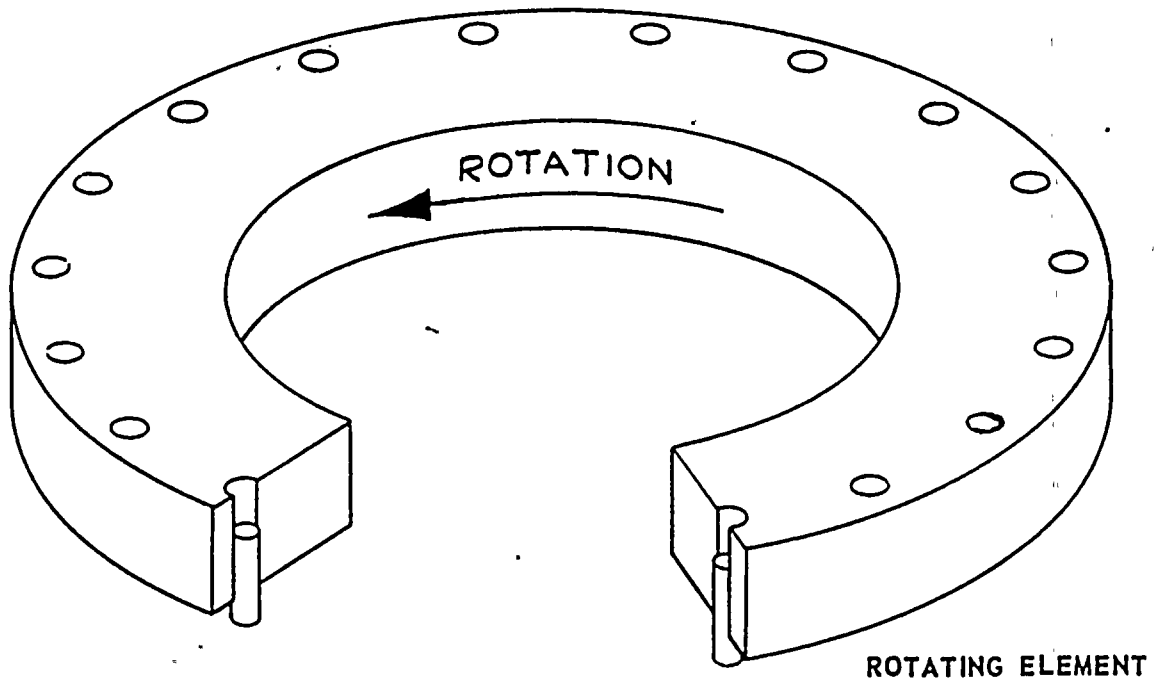
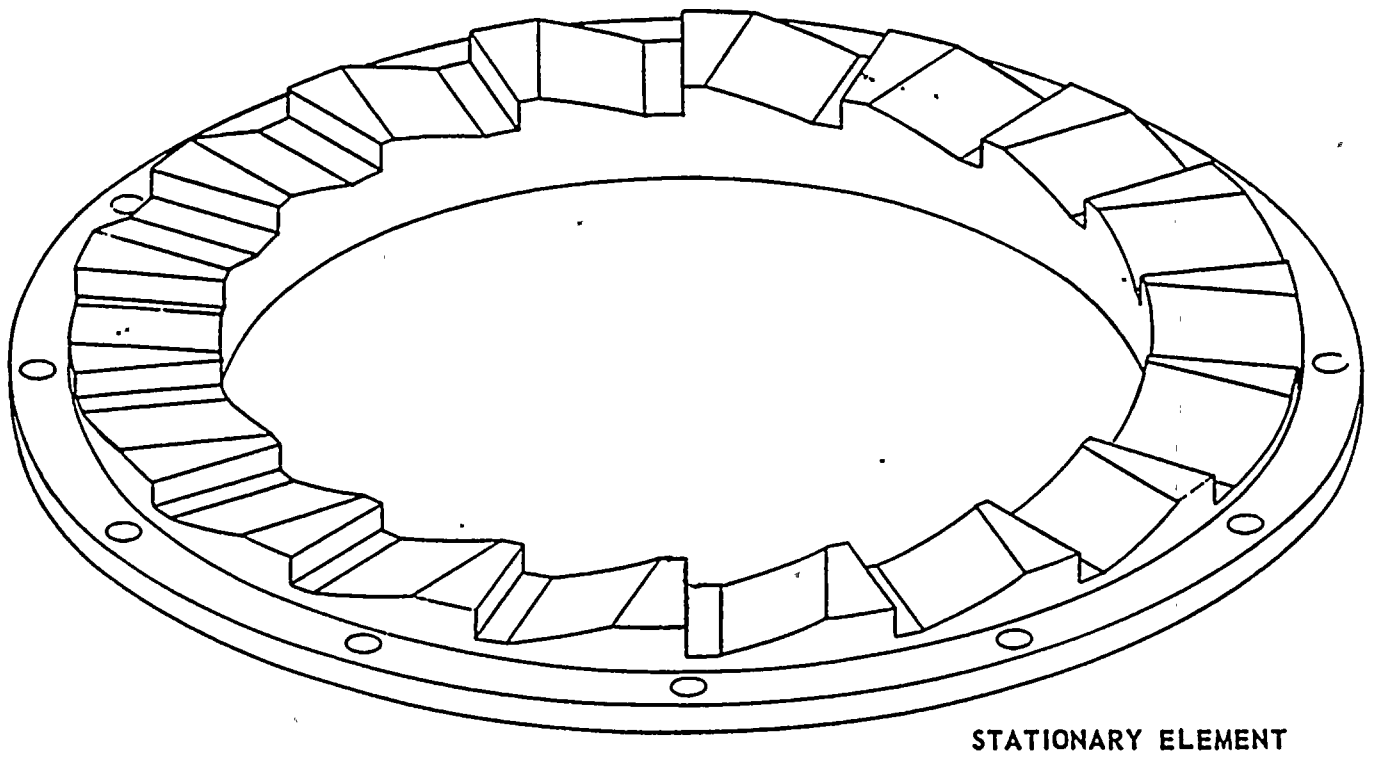
FIGURE 1

The Anti-Reverse Rotation Device (ARRD) on each Allis-Chalmers Reactor Coolant Pump (RCP) motor consists of a stationary ratchet element bolted to the motor frame, and a rotating element keyed to the motor shaft with thirty-six anti-rotational pins and pin retainers. At speeds of less than 100 rpm in the forward direction the pins contact the stationary element and ride up the ramps. At approximately 100 rpm the ramps push the pins into the retainers in the rotating element where centrifugal force will hold them until the RCP speed slows to below 100 rpm. As the RCP coasts down the pins fall and ride along the ramps. When the RCP stops, the pins contact the vertical backstops preventing reverse-rotation. The pins are $1\frac{1}{2}$ inches in diameter and about 5 inches long. They are chromium-molybdenum with a molybdenum sulphide (Fearlon) tip to reduce wear on the stationary element. Refer to figure 1.

During repair of a Unit 2 RCP in September 1985, several of the pins were found to be lodged in the pin retainers. Further investigation revealed that many pins in the other Unit 2 RCP's were lodged in their retainers and many of the pins that fell freely had broken Fearlon tips or other surface defects. The edges of the pins, which lodged in the retainers, had mushroomed out due to metal to metal contact with the stationary element such that they could no longer fall by gravity. The Unit 1 ARRD's were inspected during the present refueling outage and similarly damaged pins were discovered. A summary of the pin damage is shown in Table 1.
