Subject: R. E. Ginna Nuclear Power Plant  
Docket No. 50-244  
SEP Topics III-3.A, II-3.A, II-3.B, II-3.B.1  
& II-3.C

Response to NRC Correspondence on SEP Topics  
III-3.A (3/24/81) and II-3.A, II-3.B, II-3.B.1 & II-3.C (4/10/81)

1. SEP Topic III-3.A - "Effects of High Water Level on Structures"  
(Reference 1)

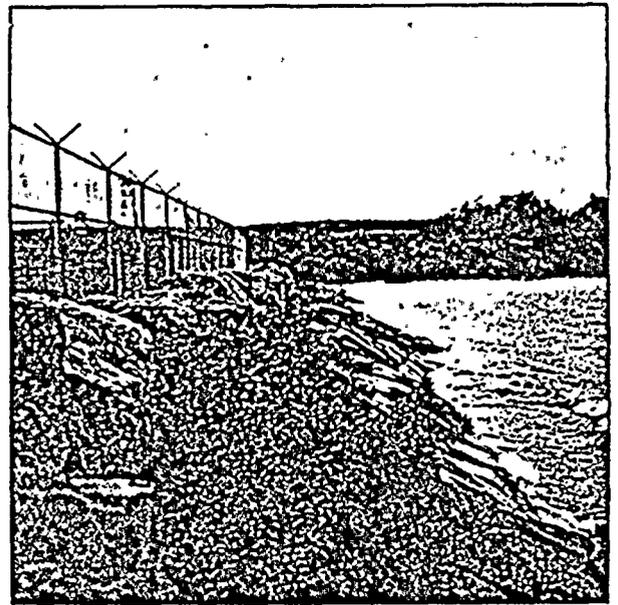
NEAR CENTER OF WEST REVETMENT -  
LOOKING WEST. NOTE LAID-UP REVETMENT  
ON RIGHT AND CAP STONES ON LEFT.

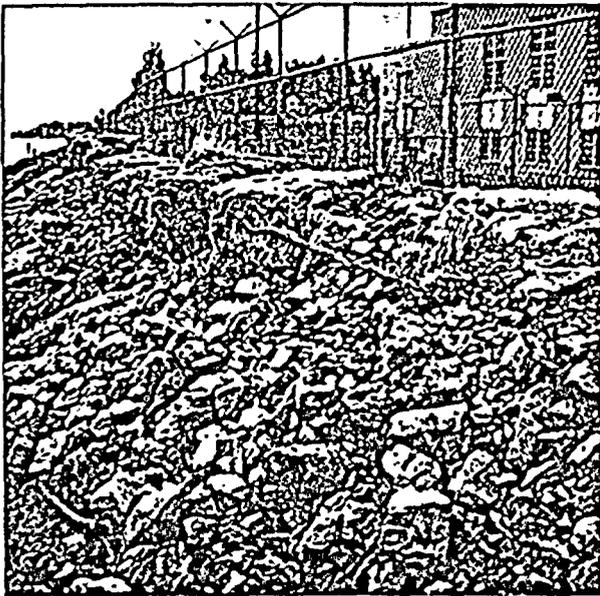
WEST REVETMENT NEAR EAST END -  
LOOKING EAST. NOTE SMALL STONE  
FILL OBSCURING TOP ARMOR STONES.  
SCREEN HOUSE IS AT RIGHT.

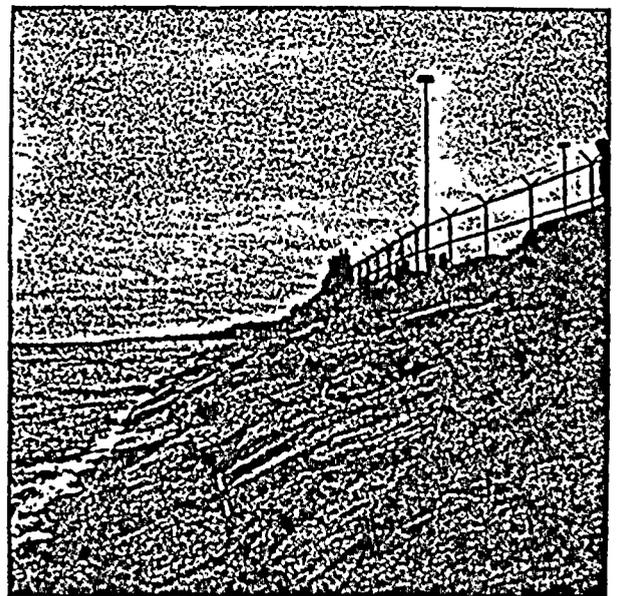
ENCLOSURE E  
WEST REVETMENT NEAR EAST END.  
LOOKING EAST. NOTE LAID-UP REVETMENT.

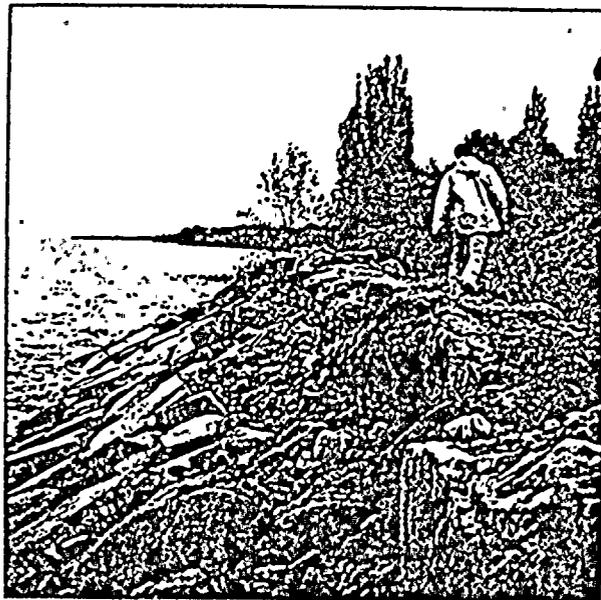
EAST REVETMENT NEAR EAST END - LOOKING EAST. NOTE SMALL STONE FILL OBSCURING TOP ARMOR STONES LAID UP REVETMENT @ LEFT, CAP STONES @ RT.

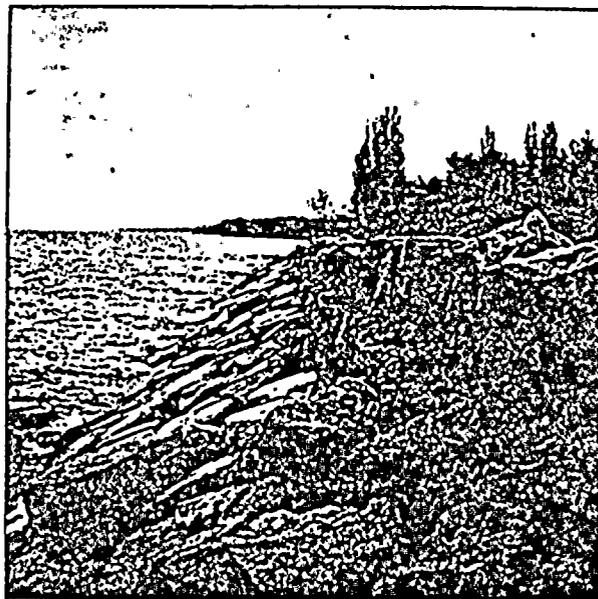
ENCLOSURE F  
EAST REVETMENT - LOOKING EAST, NEAR EAST END. NOTE LAID-UP REVETMENT, ROW

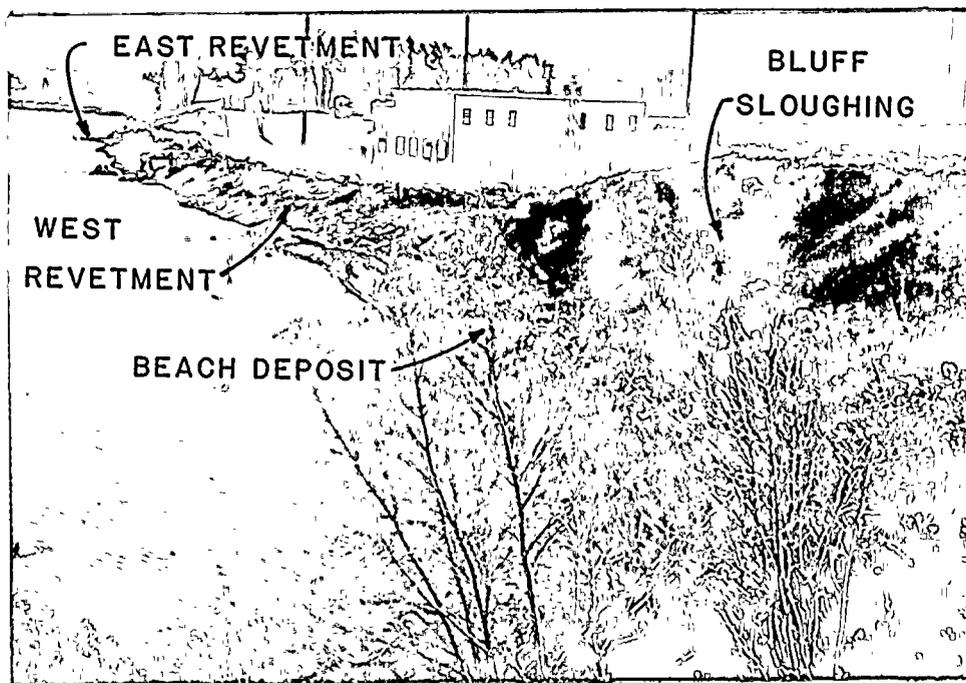
(b) Bluff Stability. Failure scarps in soil are present in the bluffs both updrift and downdrift of the West and East Revetment (Photographs 1, 2 and 4). At the terminus of the West Revetment the scarps are within several feet of the perimeter fence. Recession rates of the bluffs appear to be only slight to moderate.

Photograph 1 - East and West Revetments with adjacent bluff at right (looking east).

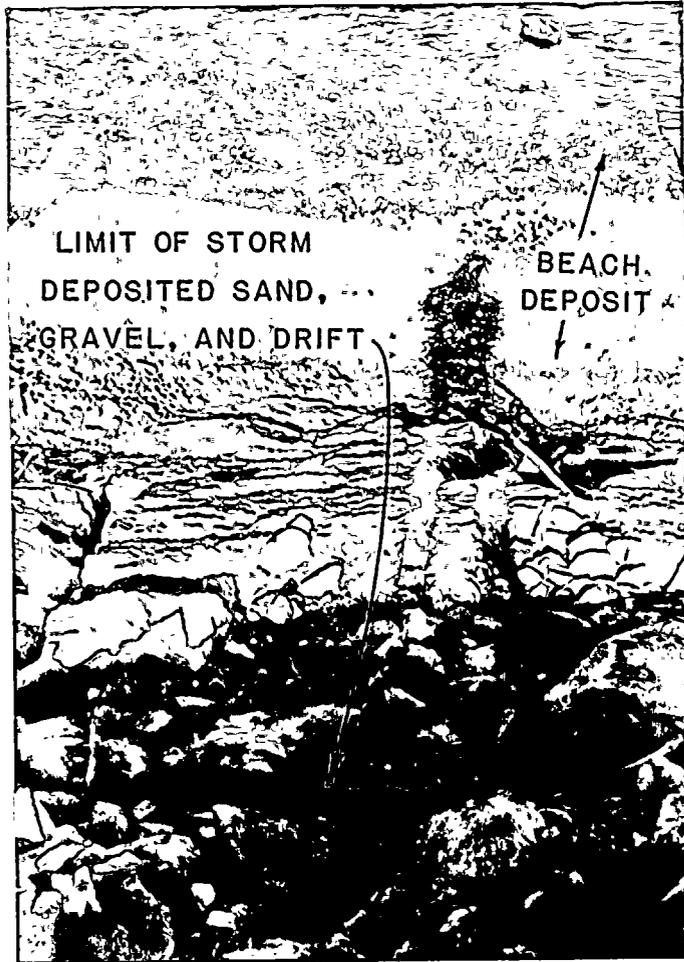
Photograph 3 - Looking at toe of West Revetment from the crest.

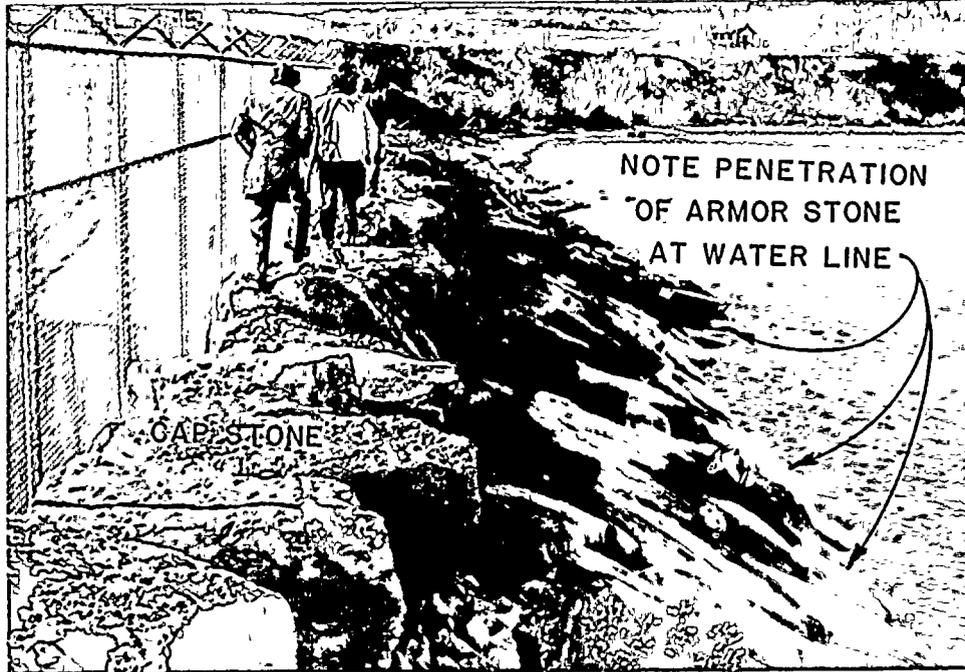
(a) Armor Stone Layers. Over most of the West and East Revetments the armor stone has good rock to rock contact with only a minimum amount of voids (Photographs 5, 6, and 7). The armor face is relatively uniform; the slope has good to excellent penetration at the water line (Photographs 5 and 7). The second layer of armor stone can be seen at numerous inspection points (voids - see Photograph 8). The outer layer of armor stone contains a fairly high amount of cracked stones. Although no counts were made, about one-third or more of the stones contained fractures that penetrate the interior of the stones (Photographs 15 and 16).

Photograph 5 - Looking west at crest of West Revetment, near west end.

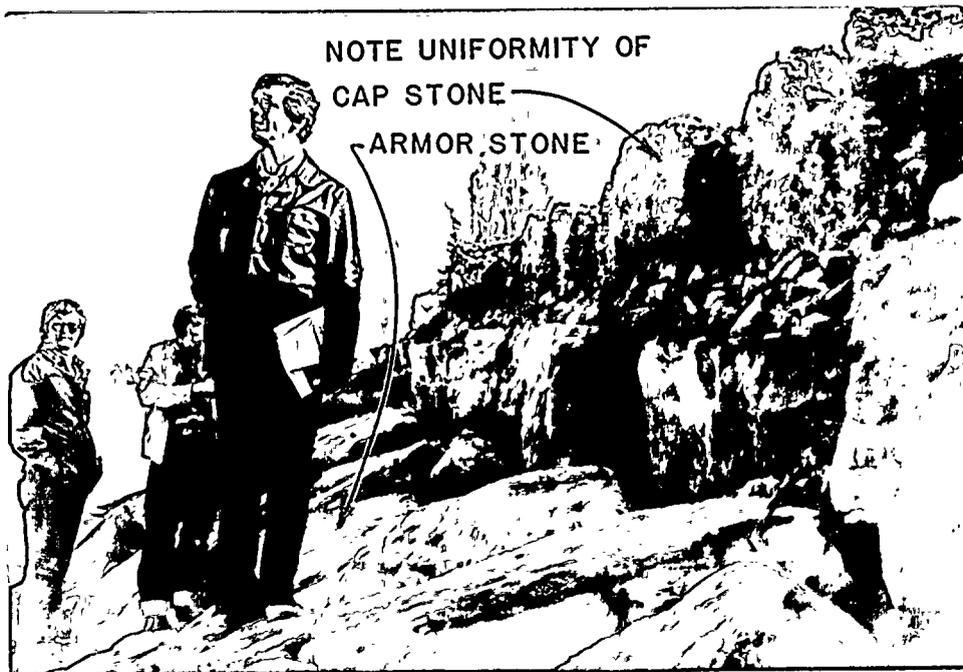
Photograph 6 - West Revetment, looking at top of armor stone slope and cap stones.

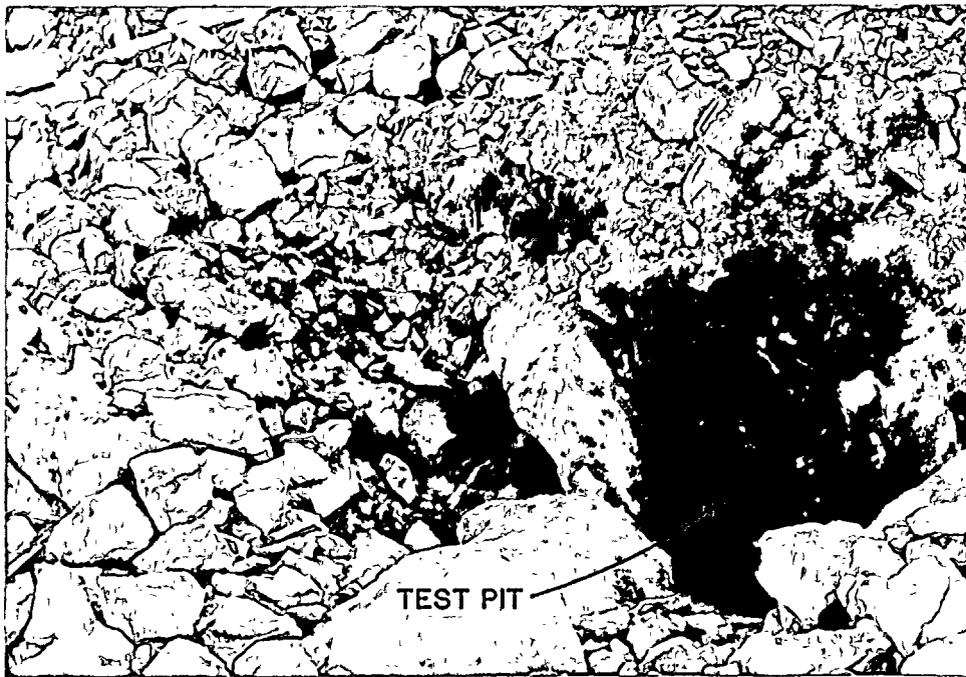
Photograph 9 - Test Pit in West Revetment revealing continuity of armor stone.

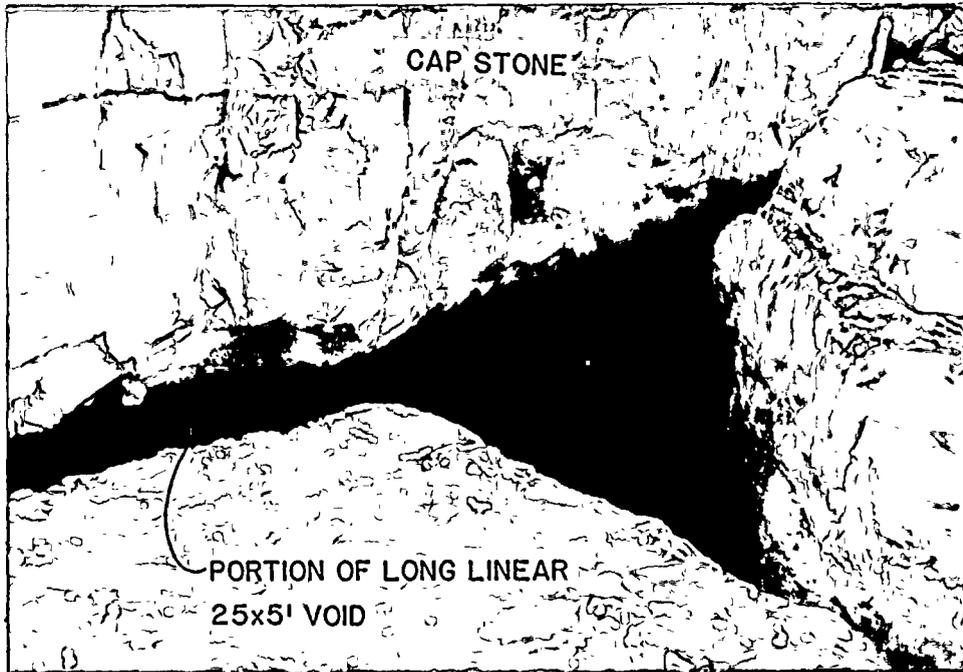
Photograph 13 - Closeup of long void in East Revetment beneath cap stones.

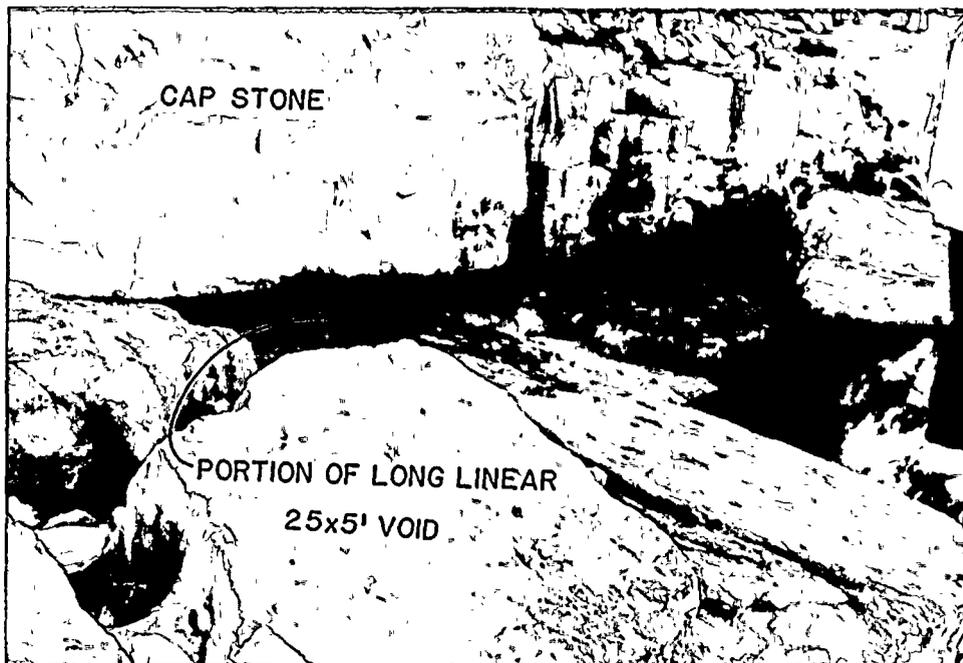
Photograph 14 - Closeup of long void in East Revetment beneath cap stones.
