Apparent Cause Evaluation – CR-CNS-2017-00223, Rev. 2
"Phase-to-Phase Fault of ESST Non-Segregated Bus"

*Cooper Nuclear Station
Brownville, Nebraska*

Phase-to-Phase Fault of ESST Non-Segregated Bus

Condition Report CR-CNS-2017-00223 Rev. 2

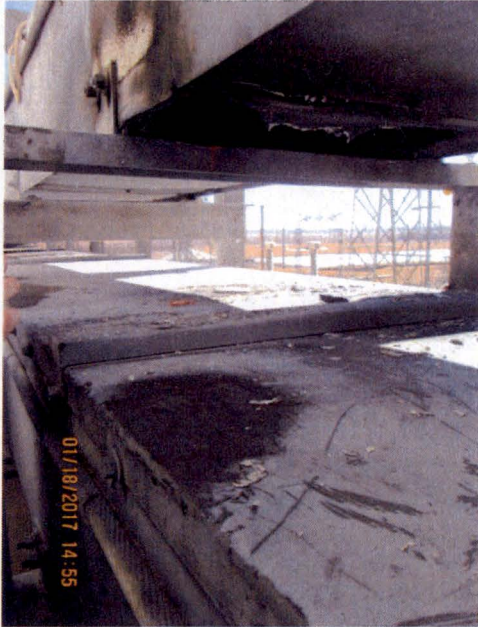
Figure 1: ESST Non-Segregated Bus top, SSST X-Winding bus bottom

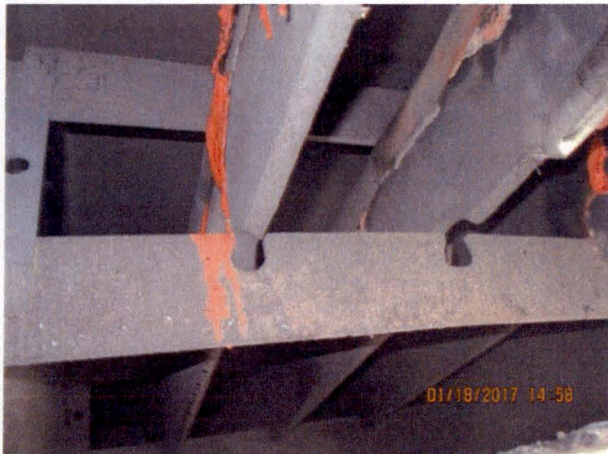
Figure 2: As-Found condition of fault location

Initial inspection of the fault location showed the bottom aluminum cover of the non-segregated bus duct was found to have a hole with material from the bus/insulation found on the SSST X-Winding bus duct below (See Figure 1). The SSST bus duct was discolored but intact. The fault occurred at a location where a lower glastic bus support insulator is located. (See Figure2) Based on the location of the fault it was determined that the entire non-segregated bus should be cleaned and inspected per

CR-CNS-2017-00240: Inspection of the ESST non-segregated bus shows the bottom cover to have a hole in it with the side covers having some buckling due to the effects of the fault. Inspections of the aluminum bus bars show that all three phases have some damage at the area by a bus support piece. The 3M insulation was also noted to be black in the area of the bus work.

Relationship to issue: This CR was written to document the as found condition of the fault location. This was damage directly related to the event and was repaired by WO 5173718.

procedure 7.3.41, EXAMINATION AND HIGH POT TESTING OF NON-SEGREGATED BUSES AND ASSOCIATED EQUIPMENT.

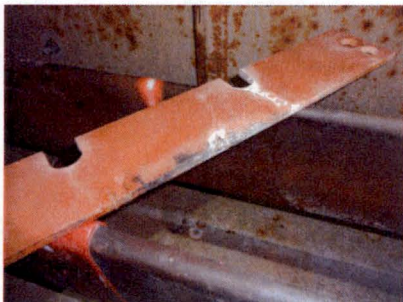
During examination of the bus, signs of tracking across some of the bus supports were found along with signs of corona damage in proximity to the point where the bus supports make contact with bus. (See Figure 3)

Figure 3: Tracking on bus supports in Non-Critical Switchgear Room

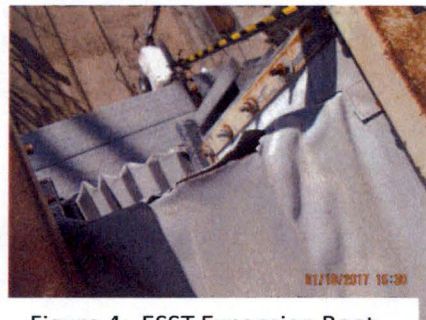
CR-CNS-2017-00239: The ESST expansion boot above the Turbine building railroad door was found to have a hole in it. See Figure 4.

Relationship to issue: During inspection of the fault the ESST boot was found to have a hole in it along the top west edge. Inspection of the bus duct showed no signs of water intrusion or foreign material due to the hole in the boot. Based on the boot being approximately 30 feet from the fault location and no signs of foreign material this did not contribute to the fault. There is no conclusive information to refute or support the conclusion that the damage to the boot was caused by the fault and resulting pressure transient. The boot was patched per work order 5173717 and was later replaced by work order 5175321 on 5/2/17.

Figure 4: ESST Expansion Boot

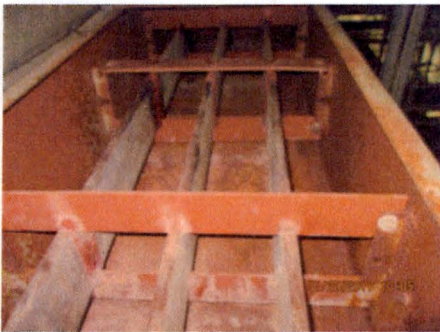
Figure 5: Non-Critical Switchgear room

CR-CNS-2017-00281: Surface corrosion was found on the inside of the ESST non-segregated bus in the non-critical switchgear room. This is surface contamination only and does not affect the structure of the bus.

Relationship to issue: Surface contamination was found on the inside of the bus duct in the non-critical switchgear room. See Figure 5. This is evidence there is condensation/humidity inside of the bus duct. This is not directly related to the fault but humidity contributes to the tracking mechanism.

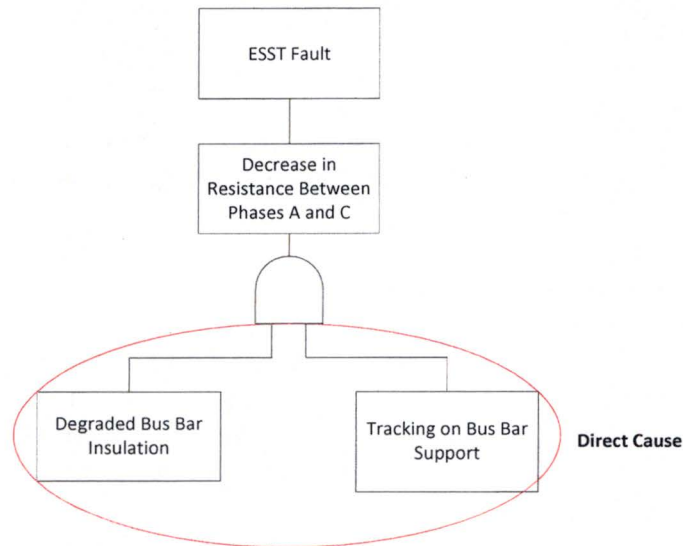
Degraded bus bar insulation combined with the formation of tracking on the bus bar support provided a path for current between phases of the ESST bus.

The Direct Cause is depicted in the WALT below.

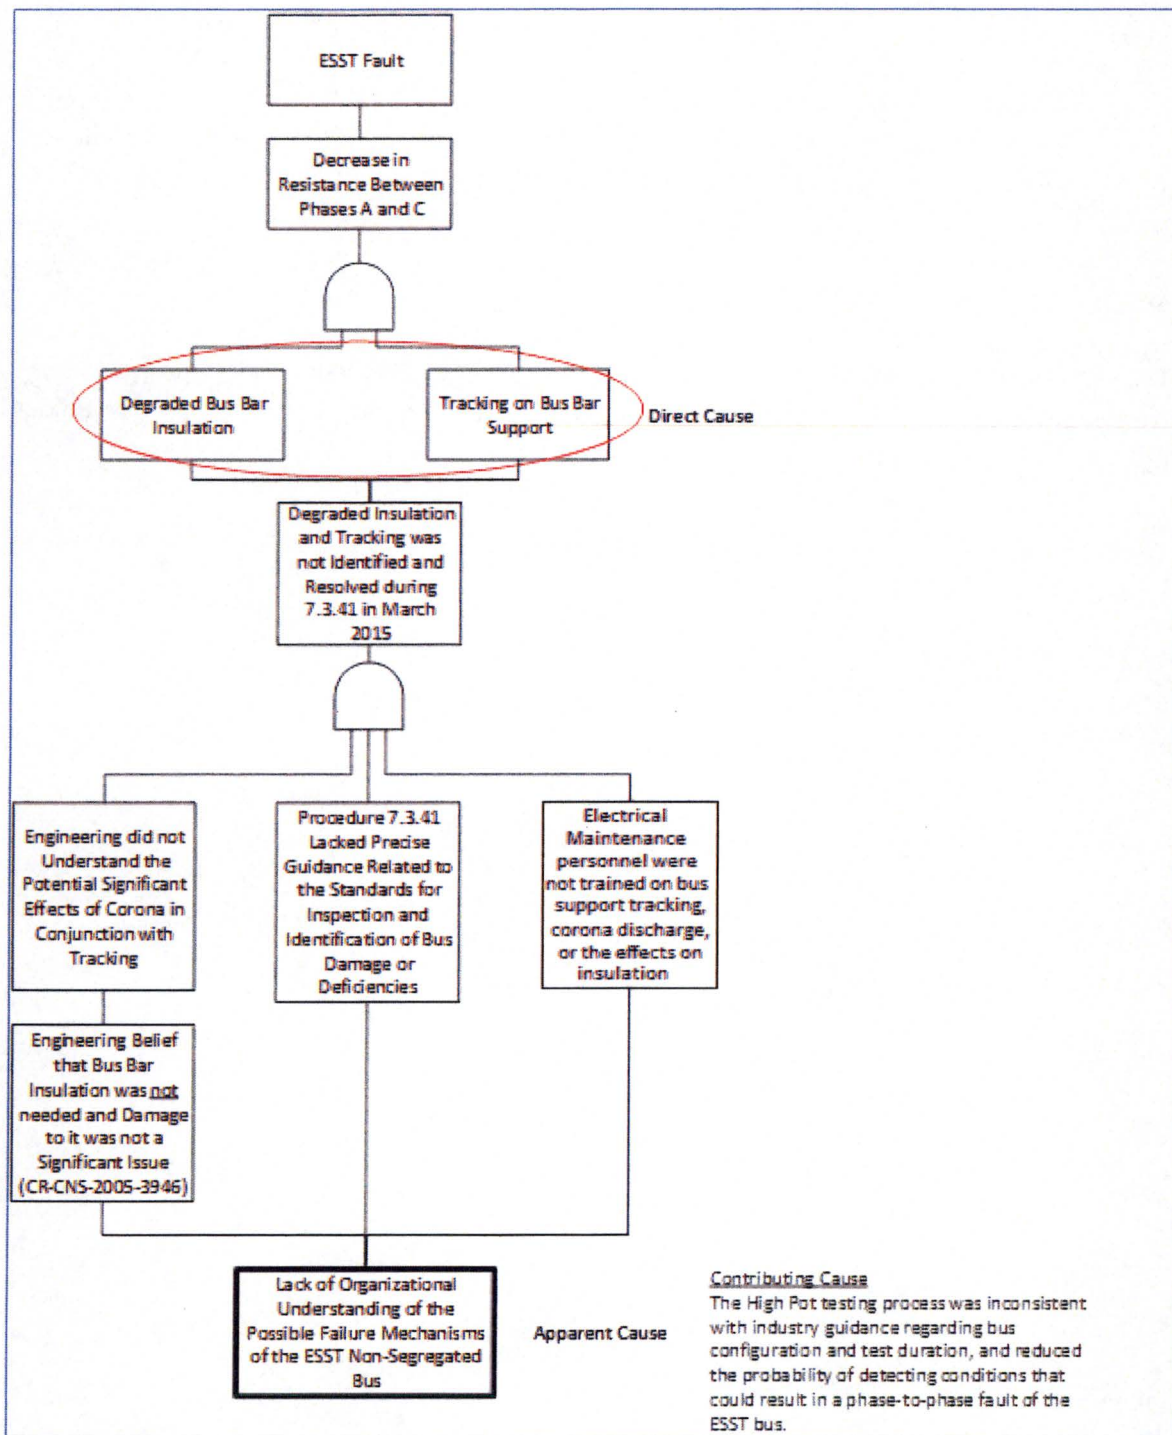
Why Analysis Logic Tree

The Direct Cause was present in 2017 because it was not identified in 2015 during the conduct of Procedure 7.3.41, Revision 10, EXAMINATION AND HIGH POT TESTING OF NON-SEGREGATED BUSES AND ASSOCIATED EQUIPMENT.

Review of 7.3.41, Revision 10, revealed that the procedure lacked precise guidance related to the extent of the inspection and the identification of bus damage or deficiencies. The procedure provided direction to remove bus bars 'as needed' to facilitate cleaning. This left the decision regarding whether to remove and examine the portion of the bus bar concealed at the interface with the support piece to the judgment of the Electrical Maintenance personnel.

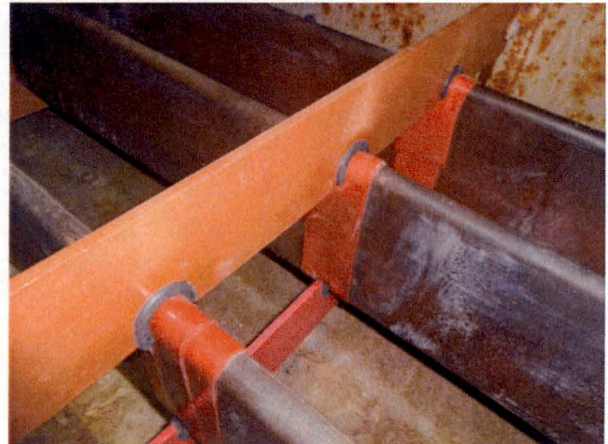
Figure 6: Grommets installed at tape splice location

Immediate actions were taken on the ESST bus to minimize corona from forming at the locations where any degradation was found. This was done by installing a grommet over the support to minimize the air gap between the support and the bus bar. This also removes the sharp corners of the bus support insulators. Figure 6 shows a repaired section of the bus, where a tape repair has been made and grommets installed. Any support brackets with degradation on them were replaced and the support brackets bus side edges were coated with Synthite AC-46 which will minimize the formation of tracking. There were a few bus support insulators in the Critical Switchgear room that were not accessible for coating. The critical switchgear room is a climate controlled environment. Inspection findings showed no damage to insulation and therefore no coating is required on bus support insulators.
