CNS-ER-2017-053  
"SSST Bus Inspection Report"

2017-053

Startup Station Service Transformer (SSST) Bus Inspection Report

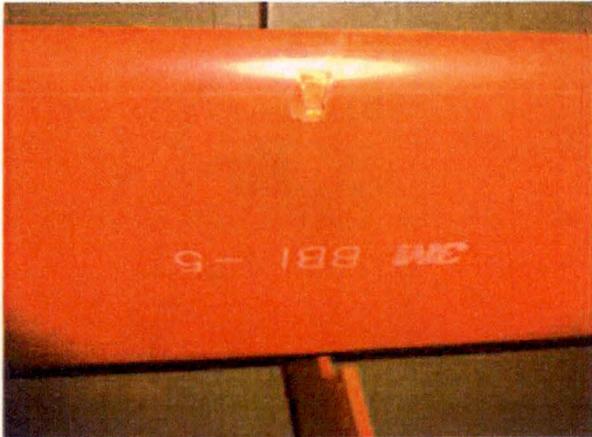
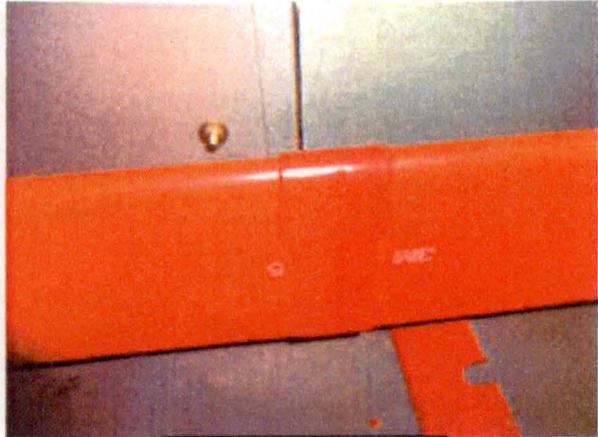
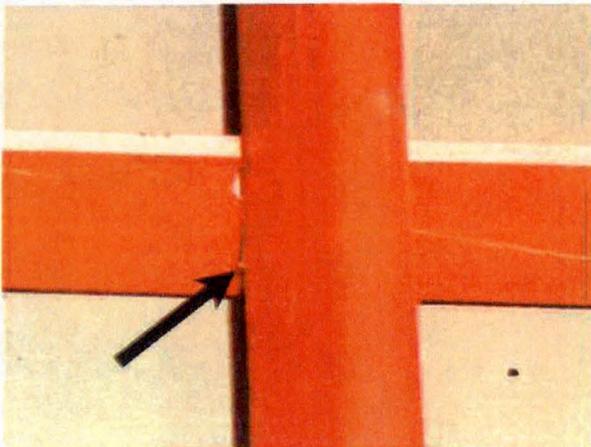
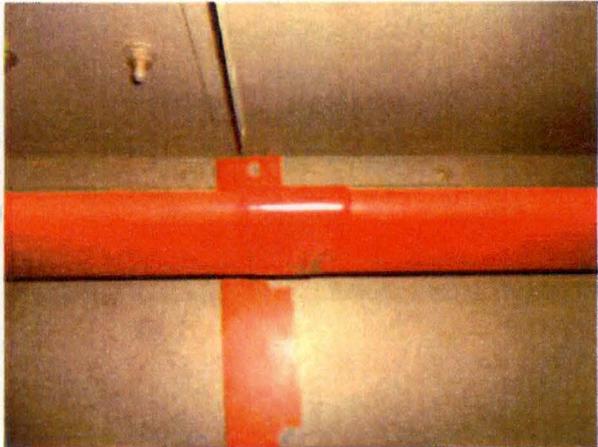
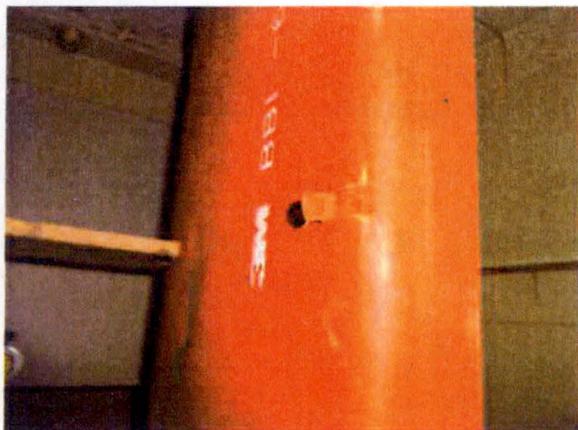
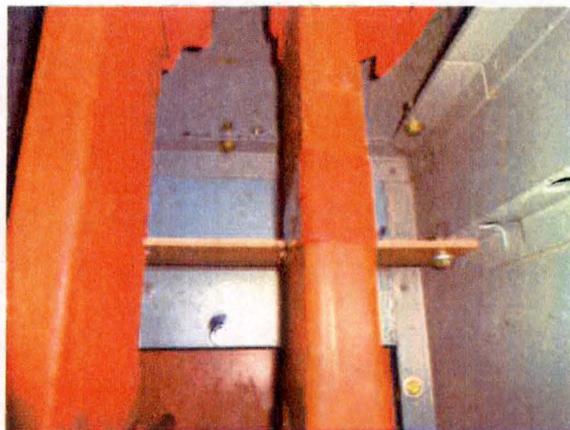
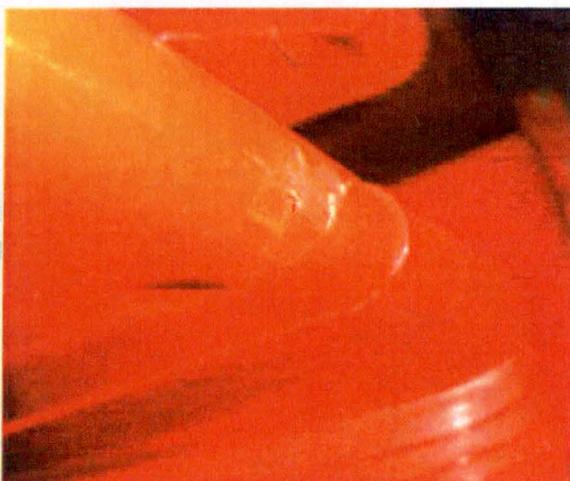
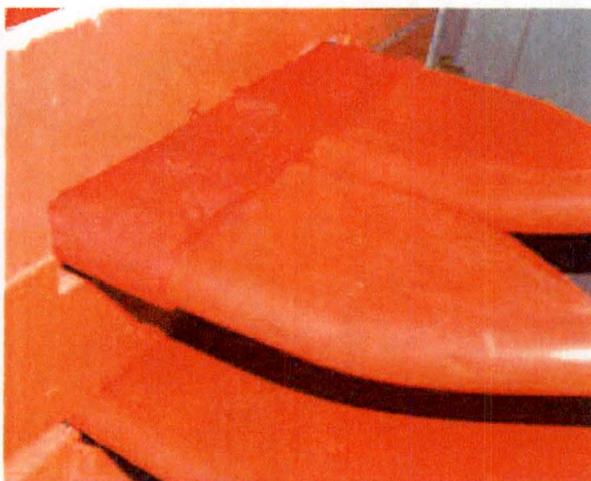
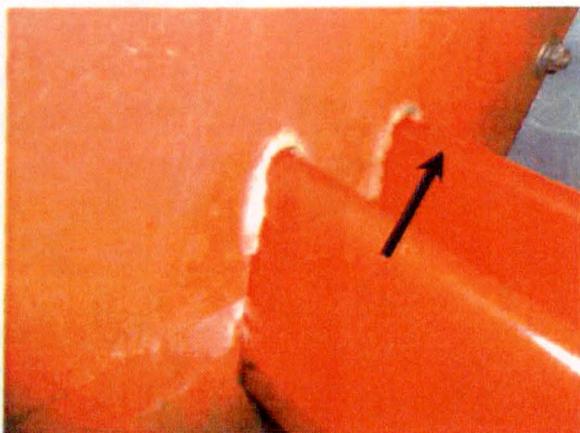
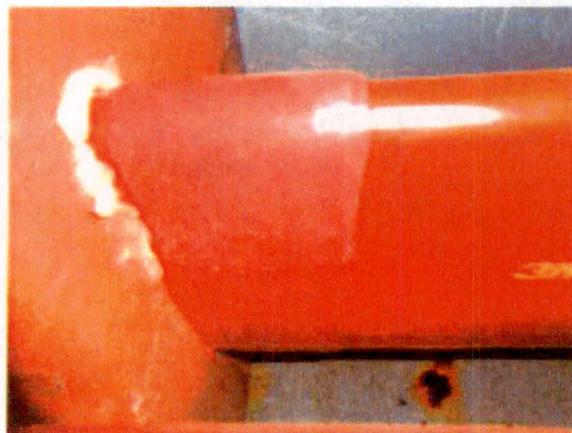
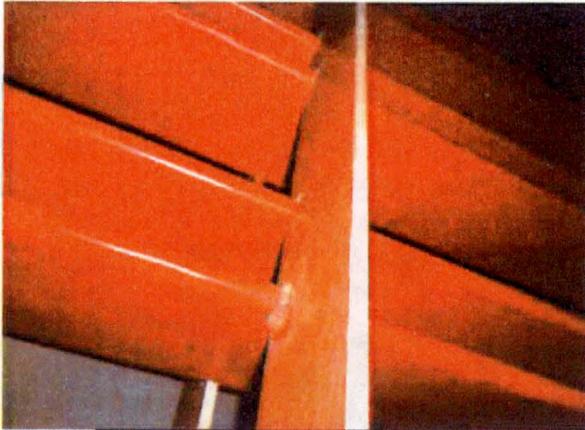
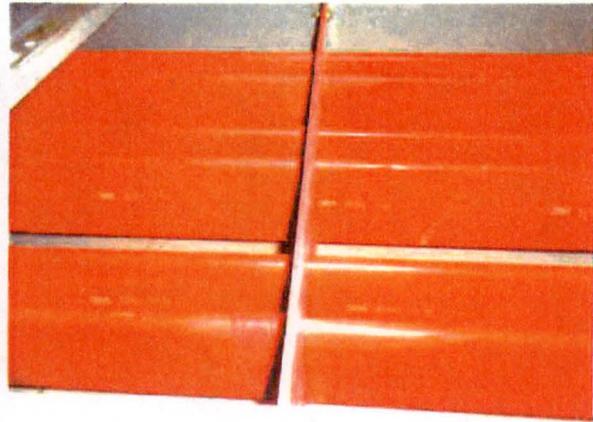
CR-CNS-2017-05764

Six areas of minor insulation mechanical damage were identified on the SSST Y-winding (2000A) and X-Winding (3000A) non-segregated bus located in the non-critical switchgear room. The first two sets of pictures are from the Y-winding, the rest are from the X-winding. All six areas were repaired.

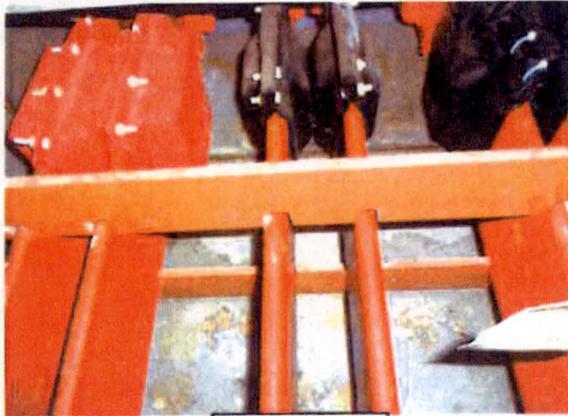
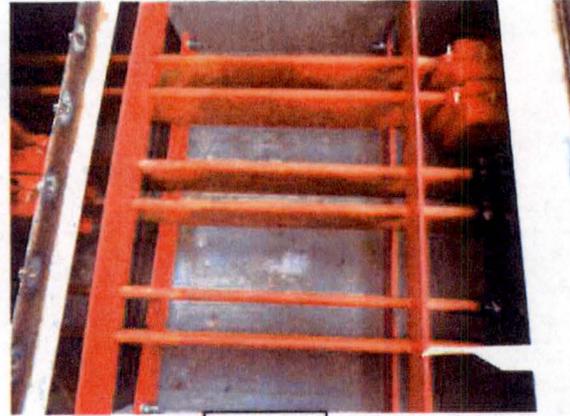
CR-CNS-2017-05780

The existing bus supports in a section of the SSST X-Winding east of the transformer, were not adequately supporting the bus. The notches in the supports were such that they were larger than normal gap between the bus and the supports.

The supports were also inspected for signs of damage and/or tracking. There were no signs of tracking identified. There were conditions identified where the supports were not adjusted correctly. In those situations the supports were replaced and properly fitted. A question was asked about some Glastic supports being too tight against the insulated bus bars. The tighter the support is to a bus bar the less likely corona damage will occur; therefore, the tightness of the Glastic support is not an issue. Areas with large gaps and indications of corona could be enhanced with the addition of a silicone grommet between the support and the bus bar to minimize the air gap, although this is not required by the design of the bus. Grommets were not installed based on the limited corona observed during the inspection of these buses. There

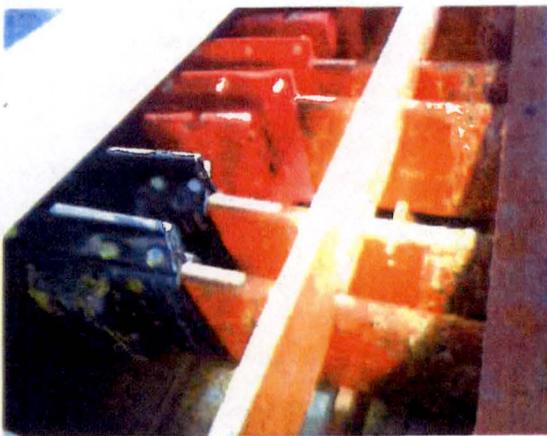
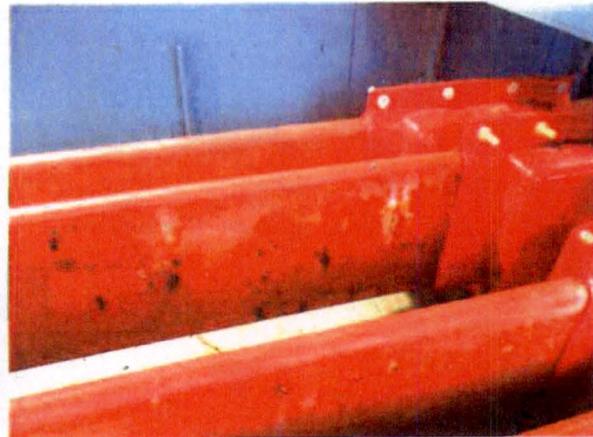
CR-CNS-2017-05783

On the SSST, X-Winding bus some bird droppings were found in the area just North of the expansion boot. The bird droppings appear to be residual from an expansion boot that was found degraded several years ago and since replaced per work order 4442920. The area was cleaned by hand.

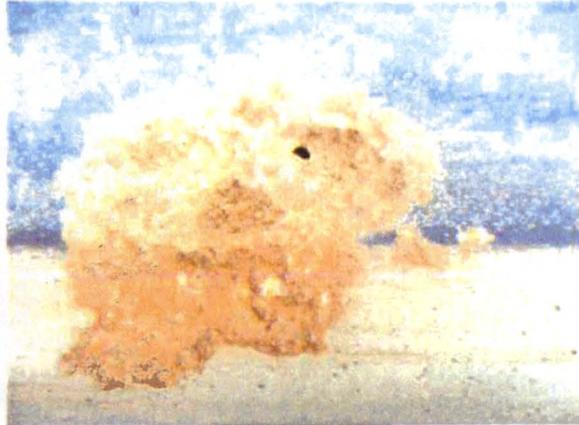
A top cover on the SSST, X-winding (3,000 amp) non-segregated bus located on the bottom of the north vertical run (90 degree) is pitted with one location that has a through hole.

As stated previously a structural inspection is also performed per this preventive maintenance plan. There was one condition report written to document pitting and a thru-hole in a SSST duct cover (reference CR-CNS-2017-05784 in Attachment 1). A weld repair was performed on this cover.

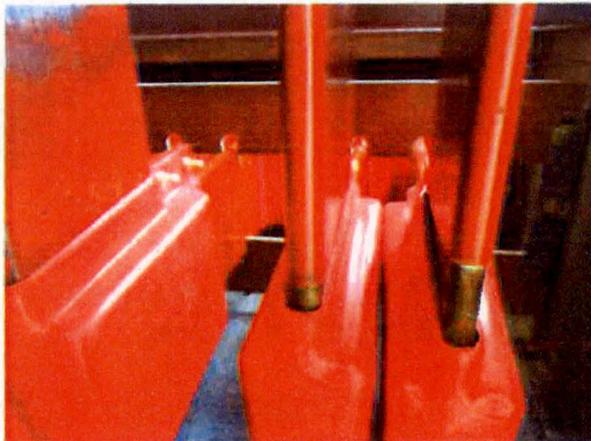
CR-CNS-2017-05787

This CR identified that a portion of bus was exposed at the bottom of a 90 degree turn. This was caused by the 90 degree boot sagging and exposing the bus. The exposed bus was covered with shrink tape. No as-left picture was available.

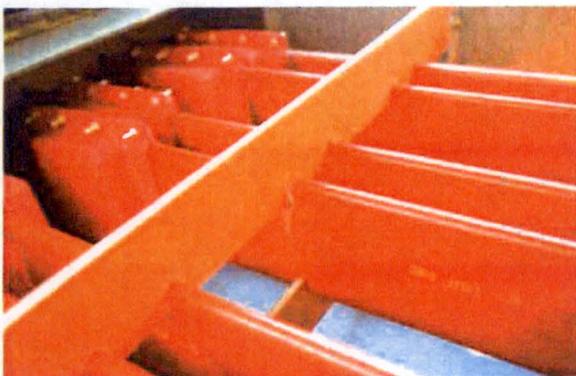
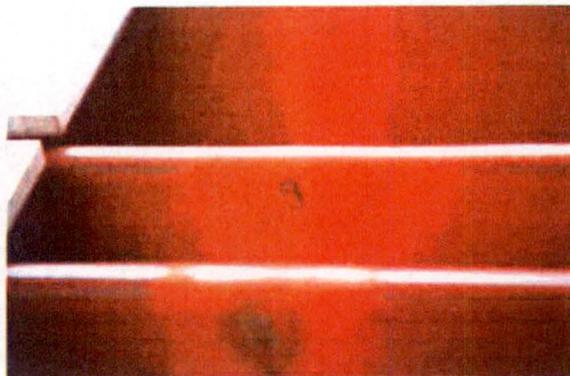
CR-CNS-2017-05788

On the X-Winding bus located on the horizontal section on north end of run above railroad door, signs of surface corona discharge damage were identified. This was cleaned per 7.3.41. The corona damage and the cleaning are shown in the pictures below. In addition, a minor nick was seen in the insulation by the bottom support. The nick was repaired by shrink tape. There is no picture of the tape repair.

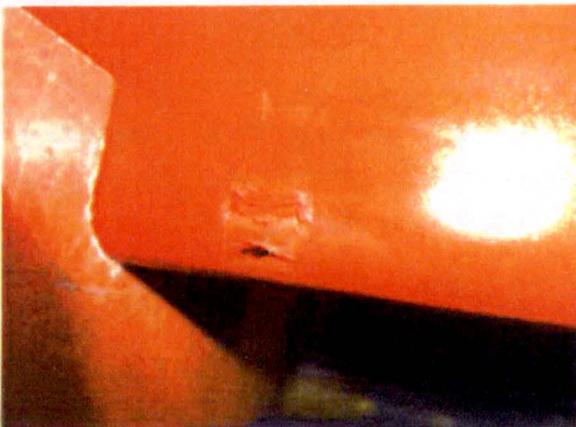
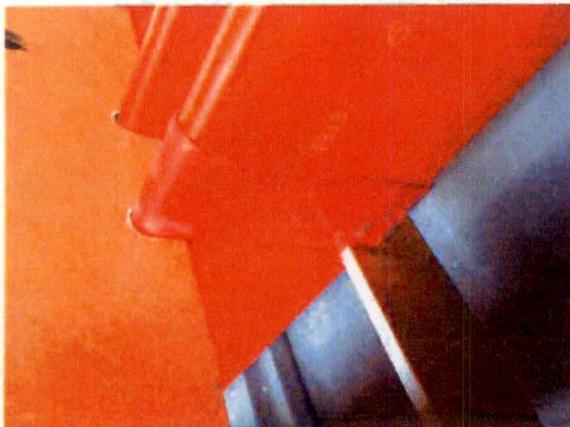
On the X-winding horizontal bus above railroad door, one spot where a nick was present in the bus insulation was identified. This item was shrink tape repaired.

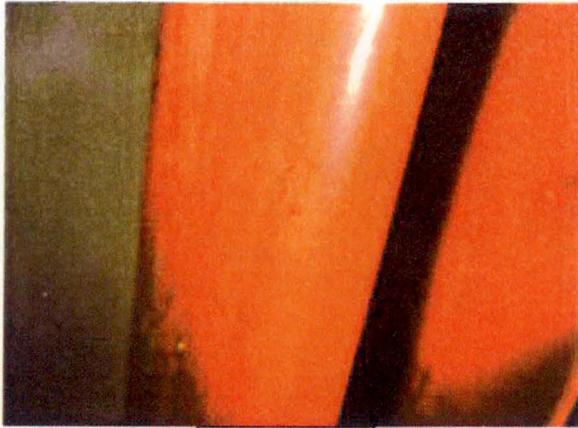
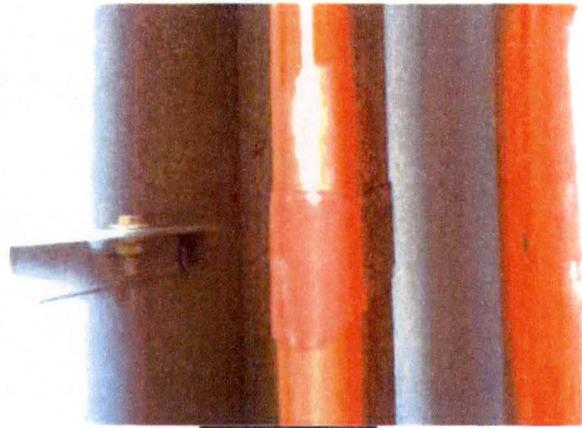
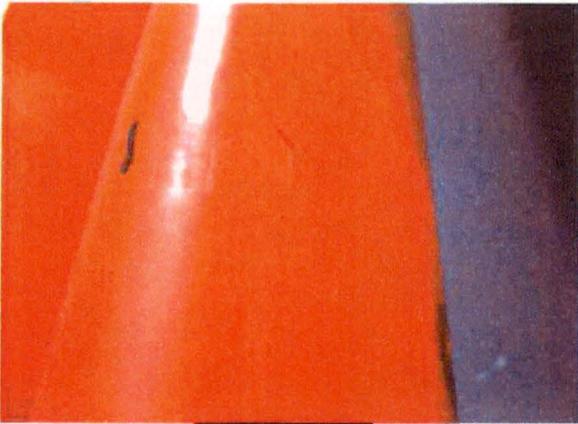
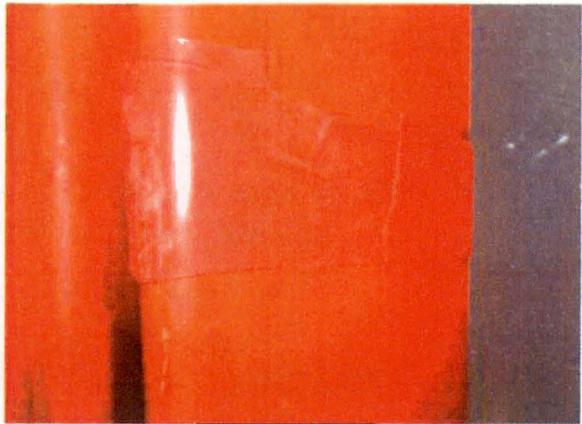
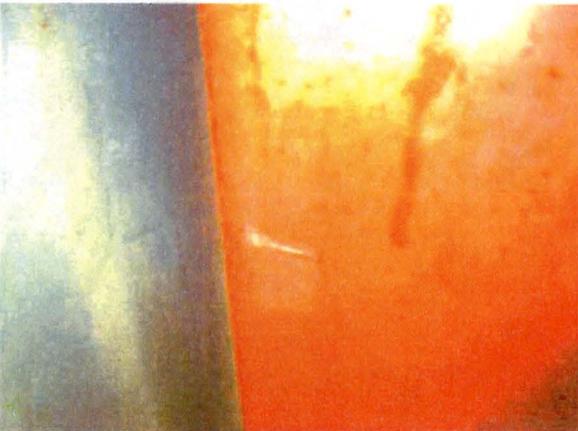
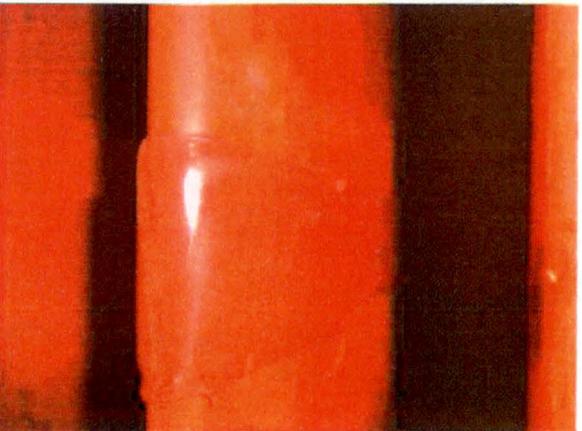
On the X-winding, south vertical run, there were three (3) spots where nicks were found in the insulation. All three were shrink tape repaired.

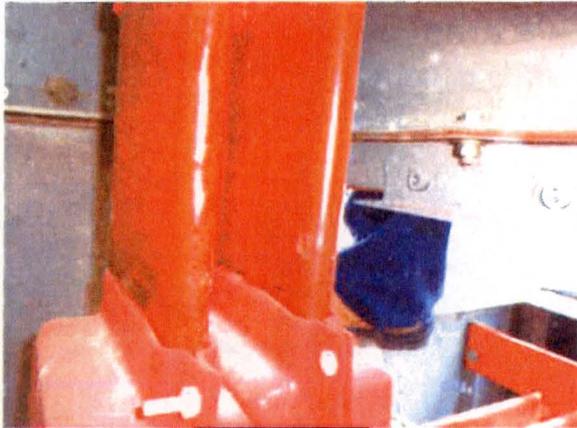
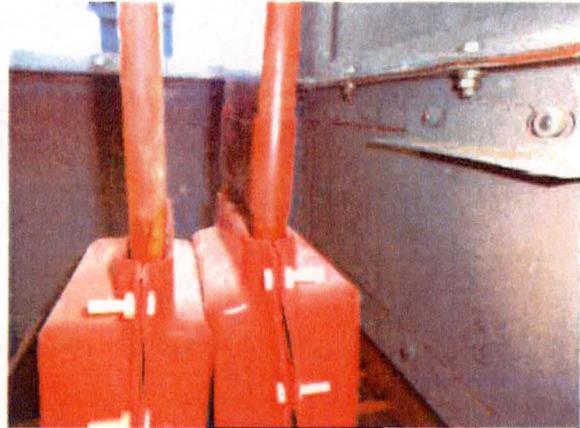
One nick was found in the X-winding bus insulation directly east of the SSST. This was shrink tape repaired.

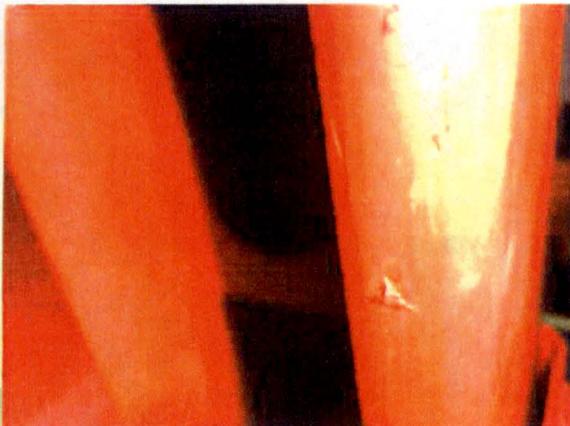
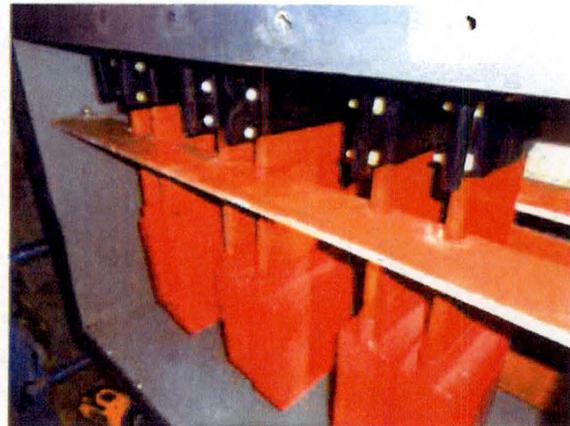
CR-CNS-2017-05790

On the X-winding bus corner section on the run just before the south vertical section a nick in the insulation on the middle phase was identified. This was shrink tape repaired

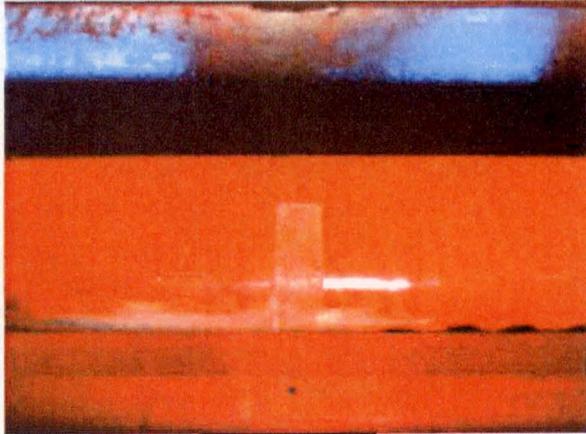
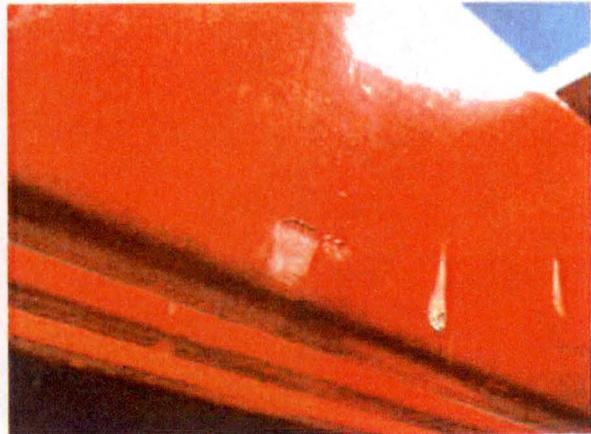
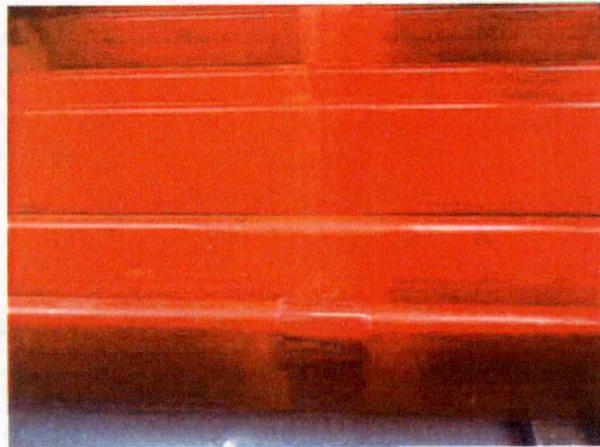
On the X-winding, the section just before the south vertical run, nicks were found in the insulation on the middle and east phases. These were shrink tape repaired.

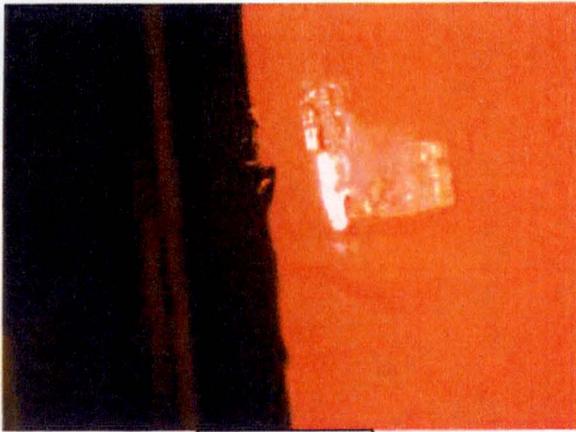
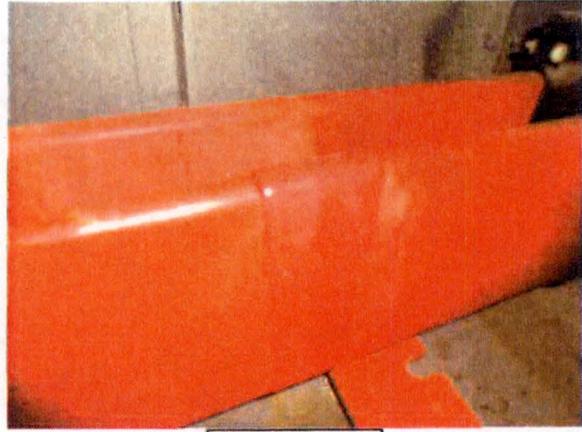
On the X-winding bus, located 2 covers to the south of the south vertical section, a gouge in the insulation on the west phase of the bus was identified. This was shrink tape repaired.

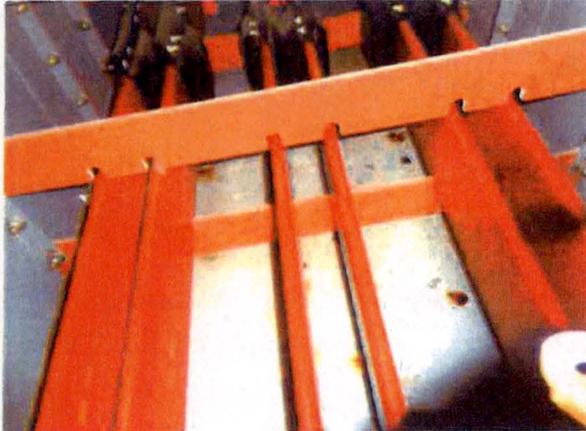
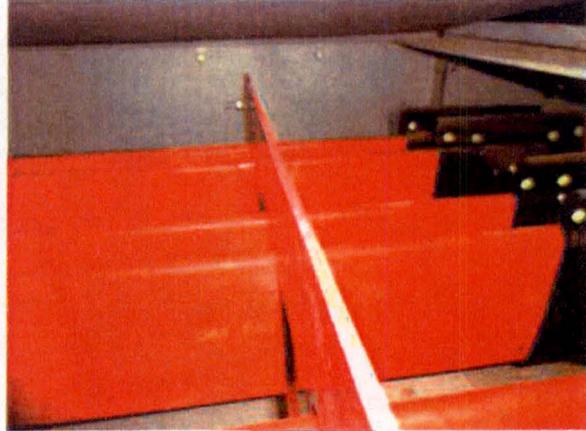
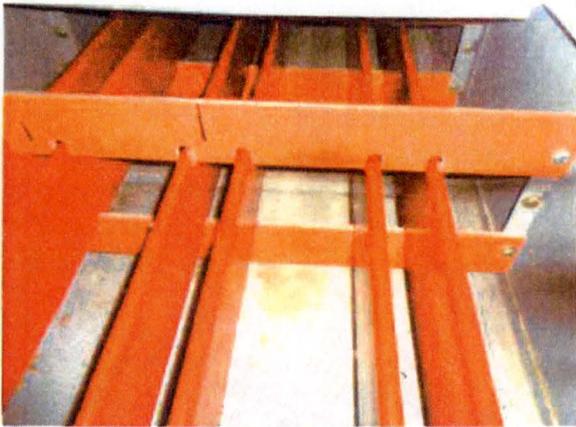
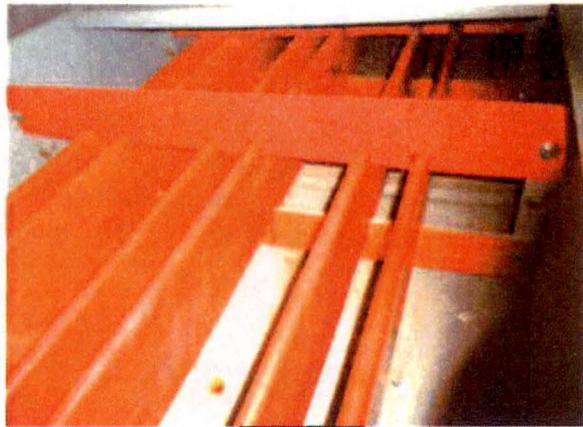
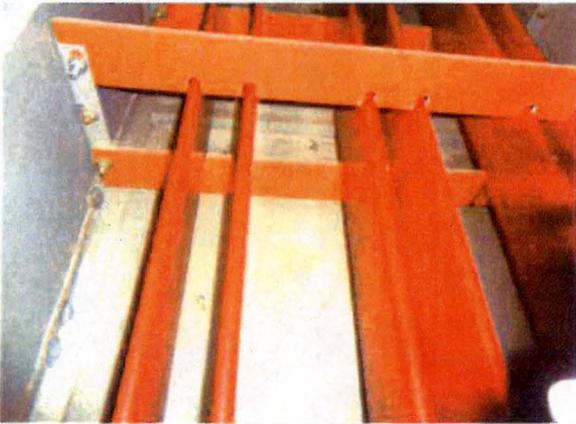
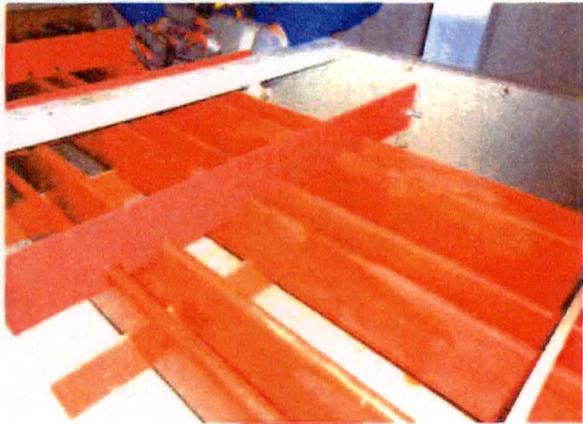
CR-CNS-2017-05791

Three top bus supports on the X-winding bus were not providing adequate support. The subject bus supports were located north of the SSST just before the south vertical section. New bus supports were installed correctly.

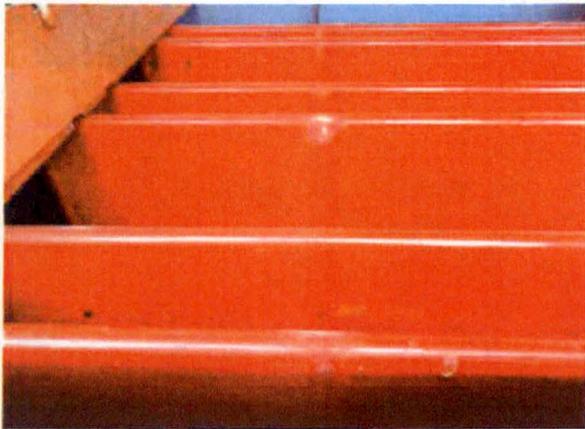
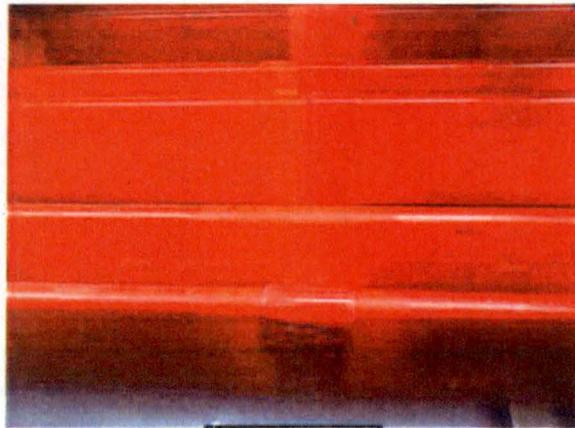
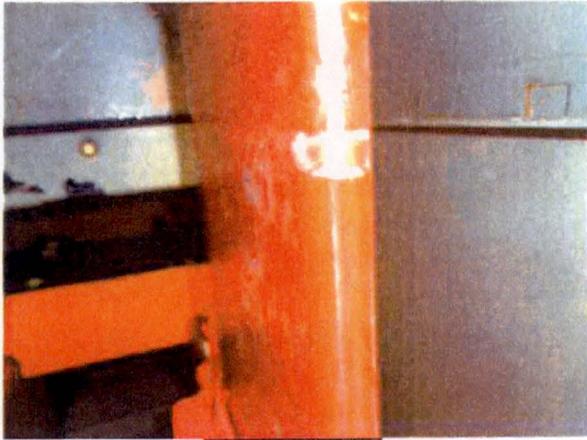
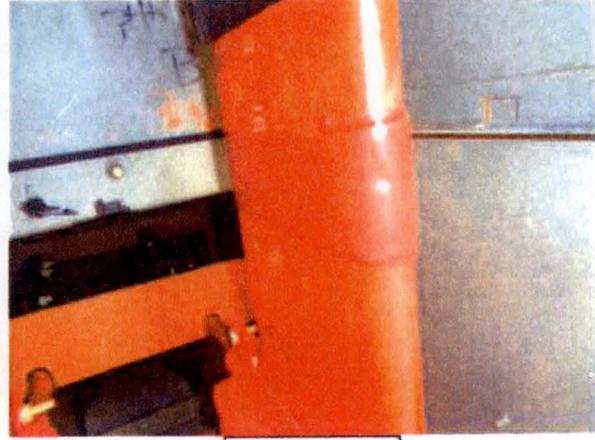
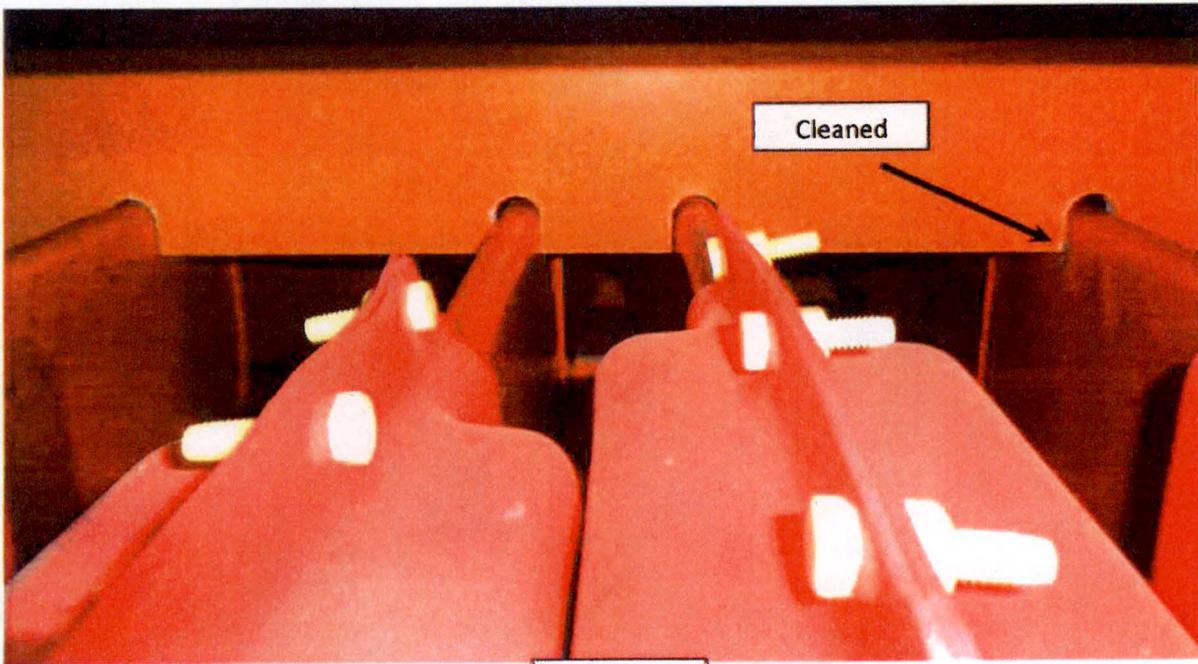
CR-CNS-2017-06310

This condition report was written twenty-six days after the actual inspection. It was identified that the work order confirmations did not match the procedure discrepancies list or condition reports written. This condition report identified eight additional spots which required either repair and/or cleaning. These spots are mostly mechanical damage with some corona damage spots. All the spots were considered minor in nature but were conservatively repaired. The last picture only has an as-found picture. The condition identified in that picture only needed to be cleaned.
