SUBJECT: Forwards preliminary SG info, consisting of data from SG  
 tube rupture investigation.

**Subject: Palo Verde Nuclear Generating Station (PVNGS)**  
**Unit 2**  
**Docket No. STN 50-529**  
**Preliminary Steam Generator Information**  
**File: 93-056-026**

The purpose of this letter is to provide you data from the PVNGS Unit 2 Steam Generator tube rupture investigation. Please note that this information is in preliminary form and has been marked as such. A summary list is also enclosed for your information.

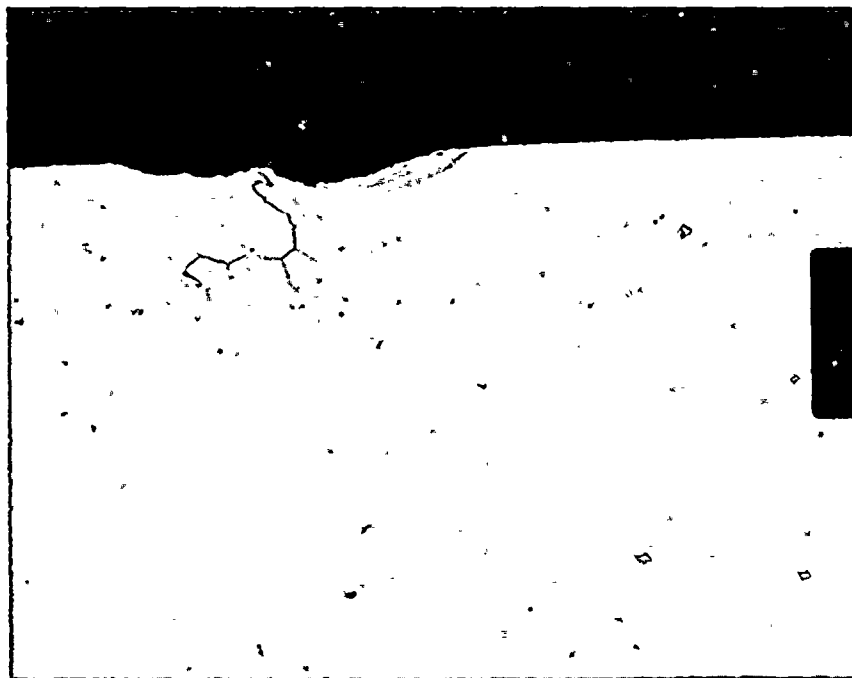
F727 PV 117-40-16 ±2  
250X 311°

PHOTO OF IGA/IGSCC UNDER 0.6 MIL SCRATCH.

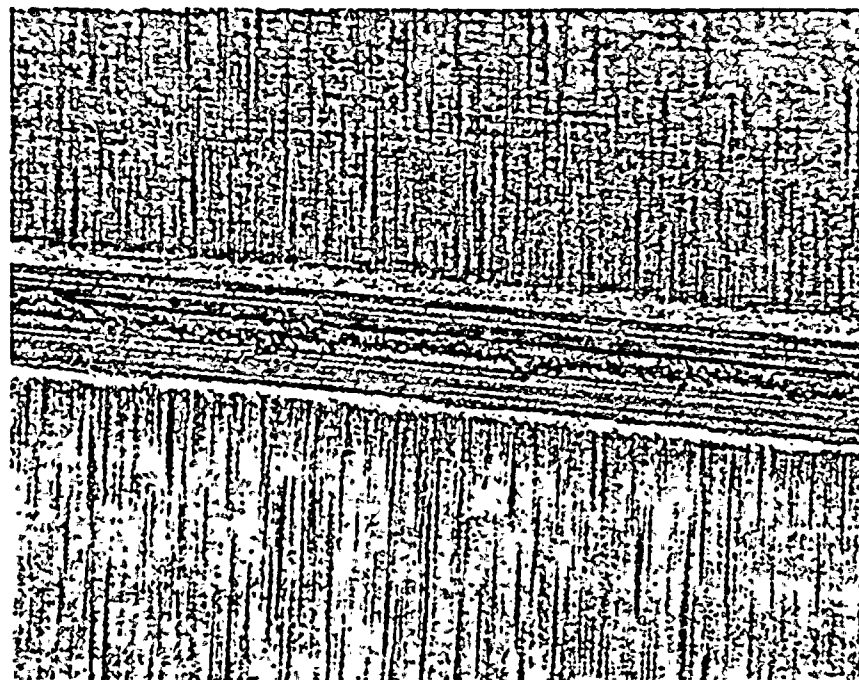
CRACK IN 117-40-16-5  
GRADE 50 3-28 FROM DE F733

LONG, SHALLOW SCRATCH WITH IGA/IGSCC AT BOTTOM. THE SCRATCH WAS APPROXIMATELY 0.6 MILS DEEP, WITH A FEW MILS ATTACK AT BOTTOM.

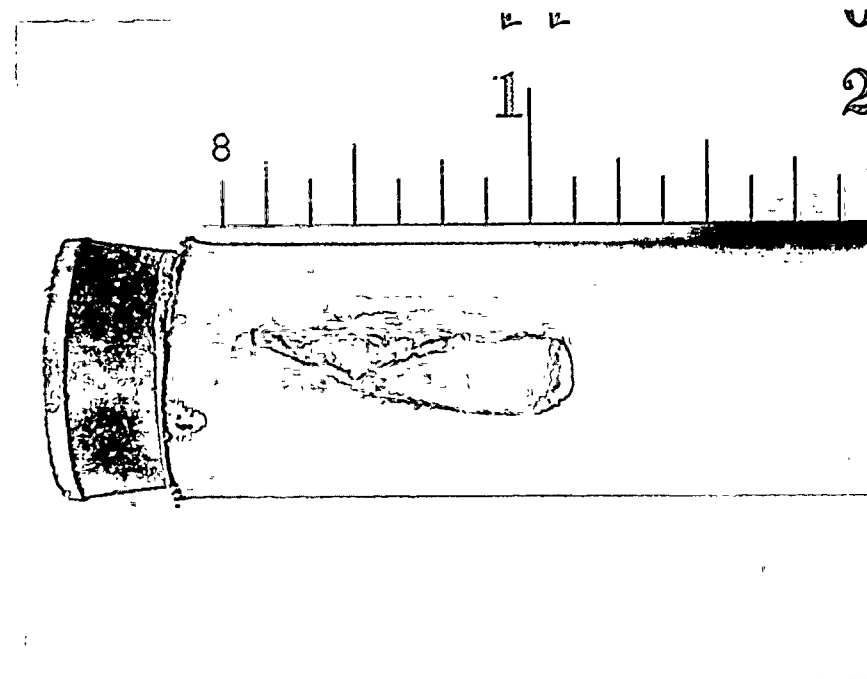
116-41 Pe. 19 0° F687

WHIP CUT END OF TUBE 116-41, SECTION 19. SHOWING WEAR MARK CAUSED BY CONTACT WITH UPPER SCALLOP BAR. MAXIMUM WALL PENETRATION WAS APPROXIMATELY 50%.

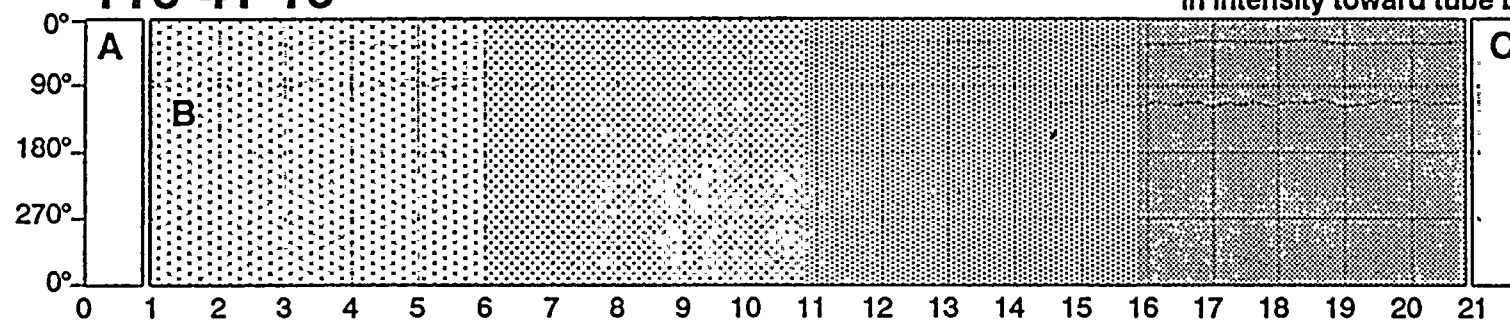
116-41-15

Axial scratches, but no crack indications.

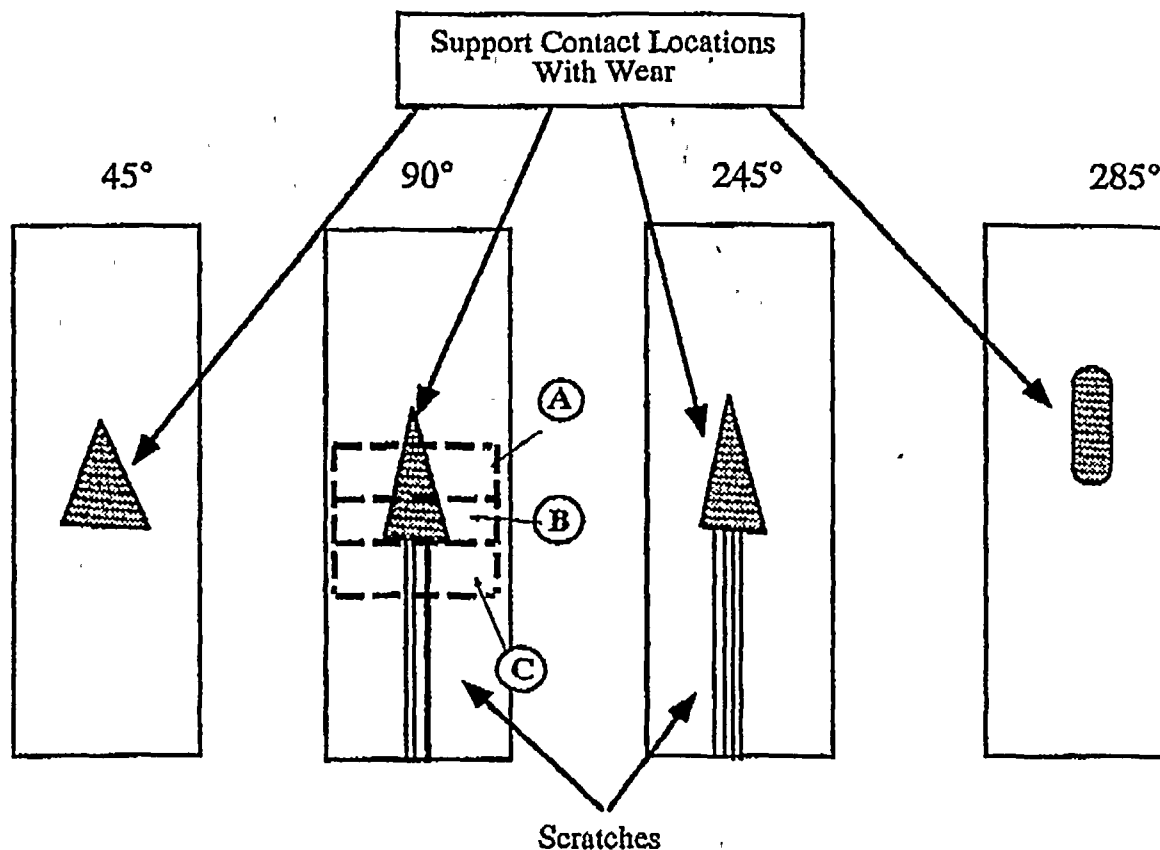
## 103/156 08H Support Descaled

- Scratches extend below the support location and not above the support
- Deepest scratch about 1 mil deep
- Wear locations 6 mils deep

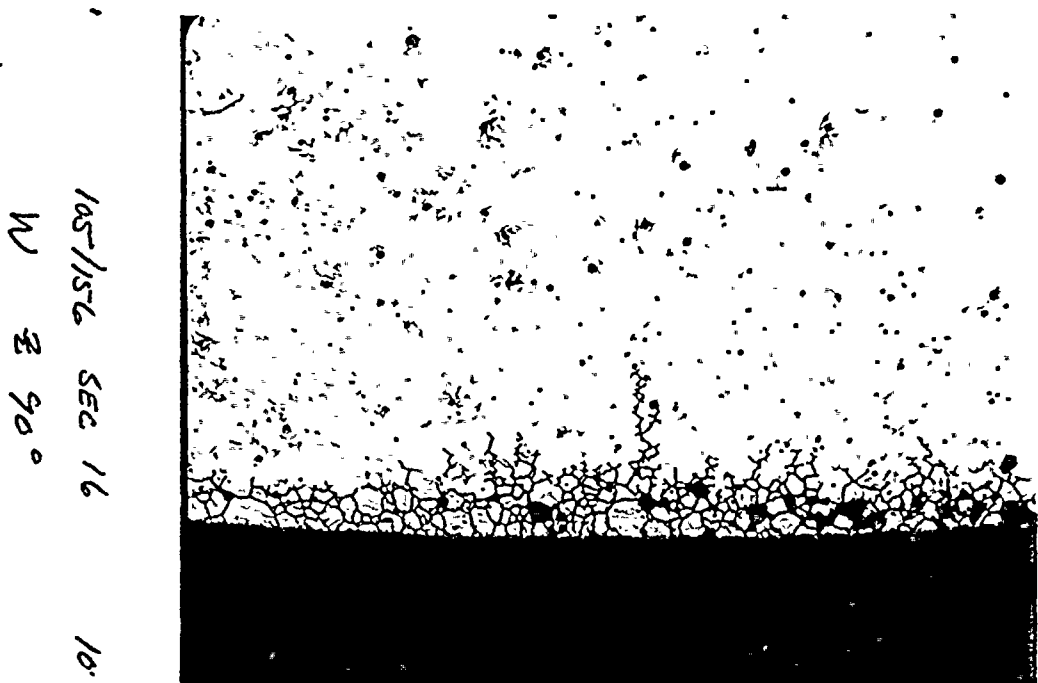
VIEW OF TUBE O.D. SHOWING BOTH IGA AND SHALLOW IGSCC. PVNGS U2 - SG  
#22 TUBE NO. 105/156 - SECTION 16. - W - 90 DEGREE.

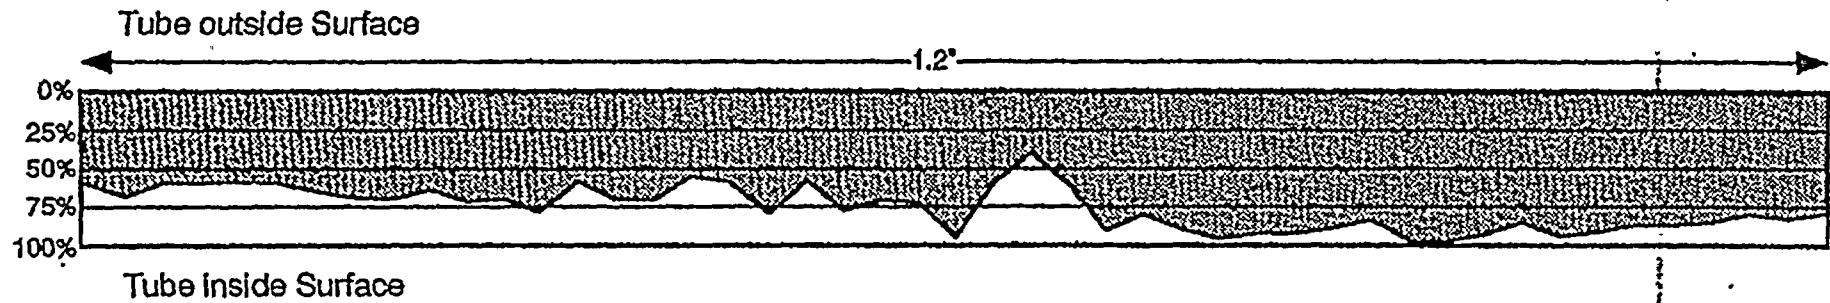
Steam Generator 22  
 Tube R105 L156  
 Section 16 Burst Face Crack Depth Diagram

IGA/IGSCC  
 Ductile  
 Average Depth 77.2%  
 Max. Depth 98.2%

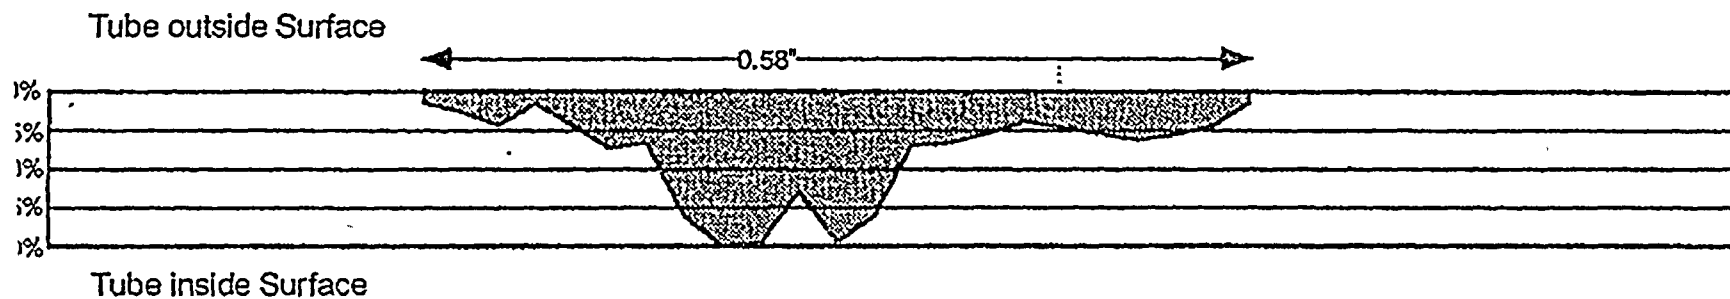
Steam Generator 22  
 Tube R127 L140  
 Section 13 Burst Face Crack Depth Diagram

IGA/IGSCC  
 Ductile  
 Average Depth 39.9%  
 Max. Depth 100%

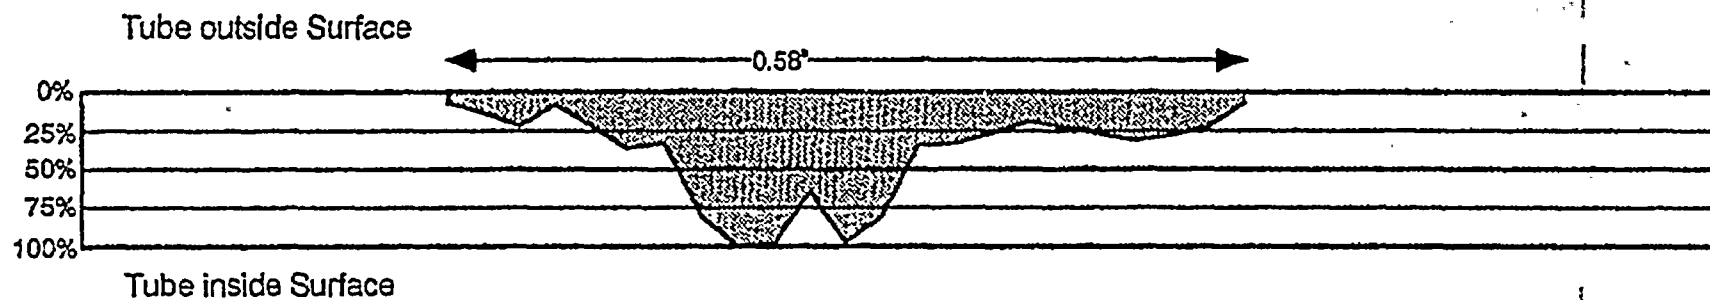
Steam Generator 22  
Tube R127 L140  
Section 13 Burst Face Crack Depth Diagram

Average Depth 39.9%  
Max. Depth 100%

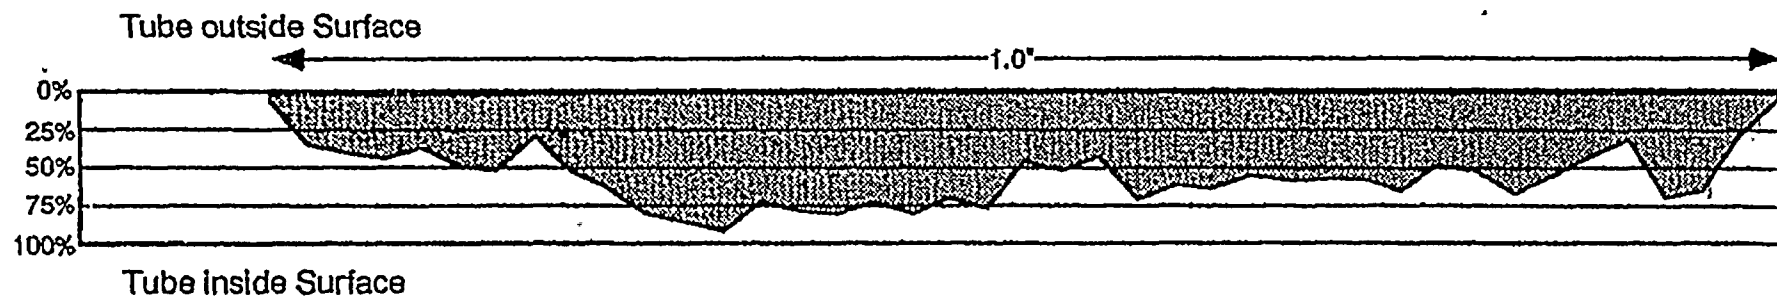
Steam Generator 22  
Tube R127 L140  
Section 15 Burst Face Crack Depth Diagram

IGA/IGSCC  
Ductile  
Average Depth 58%  
Max. Depth 89.3%
