Palo Verde Nuclear Generating Station

Unit 2
Steam Generator
Tube Rupture
Analysis Report

July 1993

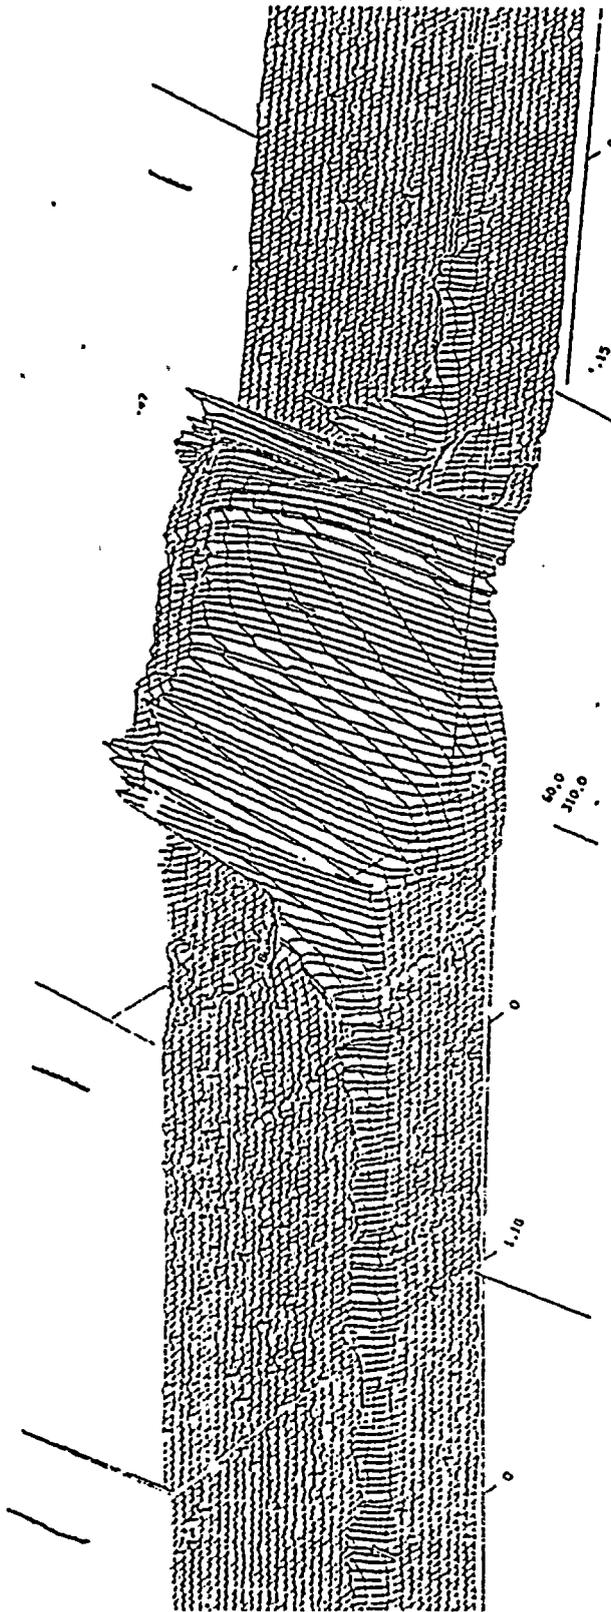
A revised eddy current testing (ECT) program was initiated after visual and ECT examination identified the location and orientation of the tube failure (R117C144) in Steam Generator 22 (See Figures I-a and I-b). Axial crack indications at free span and eggcrate support locations were found on multiple tubes in the upper region of the tube bundle. The Task Force, based on ECT evidence of outside diameter (OD) initiated axial cracking, assembled a list of possible failure modes in order to develop action plans for ECT, tube pull selection, engineering analysis and laboratory techniques.

Eddy Current Axial Crack Signature of Failed Tube

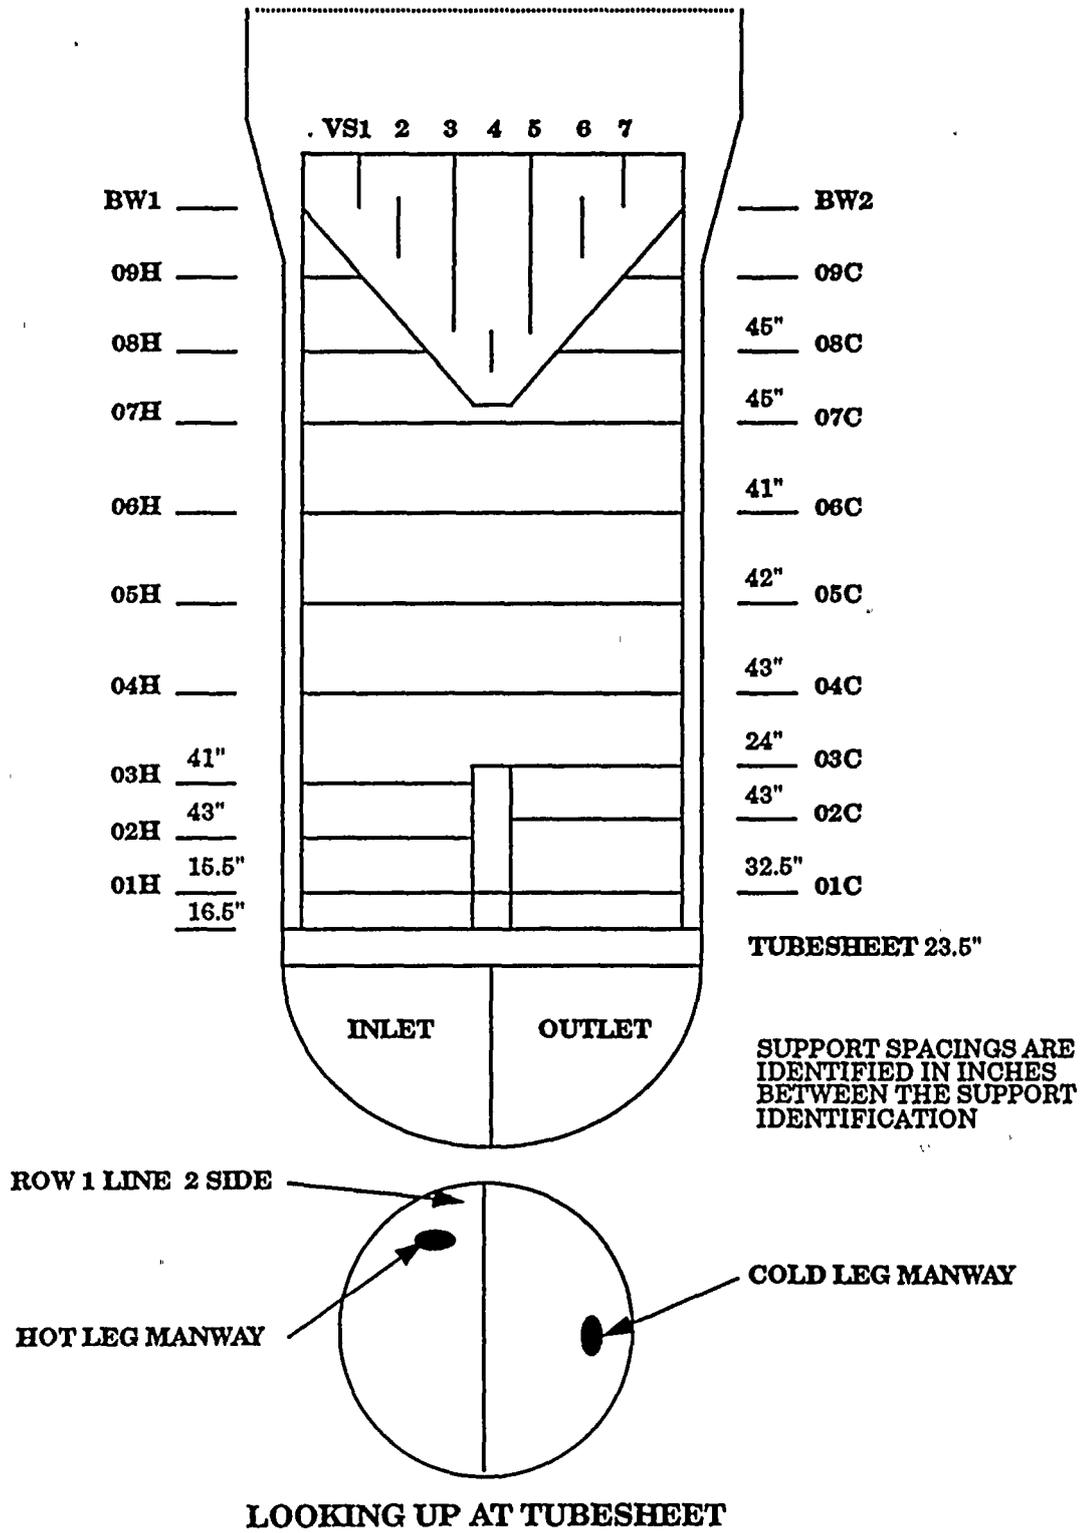
There are four types of tube supports in the Palo Verde steam generators. Refer to Figure III-c for the location and designation of the tube supports.
