UNITED STATES  
NUCLEAR REGULATORY COMMISSION  
OFFICE OF NUCLEAR REACTOR REGULATION  
WASHINGTON, DC 20555-0001

December 13, 2017

NRC INFORMATION NOTICE 2017-05, Revision 1: POTENTIAL BINDING OF SCHNEIDER  
ELECTRIC/SQUARE-D MASTERPACT  
NT AND NW 480-VAC CIRCUIT  
BREAKER ANTI-PUMP FEATURE

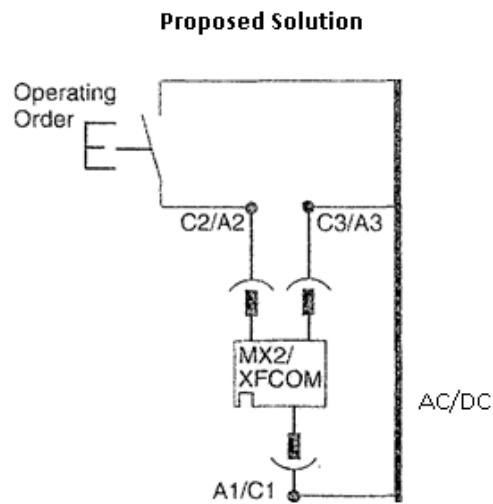
Appendix B, "Quality Assurance Criteria for Nuclear Power Plants and Fuel Reprocessing Plants," to 10 CFR Part 50, Criterion III, "Design Control," requires, in part, to subject design changes to control measures commensurate with those applied to the original design. The Masterpact breakers used at River Bend Station and at several other sites are a modification from the original General Electric AKR electrically-operated breakers. The original breakers used an electrical anti-pump interlock feature. The change from the electrical anti-pump interlock to a mechanical anti-pump interlock feature introduces mechanical binding as a potential failure mode.

- (1) The closing circuit is continually energized during charge and/or open operations.
- (2) An anti-pump condition is present.
- (3) The breaker receives a command to open electrically before or at the same time as the close command is initiated.
- (4) The operator initiates a local or remote electrical closing action that may hold the close signal for longer than 200 milliseconds, which would extend into the closing spring charging cycle.<sup>1</sup>
- (5) The logic scheme has a component controlling the close circuit that would apply the voltage to the close coil for longer than 200 milliseconds, extending into the closing spring charging cycle.<sup>1</sup>

**Figure 1: The XF coil in the original logic is replaced by an XFCOM coil, which releases the close coil plunger as soon as the close signal is received, eliminating the potential for binding.**

In Technical Bulletin TB-12-007, Revision 3, which is attached to the referenced 10 CFR Part 21 report (ADAMS Accession No. ML16278A471), AZZ/NLI provided a proposed modification to the breaker and an updated circuit diagram, shown in Figure 1 of this document. This modification replaces the normal XF (closing) coil in the breaker with an XFCOM coil. The XFCOM coil acts as a oneshot and releases the close coil plunger immediately after the close signal is applied to the breaker and will not reactivate the close coil plunger unless power is first removed from the operating order signal of the XFCOM and then re-applied. With the closing coil plunger retracted, this modification is designed to eliminate the potential for mechanical binding from the anti-pump feature.
