UNITED STATES  
NUCLEAR REGULATORY COMMISSION  
OFFICE OF NUCLEAR REACTOR REGULATION  
WASHINGTON, DC 20555-0001

NRC INFORMATION NOTICE 2017-05, Revision 1: POTENTIAL BINDING OF SCHNEIDER  
ELECTRIC/SQUARE-D MASTERPACT  
NT AND NW 480-VAC CIRCUIT  
BREAKER ANTI-PUMP FEATURE

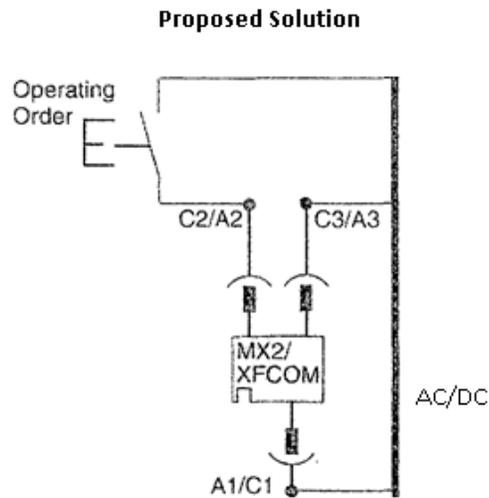
Appendix B, "Quality Assurance Criteria for Nuclear Power Plants and Fuel Reprocessing Plants," to 10 CFR Part 50, Criterion III, "Design Control," requires, in part, to subject design changes to control measures commensurate with those applied to the original design. The Masterpact breakers used at River Bend Station and at several other sites are a modification from the original General Electric AKR electrically-operated breakers. The original breakers used an electrical anti-pump interlock feature. The change from the electrical anti-pump interlock to a mechanical anti-pump interlock feature introduces mechanical binding as a potential failure mode.

Additional breaker testing by Schneider Electric identified the following five scenarios in which the circuit breaker could be more susceptible to the mechanical binding condition that would prevent the breaker from being able to reclose on command:

**Figure 1: The XF coil in the original logic is replaced by an XFCOM coil, which releases the close coil plunger as soon as the close signal is received, eliminating the potential for binding.**

In Technical Bulletin TB-12-007, Revision 3, which is attached to the referenced 10 CFR Part 21 report (ADAMS Accession No. ML16278A471), AZZ/NLI provided a proposed modification to the breaker and an updated circuit diagram, shown in Figure 1 of this document. This modification replaces the normal XF (closing) coil in the breaker with an XFCOM coil. The XFCOM coil acts as a oneshot and releases the close coil plunger immediately after the close signal is applied to the breaker and will not reactivate the close coil plunger unless power is first removed from the operating order signal of the XFCOM and then re-applied. With the closing coil plunger retracted, this modification is designed to eliminate the potential for mechanical binding from the anti-pump feature.
