Report
Millstone Unit 1
Diesel Generator DC Field Rewind

MT Smaga

July 15, 1991

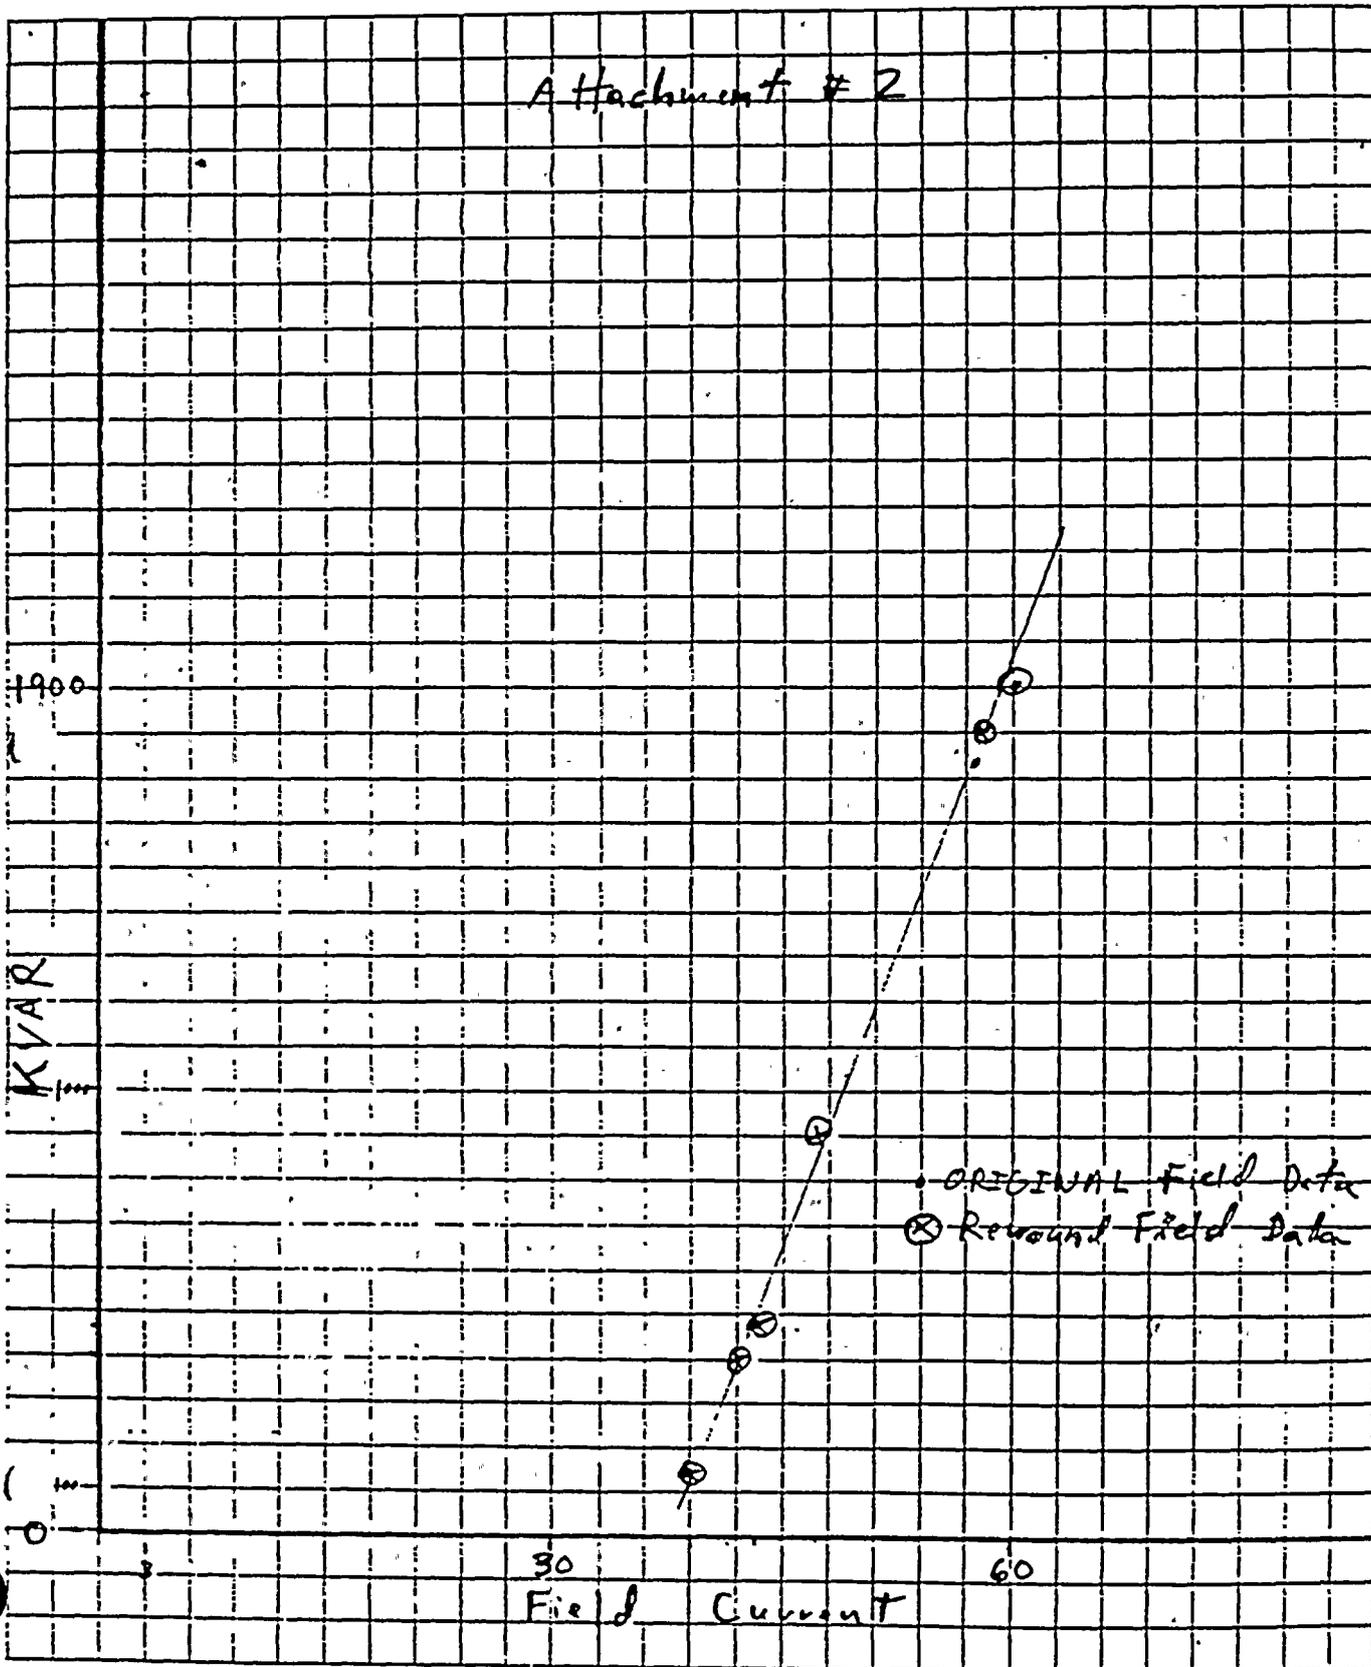
SUBJECT MP#1 Diesel Generator
Field Rewind
Full Load Test Results

The no-load tests showed that for a range of field voltages the output voltage was within 5% of the original generator test results. The next test was to operate the generator at full load for one hour, stop the generator and perform an inspection to discover any changes in the field winding configuration. Although the generator output during test reached 2665 KW, rated KW, the full 3330 KVA rating of the generator was not achieved due to system conditions that prevented full KVAR capability output. However, the generator was loaded to approximately 3058 KVA, 91% of rated KVA. The resulting inspection with the generator shut down showed no degradation of the field winding. Temperature measurements of the field winding were taken at the end of the test run. The field winding temperature was approximately 50°C well below the 180°C temperature rating of the insulation system. The generator was restarted and completed an additional 23 hour run at 91% of rated output. The static tests showed that there was no degradation of the field winding during the tests. A comparison of the these test results with initial test results indicate that the operating characteristics of the generator are unchanged. Since rated KVA of the generator was not achieved due to electrical system voltage restrictions, a comparison was made of the original and present field current vs generator KVAR. This graph, attached, shows that for a given field current the generator provides the same kvar. The generator response for a given load remains essentially unchanged.
