Subject: 10CFR21 Reporting of Defects and Non-Compliance -
Engine Systems, Inc. Report No. 10CFR21-0118, Rev. 0

Report No. 10CFR21-0118

COMPONENT: Speed Switch
P/Ns ESI50267C, ESI50267E, ESI50267H, and ESI50267K

SYSTEM: Emergency Diesel Generator

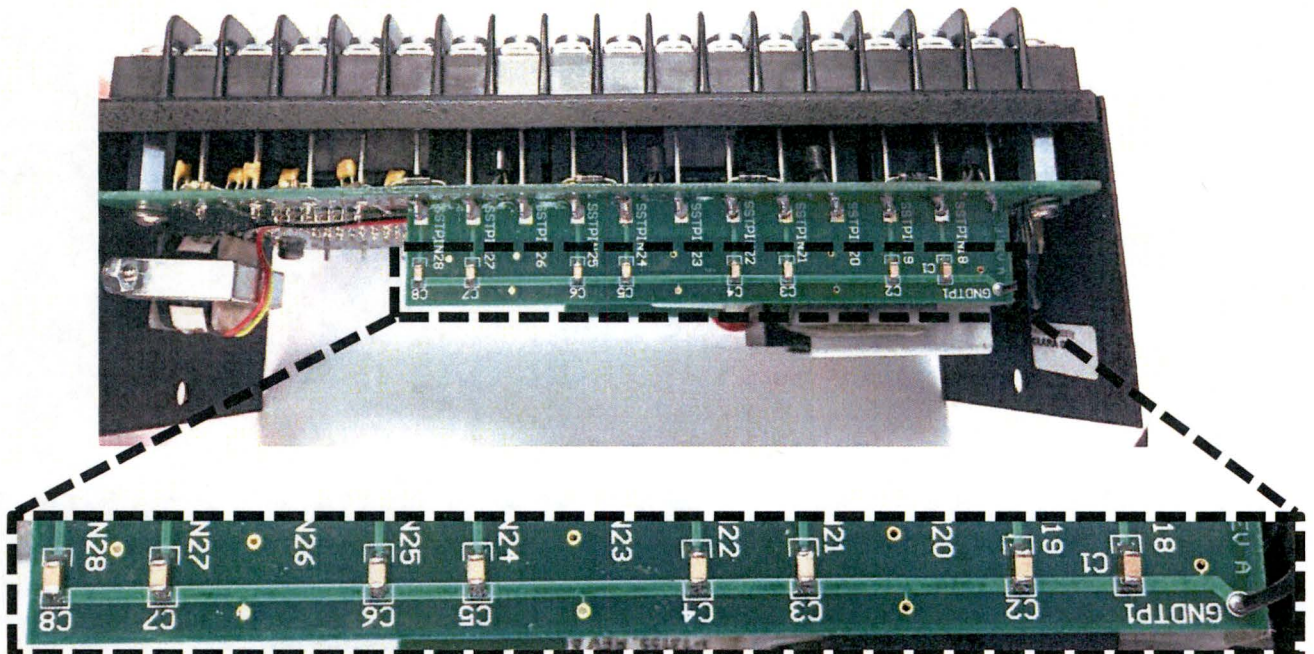
Photo 1: View Showing Capacitors C1 through C8

The failed speed switch at Hope Creek was sent to Exelon PowerLabs for analysis. It was determined that capacitor C4 (terminal 22 to ground) had degraded and exhibited a low-resistance path to ground. Capacitor C4 is rated for 200 VDC working voltage and has a withstand voltage of 500 VDC. Further investigation revealed that although the nominal system voltage is 120 VDC, the customer's external relay coils that are connected to the speed switch output contacts do not have transient suppression, such as with a flyback diode. In these cases, the voltage transient produced when de-energizing the relay's coil is large enough to damage the capacitors. Hope Creek recorded a voltage spike exceeding 1467 VDC.

- (1) For those customers that have transient suppression across the associated relay (i.e. VSR or ESR relays at the Exelon plants), there is no negative impact. The speed switch will operate properly in this system.
- (2) For those customers that do not have transient suppression across the associated relay (i.e. CRR, ASR, LSR, and HSR at Hope Creek), this speed switch design is not appropriate for their system. Any speed switch(es) that are installed should be removed from service.
- (3) ESI is currently evaluating options for re-designing the speed switch while maintaining the EMC compliance desired by many customers. This evaluation is underway and is expected to be complete within 60 days.
