# **Palo Verde Nuclear Generating Station**

## **Unit 3**

# **Steam Generator**

# **Inspection Report**

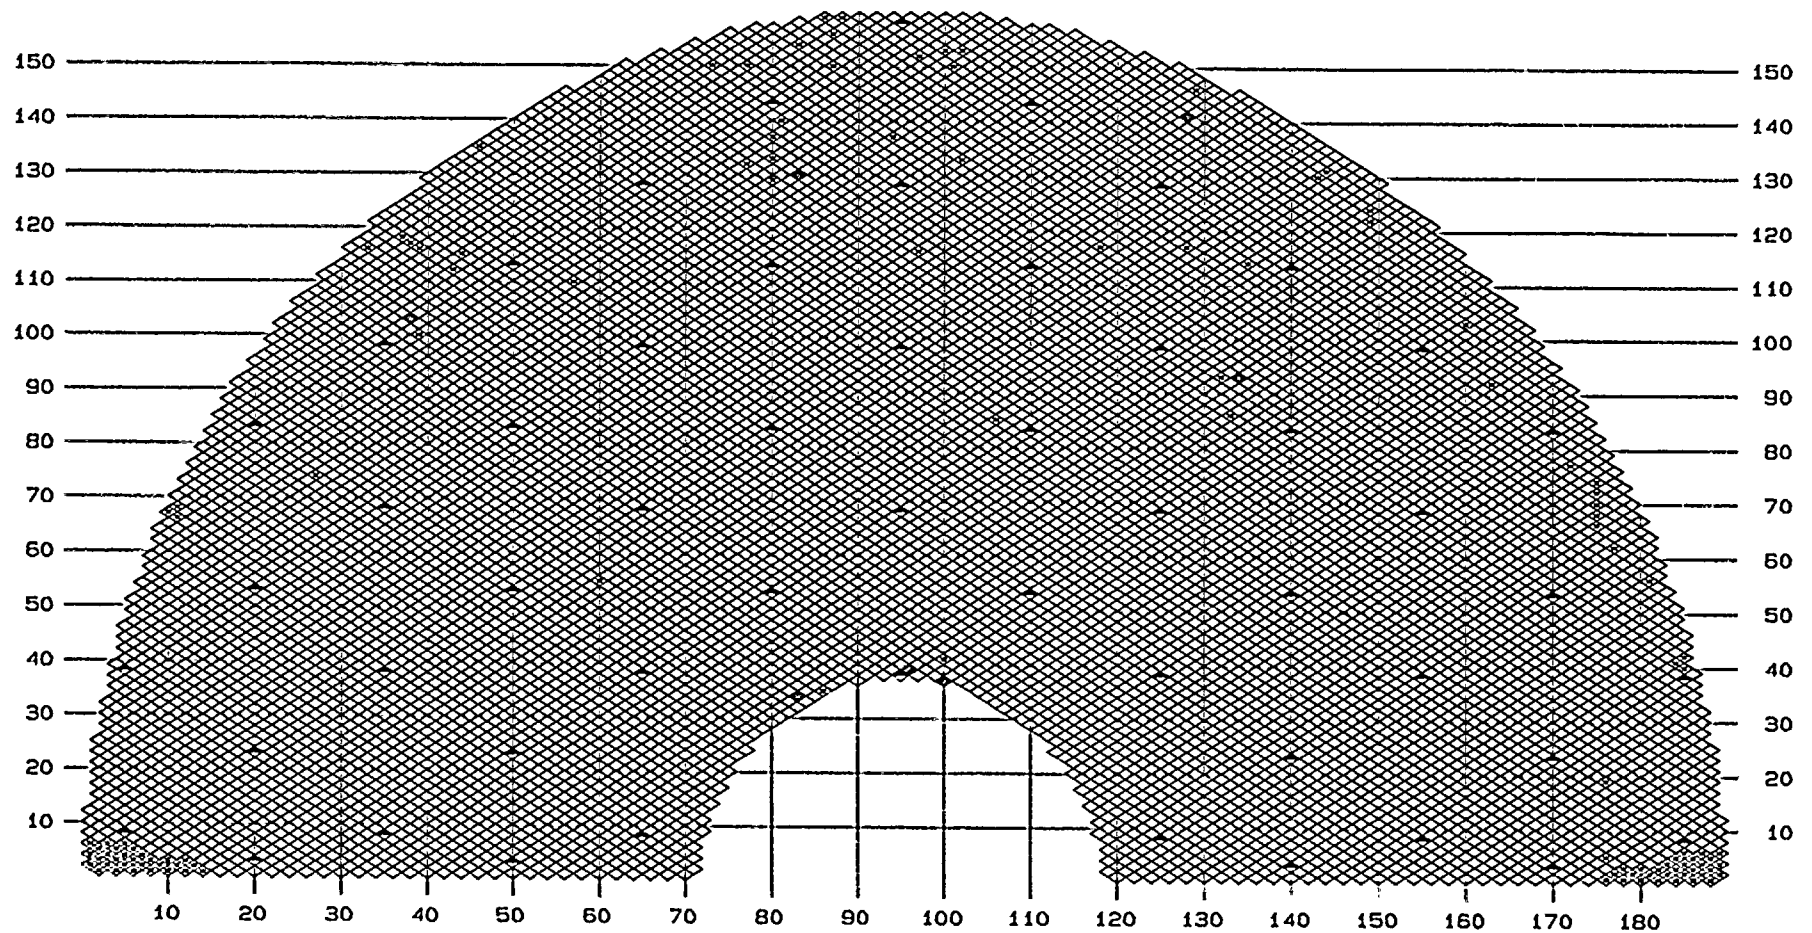
**TABLE A-1: STEAM GENERATOR 3-1 TUBE PLUG SUMMARY REPORT**

| Row | Column | ET Call | Degradation | Elevation | Hot Leg Configuration | Cold Leg Configuration | Outage/Date Removed |
|---|---|---|---|---|---|---|---|
| 39 | 96 | 28% | Bat Wing Stay Cylinder Wear | BW1-2.01 | B&W Rolled Plug + 390" Stake | B&W Rolled Plug | U3R4 - 5/94 |
| 37 | 100 | 23% | Bat Wing Stay Cylinder Wear | BW2-1.97" | B&W Rolled Plug + 384" Stake | B&W Rolled Plug | U3R4 - 5/94 |
| 141 | 128 | 41% | Vertical Support Wear | VS5+0.83" | B&W Rolled Plug | B&W Rolled Plug | U3R4 - 5/94 |
| 93 | 134 | 41% | Bat Wing Wear | BW1+2.72" | B&W Rolled Plug | B&W Rolled Plug | U3R4 - 5/94 |

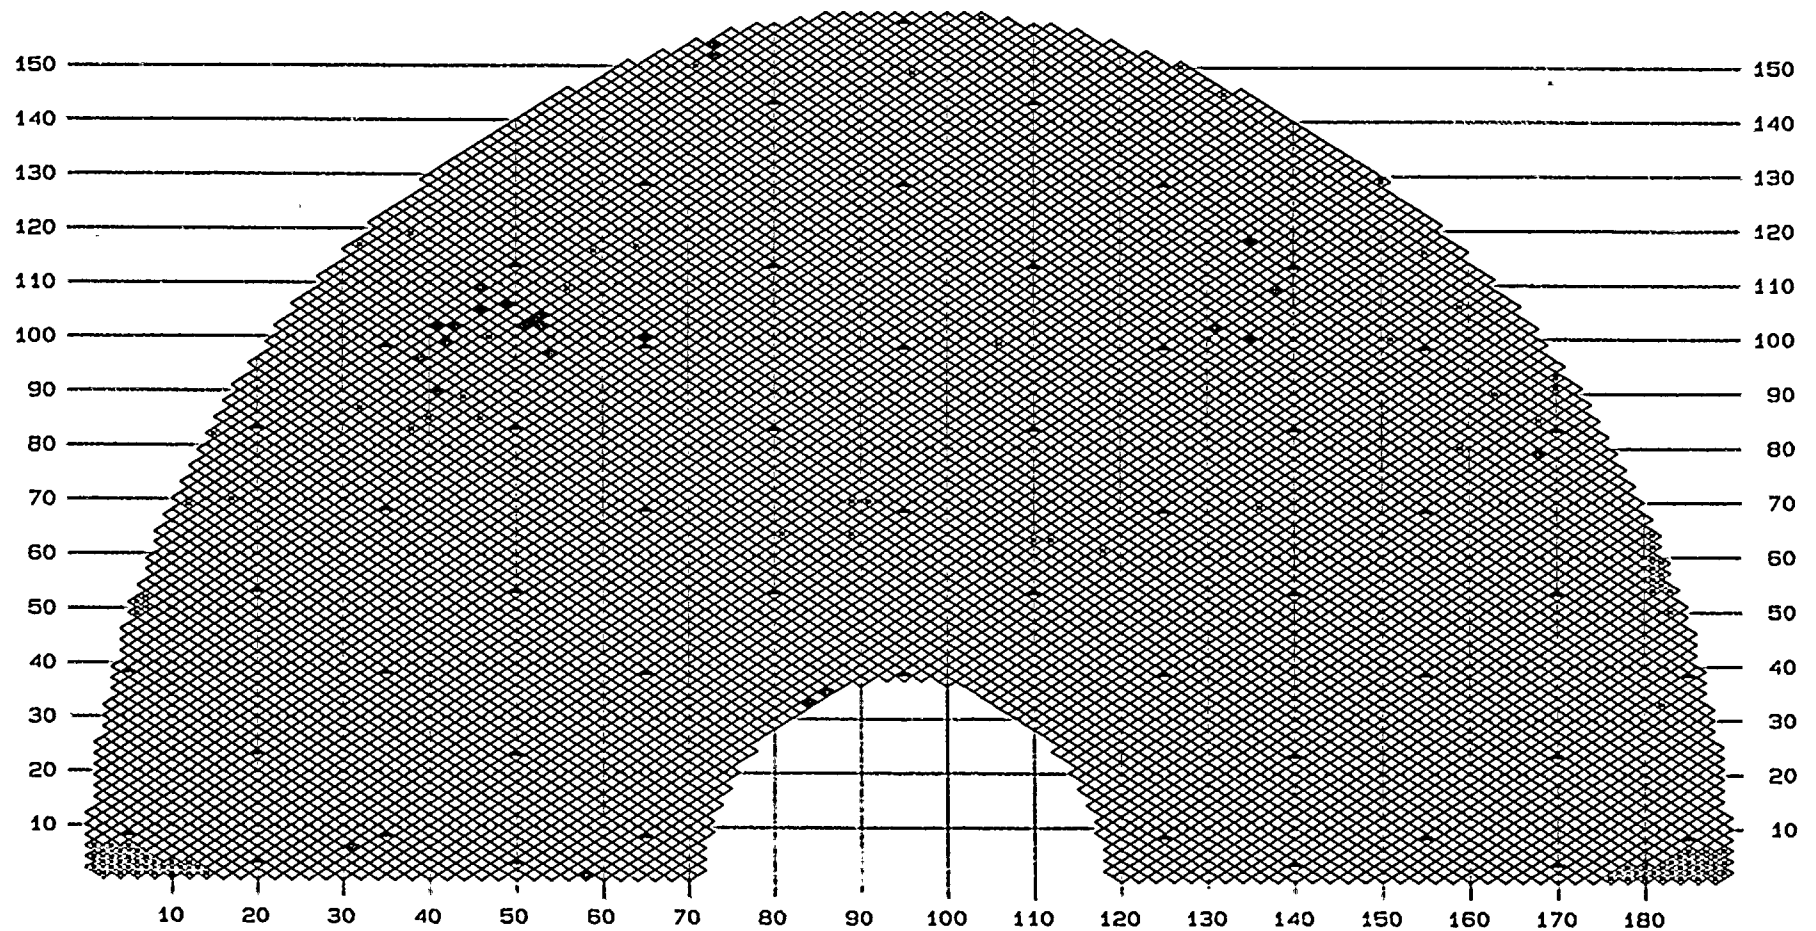
TABLE A-2: STEAM GENERATOR 3-2 TUBE PLUG SUMMARY REPORT

| Row | Column | ET Call | Degradation | Elevation | Hot Leg Configuration | Cold Leg Configuration | Outage/Date Removed |
|---|---|---|---|---|---|---|---|
| 33 | 84 | 24% | Bat Wing Stay Cylinder Wear | BW1-2.00" | B&W Rolled Plug + 373" Stake | B&W Rolled Plug | U3R4 - 5/94 |
| 35 | 86 | 21% | Bat Wing Stay Cylinder Wear | BW1+1.88" | B&W Rolled Plug + 379" Stake | B&W Rolled Plug | U3R4 - 5/94 |
| 118 | 135 | 39% | Bat Wing Wear | BW1-1.79" | B&W Rolled Plug | B&W Rolled Plug | U3R4 - 5/94 |
| 79 | 168 | 40% | Vertical Support wear | VS3+0.93" | B&W Rolled Plug | B&W Rolled Plug | U3R4 - 5/94 |

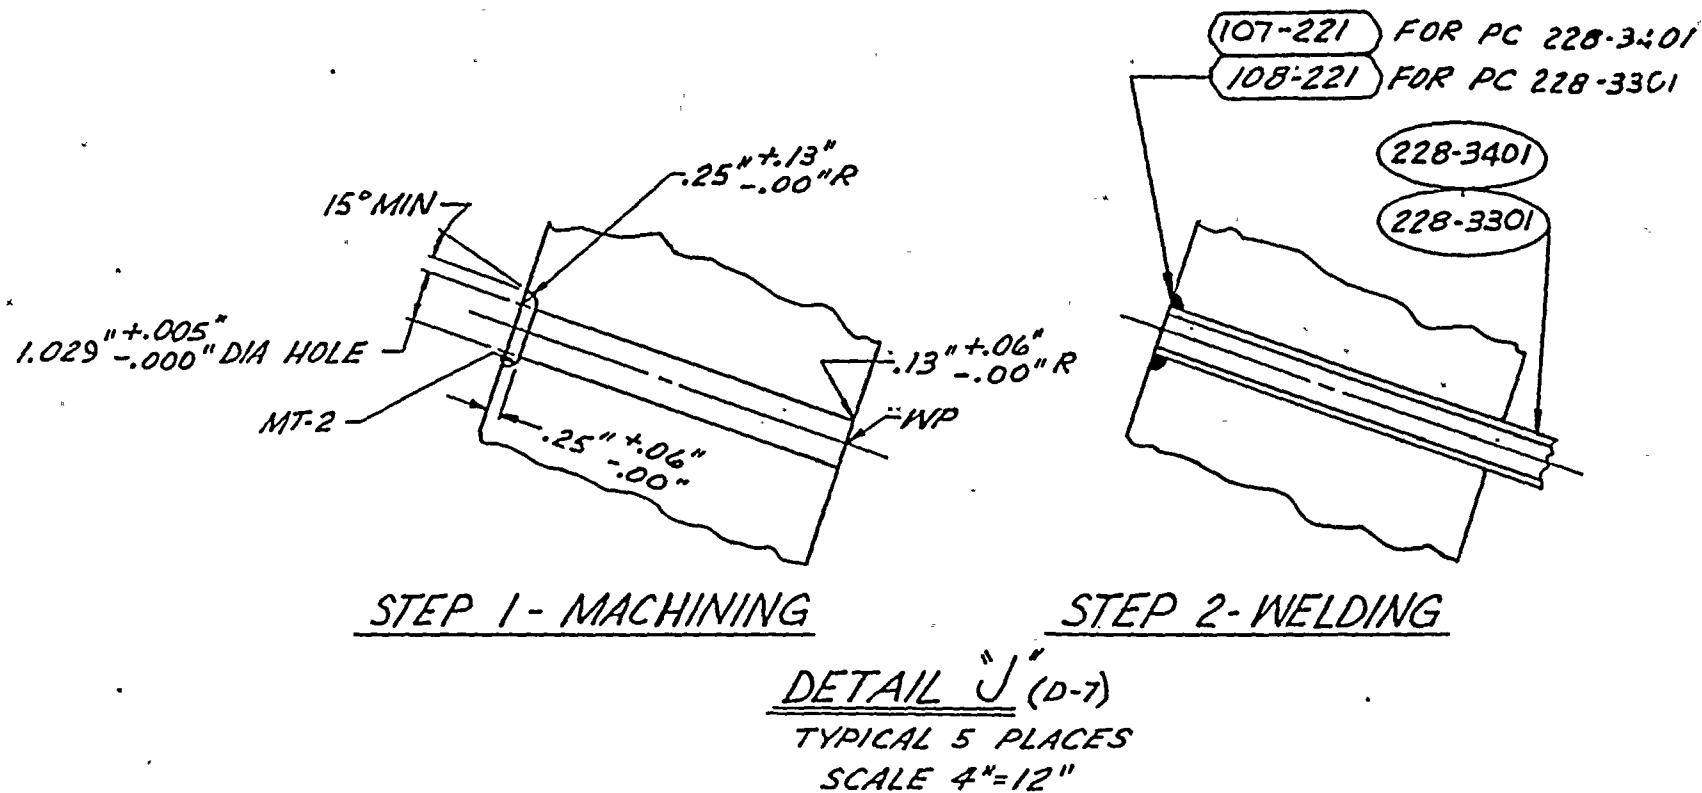
FIGURE IV.1  
SHELL CONE LEVEL TAP AND SAMPLE NOZZLE DETAIL

The nozzles which leaked in Unit 3 were a shell cone level nozzle and the downcomer sample nozzle. Both are designed as indicated in Detail J of Figure IV.1. The carbon steel SA106 grade B, 3/4" nozzles were attached to the Class 2 SG shell wall with an internal ID partial penetration weld. This partial penetration weld provided the structural pressure boundary support for the nozzle and met ASME Section III, Class 2 design stress requirements.

It is currently believed that the SG nozzle leaks encountered in Units 2 and 3 were due to weld porosity of the original, inside nozzle to shell, weld. The presence of porous weld in the SG nozzles may not have been identified during fabrication and would perform adequately for a period of time. At some point it is believed that cyclic stress (thermal, vibration, etc) can cause ligaments between the areas of weld porosity to degrade and open a path for leakage through the weld. The welds opened up over the period of plant operation until a leak path developed to containment atmosphere.

The shell cone level indication nozzle was repaired utilizing a design in which the structural pressure boundary weld was moved to the outside of the SG shell. The structural weld was attached to a built up weld pad that was attached to the SG shell and sized to provide sufficient area and depth to support the structural weld in a metallurgically and structurally sound application. Both the pad and the weld were designed and installed per the applicable requirements of the ASME B&PV Code, Section III, and sufficient non-destructive examinations (NDE) were performed before (SG shell base material), during, and after the repair process to provide assurance that the secondary pressure boundary was restored to its original structural limits.

The structural integrity of the SG at this penetration was once again determined to be impaired. Following this loss of integrity (relative to TS 3.4.9), action b of the LCO was entered, and the plant was taken to Mode 5 to affect repairs. The repair process was similar to that employed for the instrument nozzle.

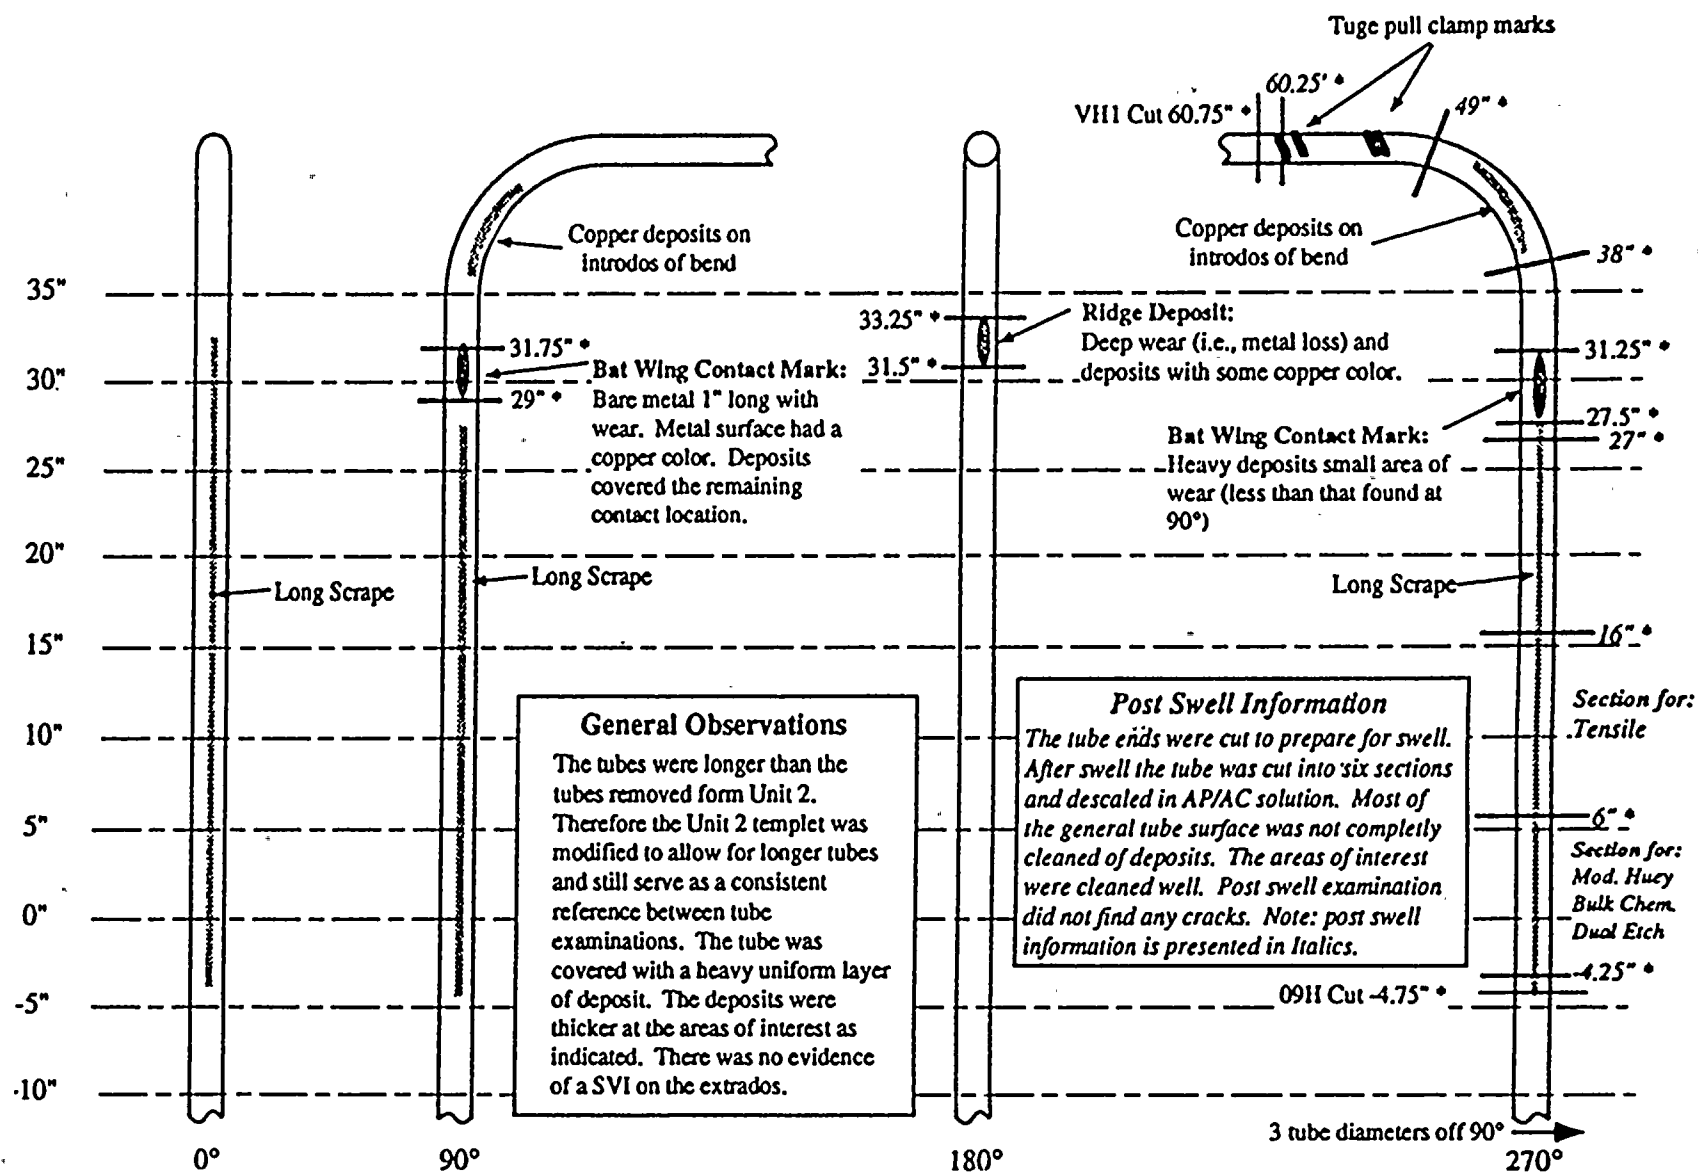
**FIGURE V.1**  
**VISUAL OBSERVATIONS FOR TUBE R152C73**

Figure V.1 shows the results of the visual examination of the R152C73 tube section (65.5 inches). Wear scars were evident at the batwing support location. A long axial scrape from the bottom of the tube section to just below the bend was determined to be a fabrication flaw. A ridge deposit and an apparent wear scar existed at the tube intrados approximately 35 inches above the 09H location. Heavy deposits were located in the 270° orientation 30 to 34 inches above the 09H location. The tube was sectioned into six pieces for further evaluation. Visual examination after tube swelling and descaling revealed no indications of IGA.

The SVI was determined to be a long (2-3/16 inches), narrow (1/4 inch) groove area of OD metal loss that extended approximately 26% throughwall on the intrados of the tube. Scanning electron microscope examination indicated a general corrosion process (micropitting) beneath a ridged deposit. Sulfur was detected in the deposit analysis (Table V.1). The chemistry conditions that produced the area of degradation could not be determined. There was no indication of cold work or increased microhardness in the thinned region. However, tube-to-tube contact was suspected and may have influenced the corrosion. No IGSCC or IGA was found to be associated with the corrosion area.
