EQUIPMENT ROOT CAUSE OF FAILURE ANALYSIS REPORT

UNIT 2 STEAM GENERATOR TUBE RUPTURE

Event Date
March 14, 1993

PALO VERDE NUCLEAR GENERATING STATION

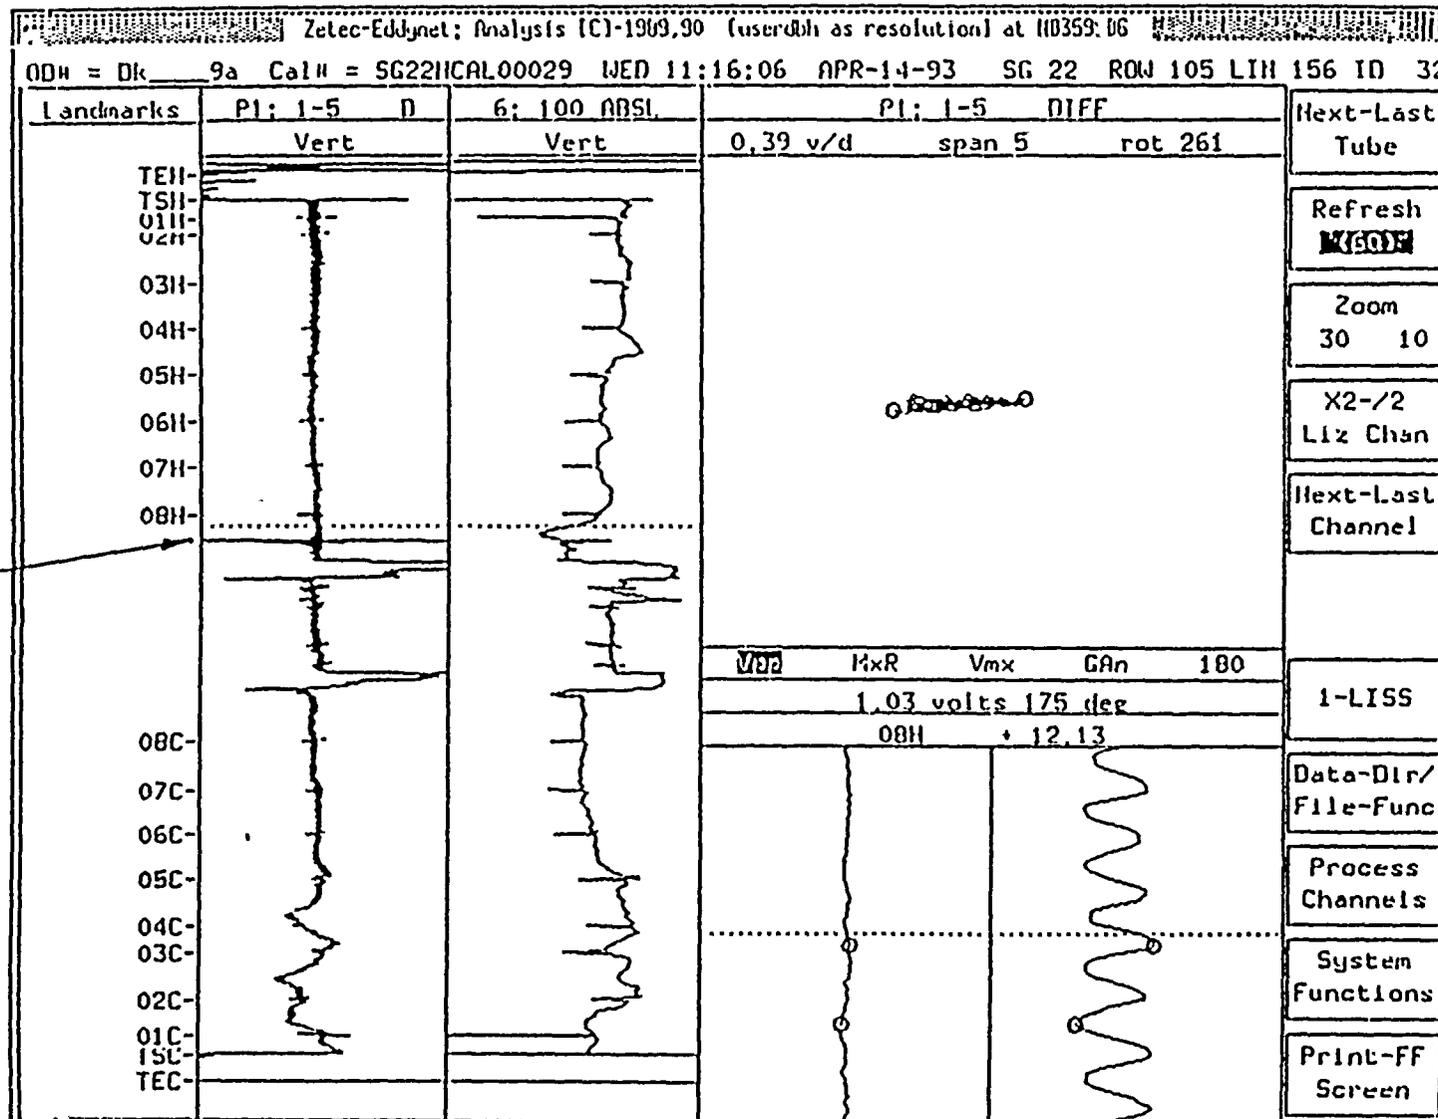
FIGURE V.B.10

TUBE R105C156 HORIZONTAL NOISE IN CHANNEL P1 USED FOR DEFECT SCREENING

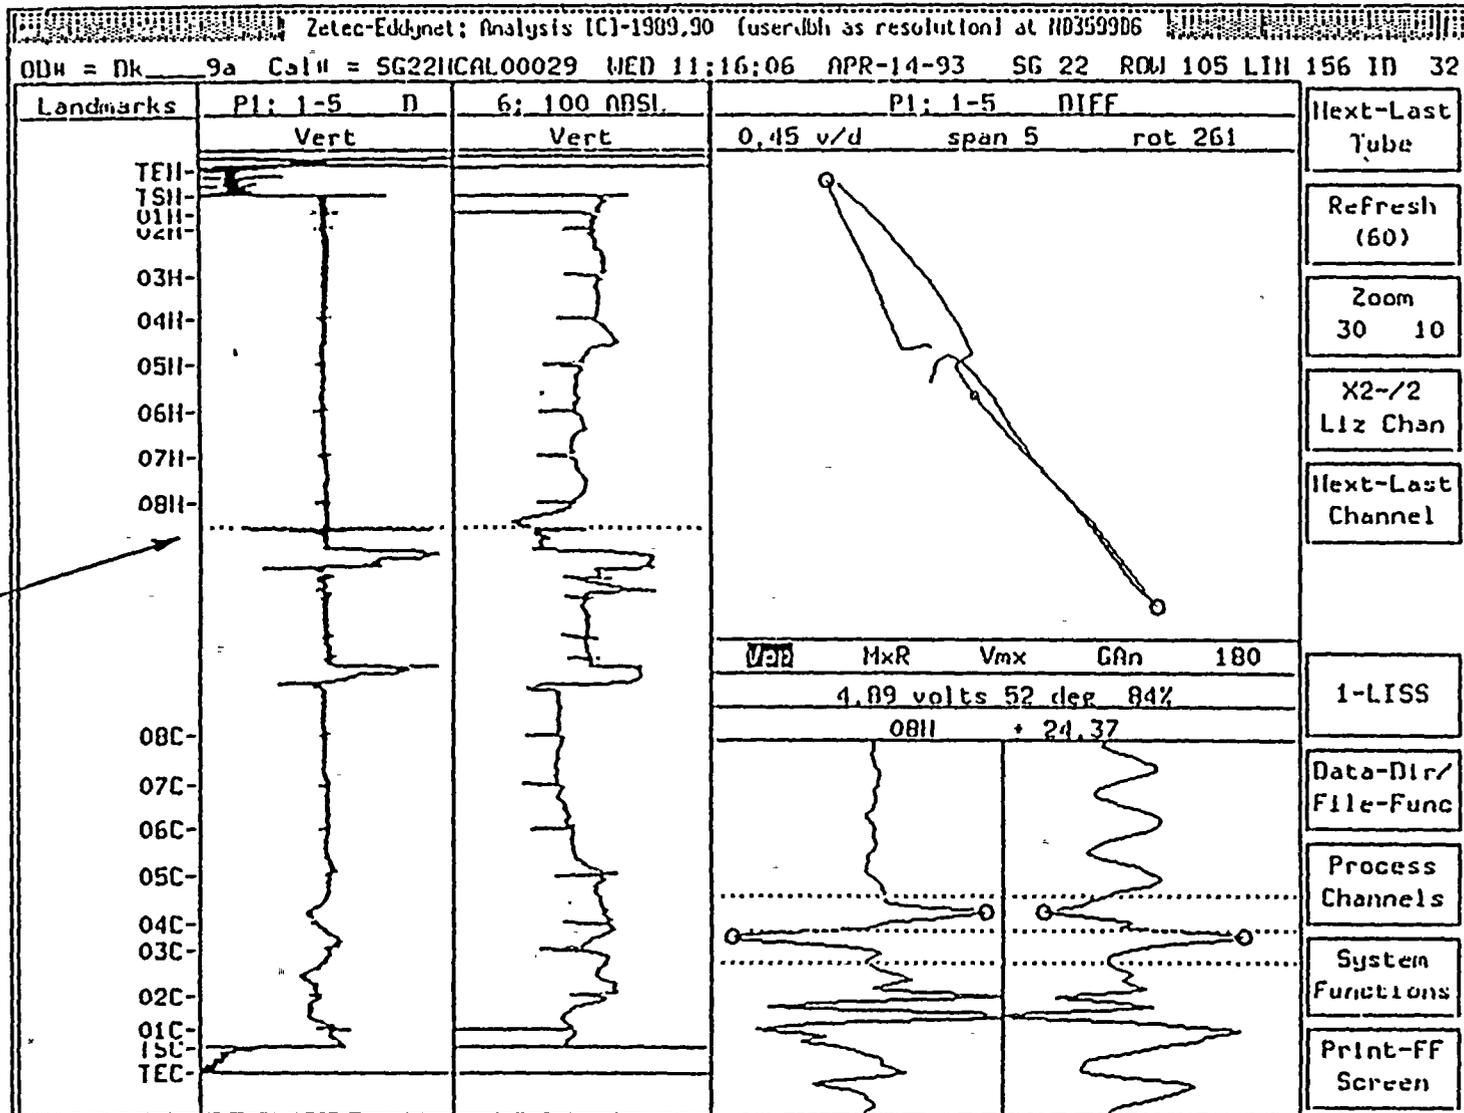
FIGURE V.B.11

TUBE R105C156 SAI DEFECT SIGNAL USING CHANNEL P1

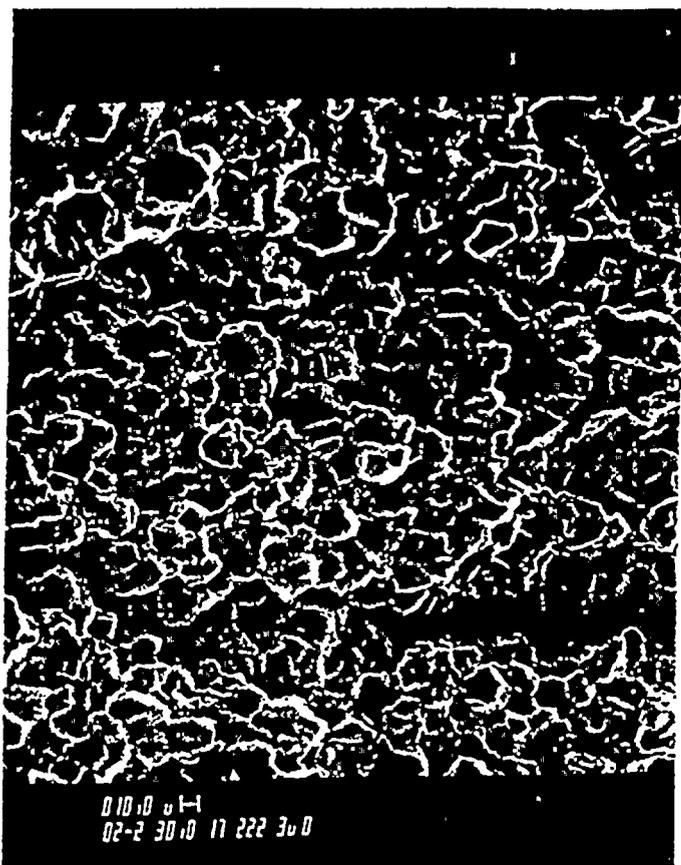
V.L  
Figure R. As-received sample of ruptured tube R117C144 after bending to open up surface IGA.

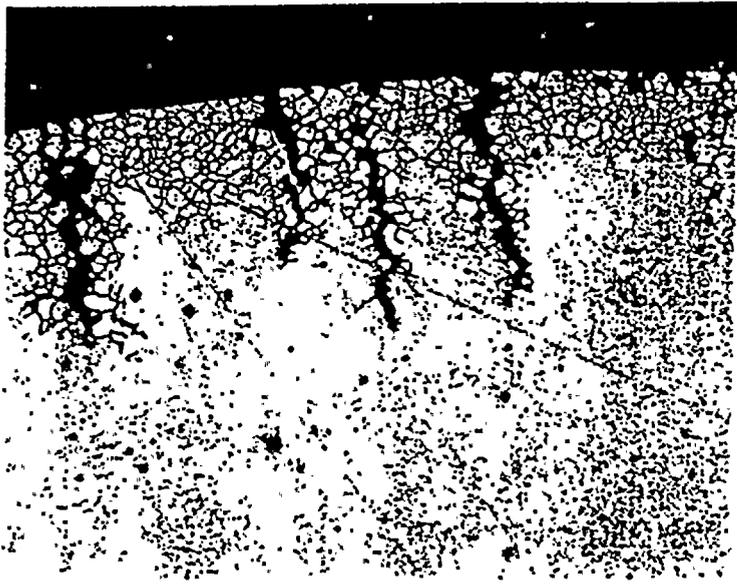
V.L  
Figure N. Photomicrograph of tube R103C156 freespan area showing surface damage and associated IGA / IGSCC. Arrow notes the end of damaged area and associated IGA.

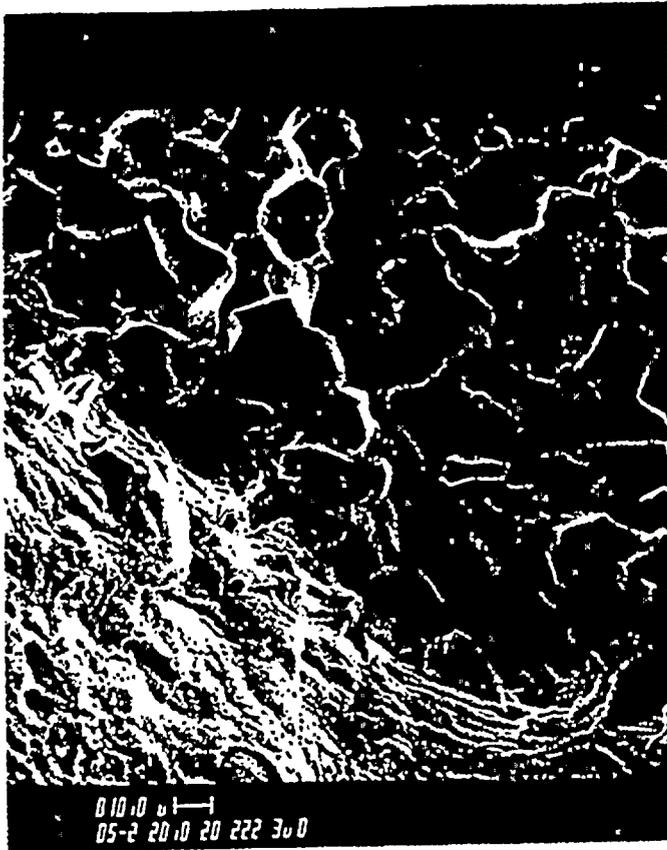
V.L.  
Figure L. Cross-sectional photomicrograph of tube R105C156 showing IGA and IGSCC.

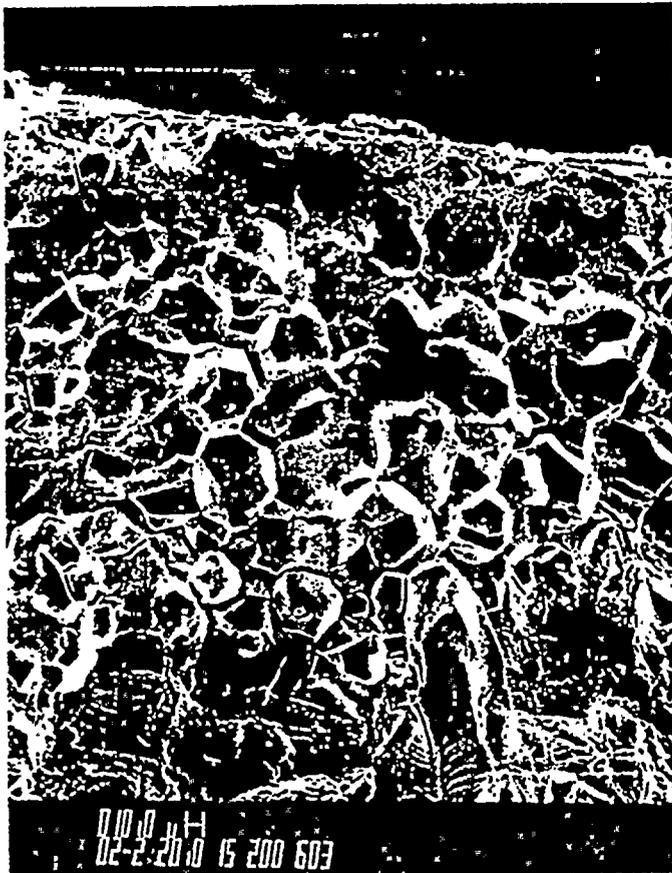
Figure I. Scanning electron micrograph of R105C156 fracture surface showing "rock candy" appearance of IGSCC. Lower left hand portion of photo is the area of ductile shear from the burst test. 500x.

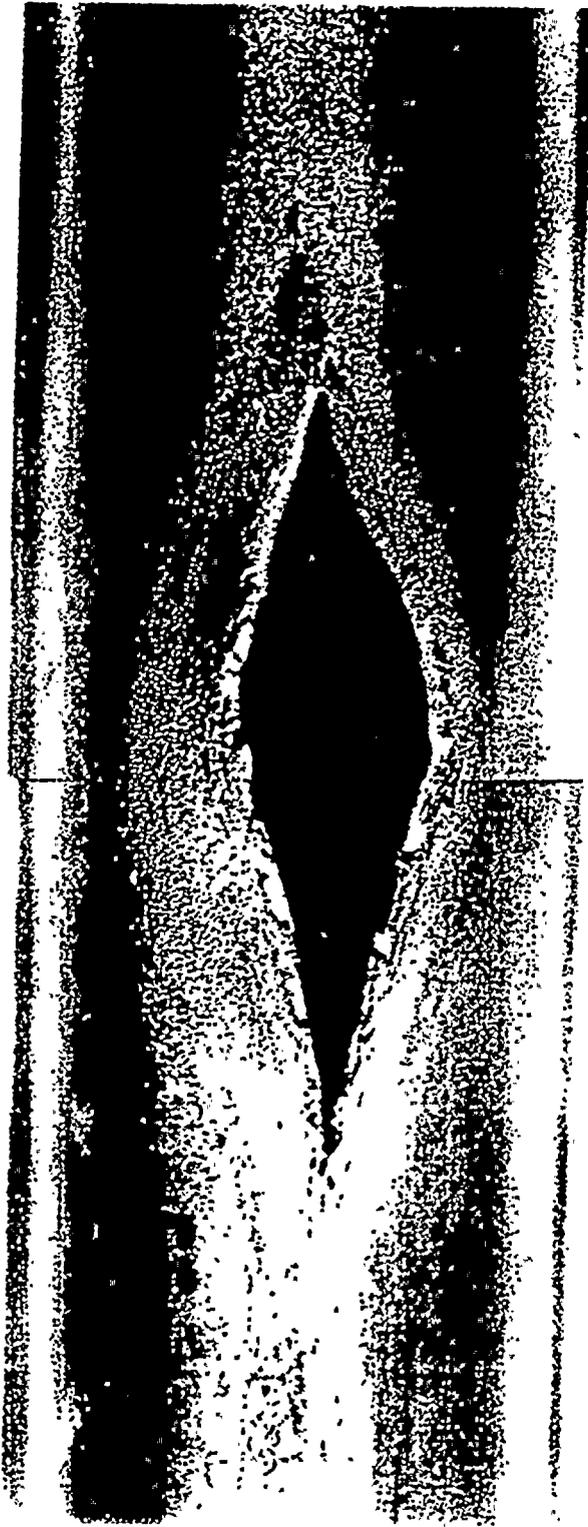
Figure J. Scanning electron micrograph of tube R117C144 burst surface confirming IGSCC as the mode of cracking.
