SUBJECT: LER 95-011-00: on 951018, identified procedural deficiency w/MSIV & FWIV ISTs due to personnel error. Verified operability of MSIVs & FWIVs. W/951123 ltr.

**Subject: Palo Verde Nuclear Generating Station (PVNGS)
Units 1, 2, and 3
Docket Nos. STN 50-528, 50-529, 50-530
License Nos. NPF-41, NPF-51, NPF-74
Licensee Event Report 95-011-00**

TITLE (4)
Inadequate Main Steam Isolation Valve and Feed Water Isolation Valve Operating Air Inservice Tests

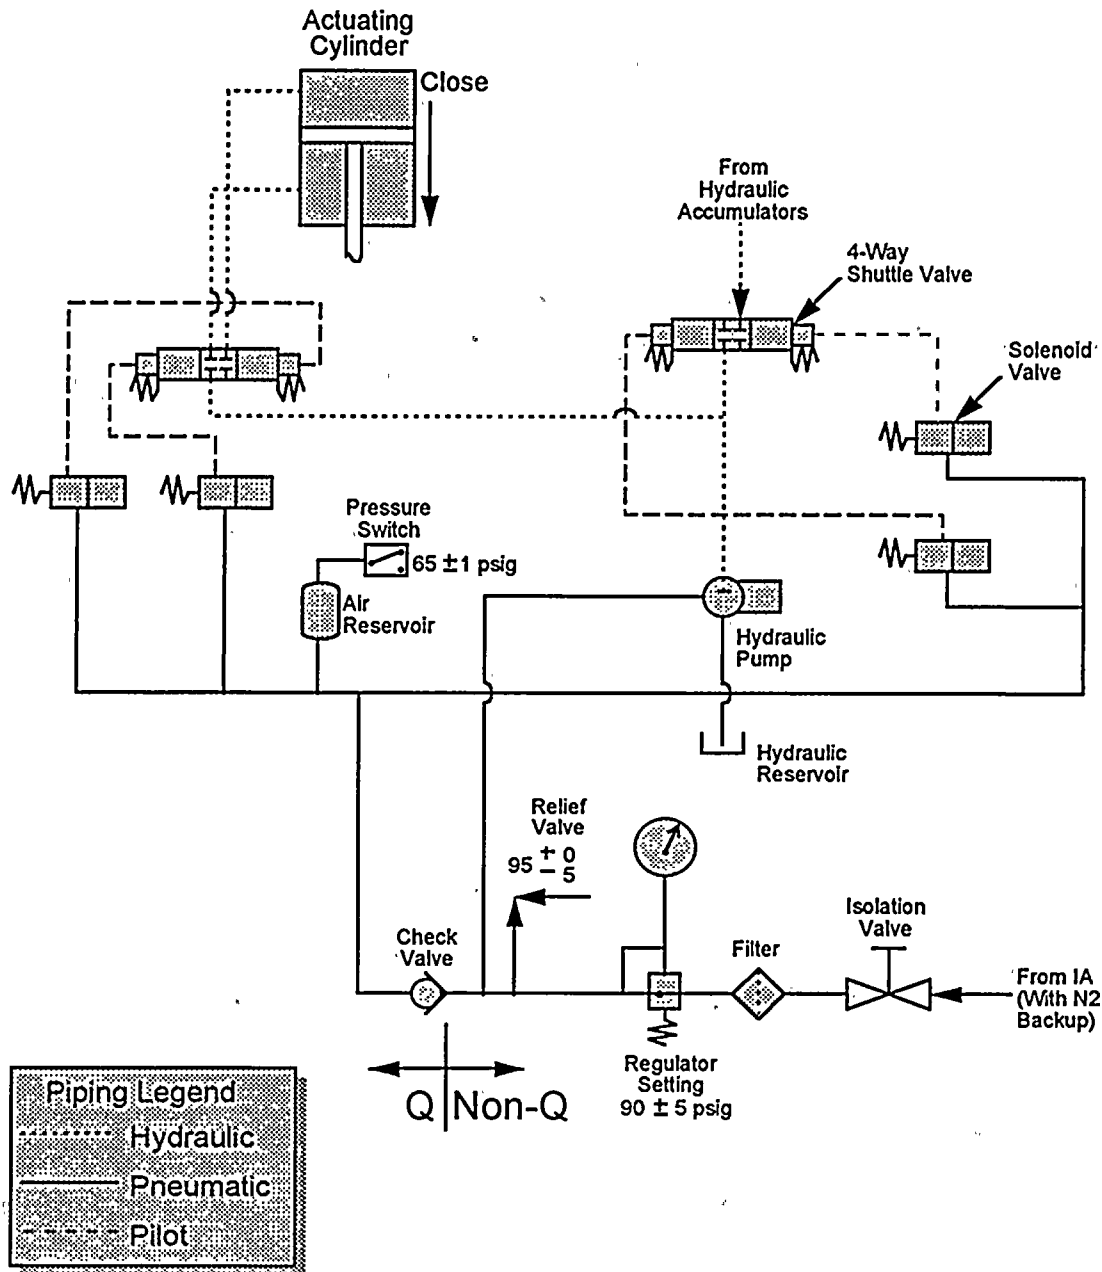
FIGURE 1 Simplified Drawing

On October 18, 1995, while reviewing a calculation to validate the SG design basis manual, an engineer (contract, non-licensed) discovered a discrepancy between the acceptance criteria specified in the MSIV and FWIV ISTs and the respective supporting calculation. The MSIVs and FWIVs are hydraulically actuated valves that rely on quality related operating air subsystems. The operating air subsystems are supplied by the Instrument Air (IA) (LD) system - a non-quality related system backed-up by the Nitrogen (GA) (LK) system which is also non-quality related. An air reservoir (RVR) and spring-loaded check valve (V) are provided in each operating air subsystem to satisfy the criteria for the quality related classification. (A typical sketch of the operating air subsystems showing the class break is provided as figure 1 in this LER.) There are a total of 8 MSIV operating air subsystems and 4 FWIV operating air subsystems per unit. The minimum air pressure needed to operate the MSIVs and FWIVs is approximately 48 psig and 47 psig respectively. The ISTs verify that the operating air subsystem pressure, when isolated, will not drop from the initial test pressure to the low pressure alarm setpoint of 65 ± 5.9 psig (note: 5.9 psig includes the setpoint tolerance of 1 psig plus instrument [90] inaccuracies of 4.9 psig). The ISTs did not consider that the operating air subsystem pressure could be as low as 59.1 psig (i.e., 65 - 5.9) at the start of an accident. The maximum operating air subsystem

pressure could be as high as 95 psig. Since leakage was not being measured, the test results to date demonstrate only that subsystem leakrate is less than 35.9 psig (i.e., 95-59.1) during the 11 minute test. The tests do not verify that the MSIV or FWIV operating air subsystems will provide sufficient air for MSIV and FWIV operation under all possible operating or accident conditions.

A new IST method has been developed to verify the integrity of the MSIV and FWIV operating air subsystems. The new test method measures subsystem leakage and calculates a leakrate. The new acceptance criteria is based on the 11 minute bounding accident and the pressure difference between a postulated initial pressure of 59.1 psig and the minimum pressure required to operate the MSIVs or FWIVs (approximately 48.1 and 47.1 psig respectively). The revised ISTs were successfully performed in Unit 3. Engineering, Operations, and Work Control personnel are evaluating the benefit and feasibility of testing the Units 1 and 2 valves on-line.
