LICENSEE EVENT REPORT (LER)

FACILITY NAME (1) Palo Verde Unit 1	DOCKET NUMBER (2) 0 5 0 0 0 5 2 8	PAGE (3) 1 OF 1 0
---	---	-----------------------------

TITLE (4)
Adverse Affect of Low Bench Set on Fisher Air Operated Letdown/Containment Isolation Valves

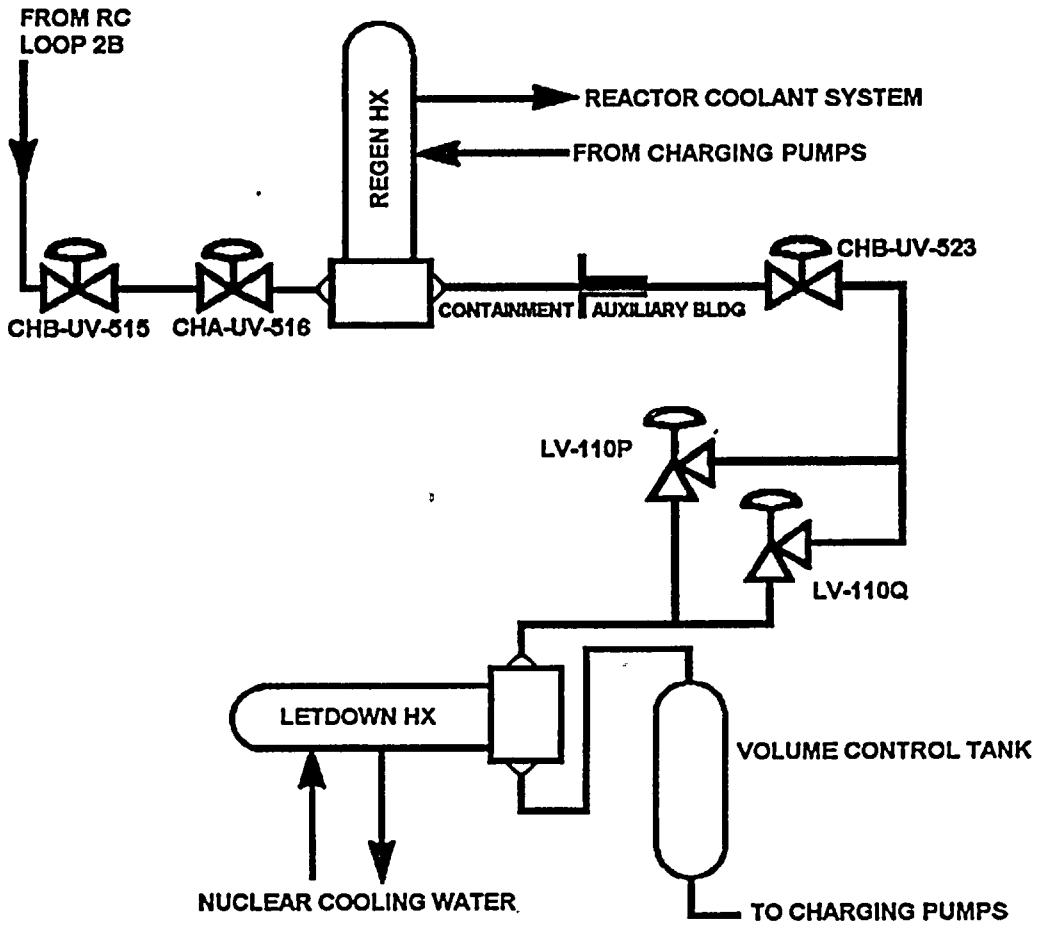
**FIGURE 1 - LETDOWN LINE
CONFIGURATION THROUGH THE
LETDOWN HEAT EXCHANGER**

Figure 1, page 10, illustrates the letdown system. The following Unit 1, 2, and 3 letdown line isolation valves were affected by this event: CHB-UV-515 Upstream Containment Isolation Valve, CHA-UV-516 Downstream Containment Isolation Valve, and CHB-UV-523 Outside of Containment Letdown Isolation Valve.
