UNITED STATES
NUCLEAR REGULATORY COMMISSION

SUBJECT: NRC INSPECTION REPORT 50-528/98-14; 50-529/98-14; 50-530/98-14

This special inspection was conducted to review the safety and regulatory implications of excessive high-pressure safety injection pump discharge check valve reverse leakage for Units 1 and 2. The licensee identified and reported these conditions to the NRC in accordance with 10 CFR Part 50.72 on May 14 and 15, 1998. The onsite portion of the inspection was conducted during the weeks of May 25 and June 8, 1998. Additional in-office inspection was conducted through July 21, 1998. The inspection also assessed the licensee's evaluation of the degraded conditions.

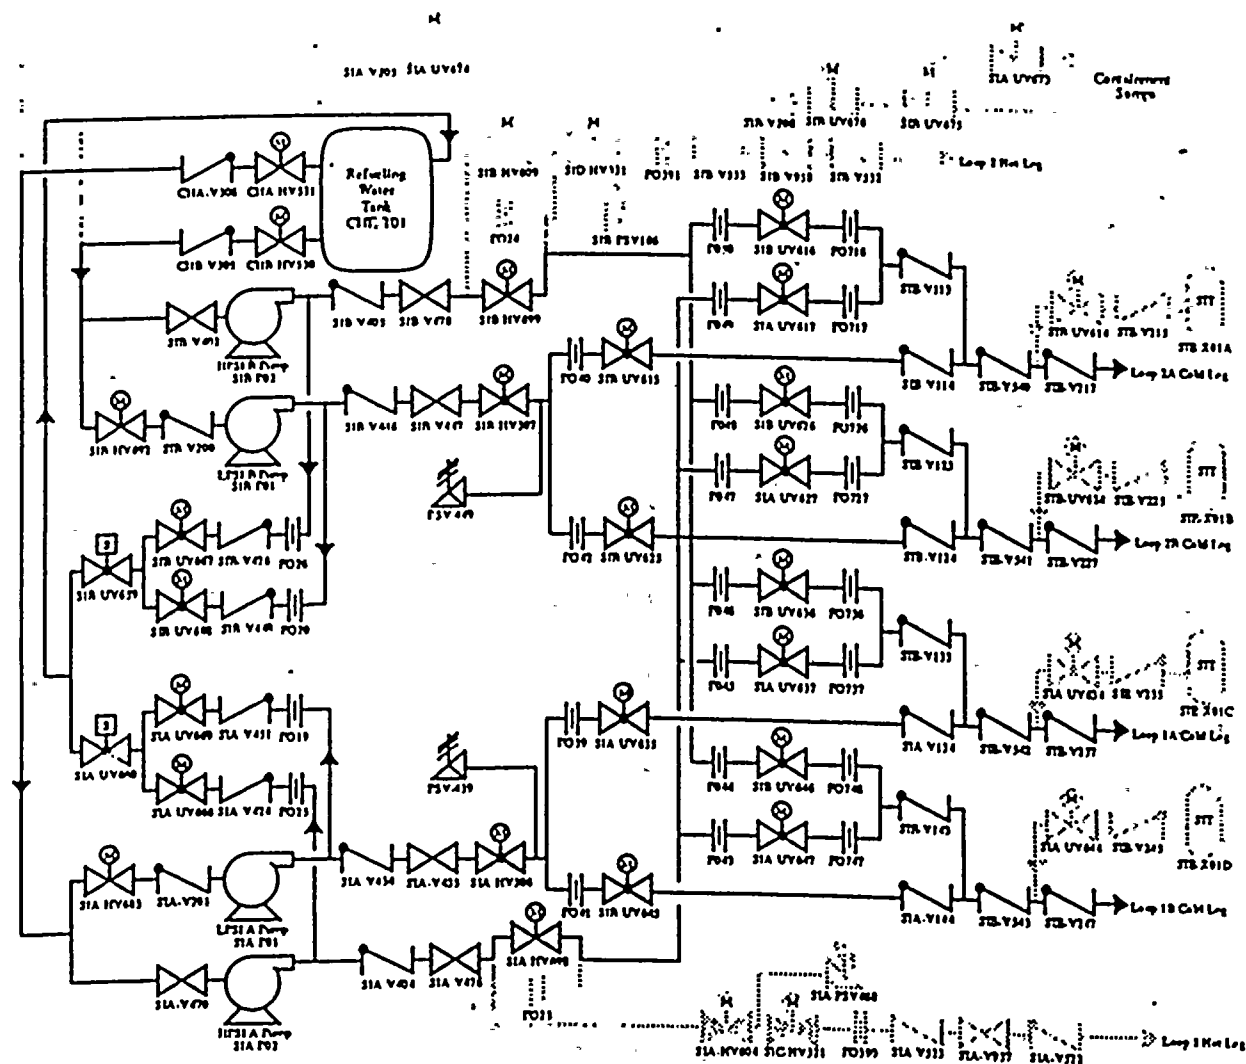
SIMPLIFIED HPSI FLOW DIAGRAM

A check valve that was improperly assembled could affect the leakage through the valve during reverse flow conditions. For example, referring to the simplified flow diagram in Attachment 2, if the "B" HPSI pump discharge check valve SIB-V405 were to fail to close completely under reverse flow conditions, and the "B" HPSI pump was not running with the injection valves open, part of the injection flow from the "A" HPSI pump would be directed back through HPSI Valves SIA-UV617, -627, -637, -647 and SIB-UV616, -626, -636, -646. The flow would then be directed through the "B" HPSI pump mini-flow line Valves SIB-UV667 and SIB-659, and back to the RWT. As stated previously, upon a safety injection actuation signal, the cold-leg injection valves would open and remain open.

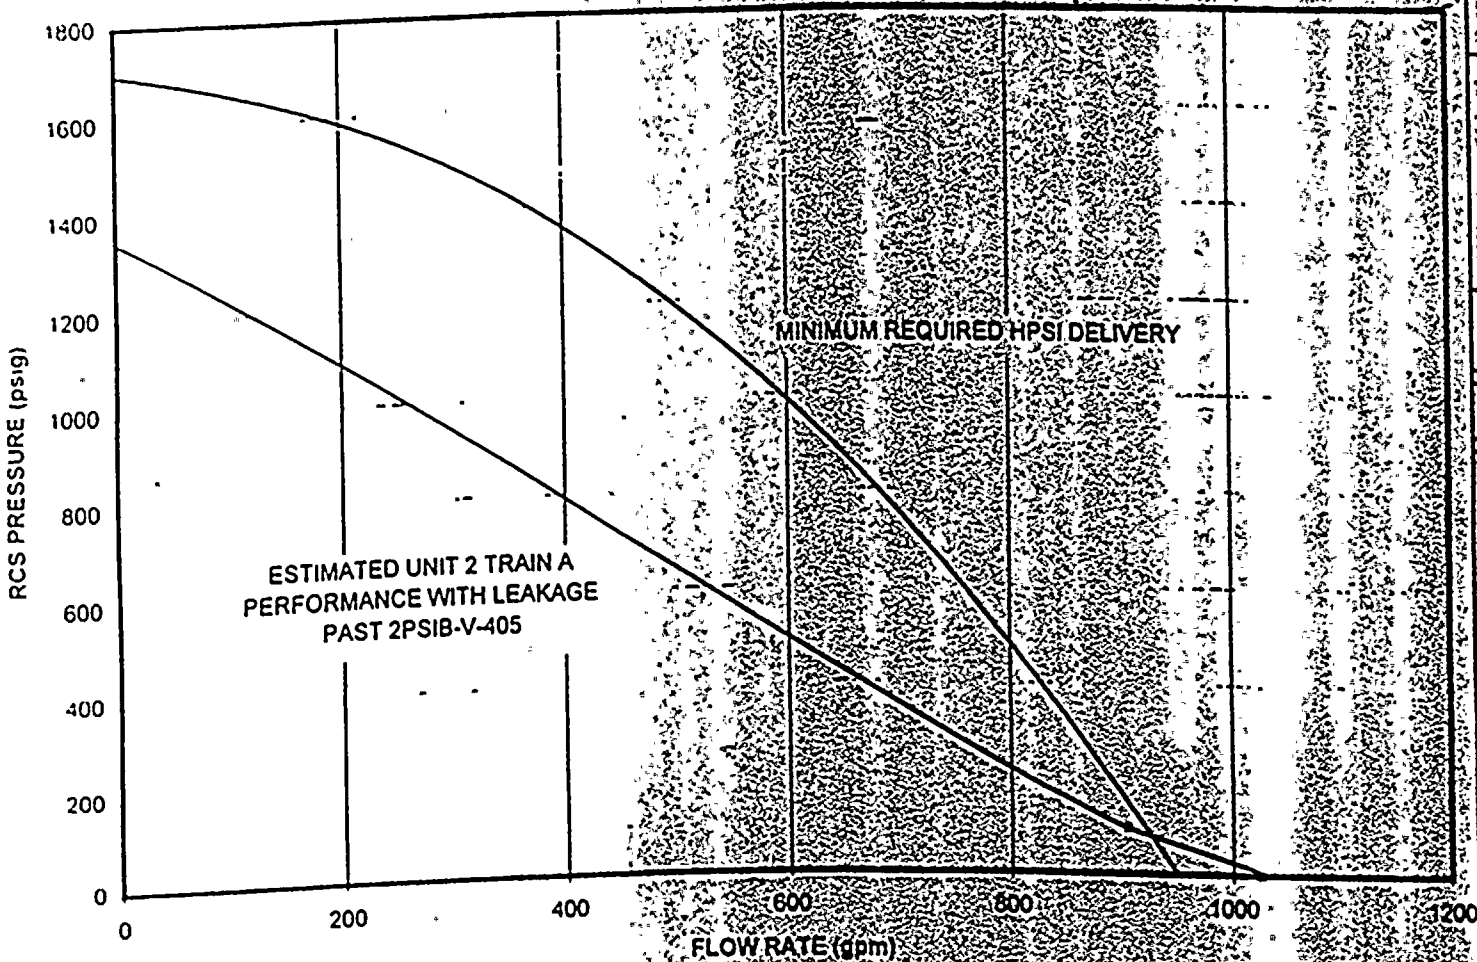
FIGURE 15
FINAL DEGRADED HPSI FLOW
UNIT 2 TRAIN A

Valve 2PSIB-V405 had an as-found reverse leakage test result of 37 gpm at 6 psid. The licensee calculated an as-found loss coefficient for the subject valve and developed a HPSI delivery curve that accounted for leakage through Valve 2PSIB-V405. The as-found degraded HPSI delivery curve and the minimum-required ECCS delivery curve are depicted in Attachment 3. As shown, the estimated as-found HPSI delivery

capability was significantly degraded compared to the minimum-required HPSI delivery performance that was assumed in the LOCA analyses. For example, at an RCS pressure of 1200 psig, the estimated HPSI flow rate was approximately 350 gpm less than the flow rate assumed in the LOCA analyses. The licensee concluded that the results for Unit 1 were comparable.
