U.S. NUCLEAR REGULATORY COMMISSION
REGION IV

Docket Nos.: 50-528; 50-529; 50-530
License Nos.: NPF-41; NPF-51; NPF-74
Report No.: 50-528/98-14; 50-529/98-14; 50-530/98-14
Licensee: Arizona Public Service Company
Facility: Palo Verde Nuclear Generating Station, Units 1, 2, and 3
Location: 5951 S. Wintersburg Road
Tonopah, Arizona
Dates: May 26 through July 21, 1998
Inspectors: R. Bywater, Reactor Inspector, Engineering Branch
N. Salgado, Resident Inspector
Approved By: Thomas F. Stetka, Acting Chief, Engineering Branch
Division of Reactor Safety

Palo Verde Nuclear Generating Station, Units 1, 2, and 3
NRC Inspection Report 50-528/98-14; 50-529/98-14; 50-530/98-14

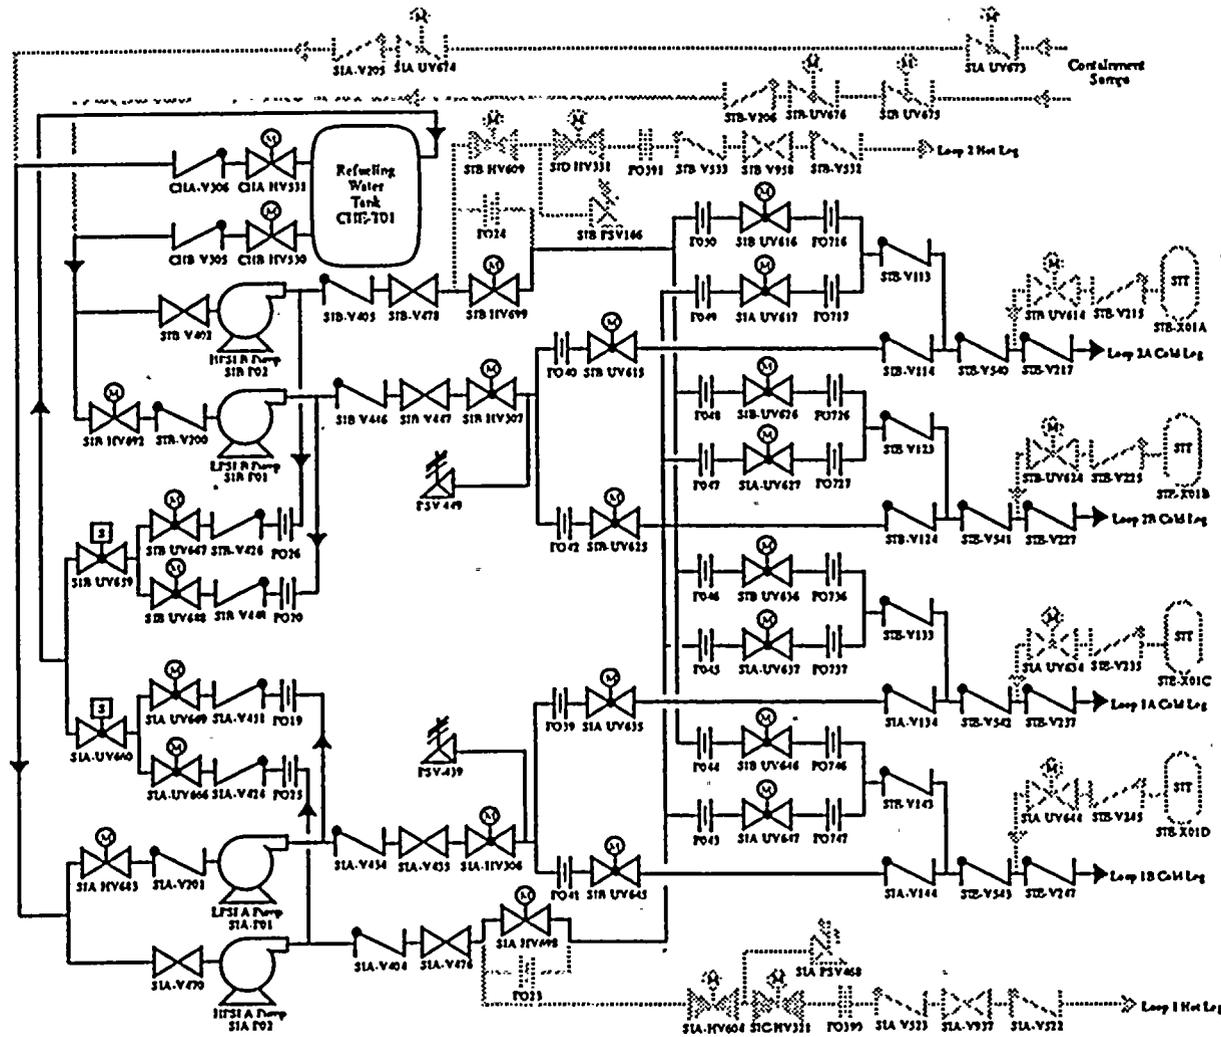
SIMPLIFIED HPSI FLOW DIAGRAM

A check valve that was improperly assembled could affect the leakage through the valve during reverse flow conditions. For example, referring to the simplified flow diagram in Attachment 2, if the "B" HPSI pump discharge check valve SIB-V405 were to fail to close completely under reverse flow conditions, and the "B" HPSI pump was inoperable, part of the injection flow from the "A" HPSI pump would be directed back through HPSI Valves SIA-UV617, -627, -637, -647 and SIB-UV616, -626, -636, -646. The flow would then be directed through the "B" HPSI pump mini-flow line Valves SIB-UV667 and SIB-659, and back to the RWT. As stated previously, upon a safety injection actuation signal, the cold-leg injection valves would open and remain open.

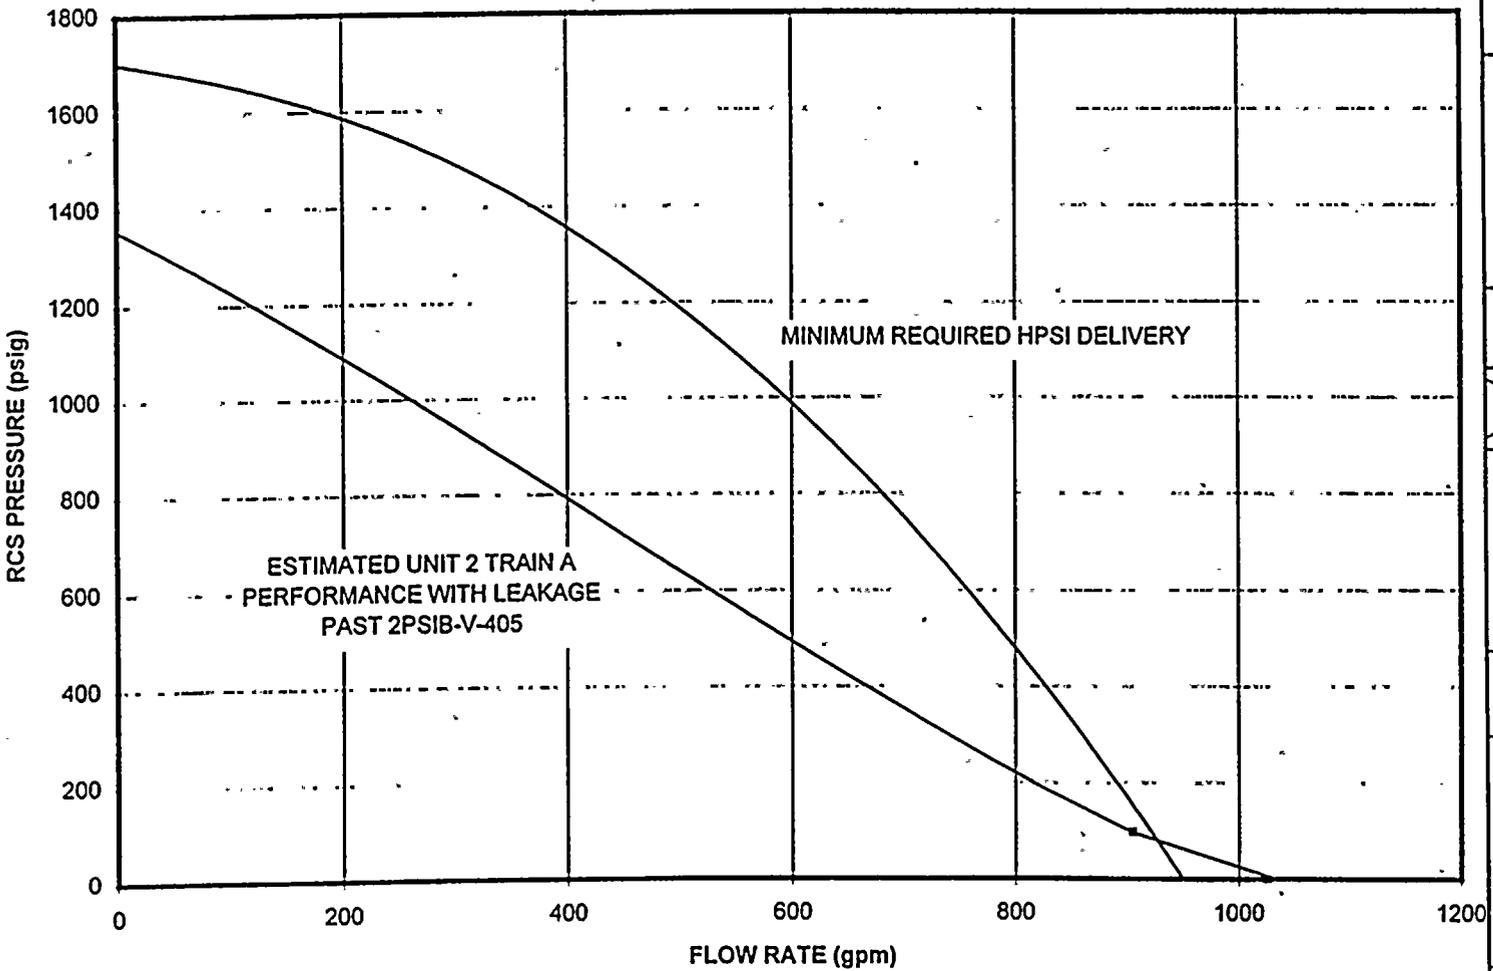
**FIGURE 15
FINAL DEGRADED HPSI FLOW
UNIT 2 TRAIN A**

Valve 2PSIB-V405 had an as-found reverse leakage test result of 37 gpm at 6 psid. The licensee calculated an as-found loss coefficient for the subject valve and developed a HPSI delivery curve that accounted for leakage through Valve 2PSIB-V405. The as-found degraded HPSI delivery curve and the minimum-required ECCS delivery curve are depicted in Attachment 3. As shown, the estimated as-found HPSI delivery capability was significantly degraded compared to the minimum-required HPSI delivery performance that was assumed in the LOCA analyses. For example, at an RCS pressure of 1200 psig, the estimated HPSI flow rate was approximately 350 gpm less than the flow rate assumed in the LOCA analyses. The licensee concluded that the results for Unit 1 were comparable.
