Docket No. 50-315  
Docket No. 50-316

UNITED STATES  
NUCLEAR REGULATORY COMMISSION  
OFFICE OF INSPECTION AND ENFORCEMENT

IE Circular No. 79-02

FAILURE OF 120 VOLT VITAL AC POWER SUPPLIES

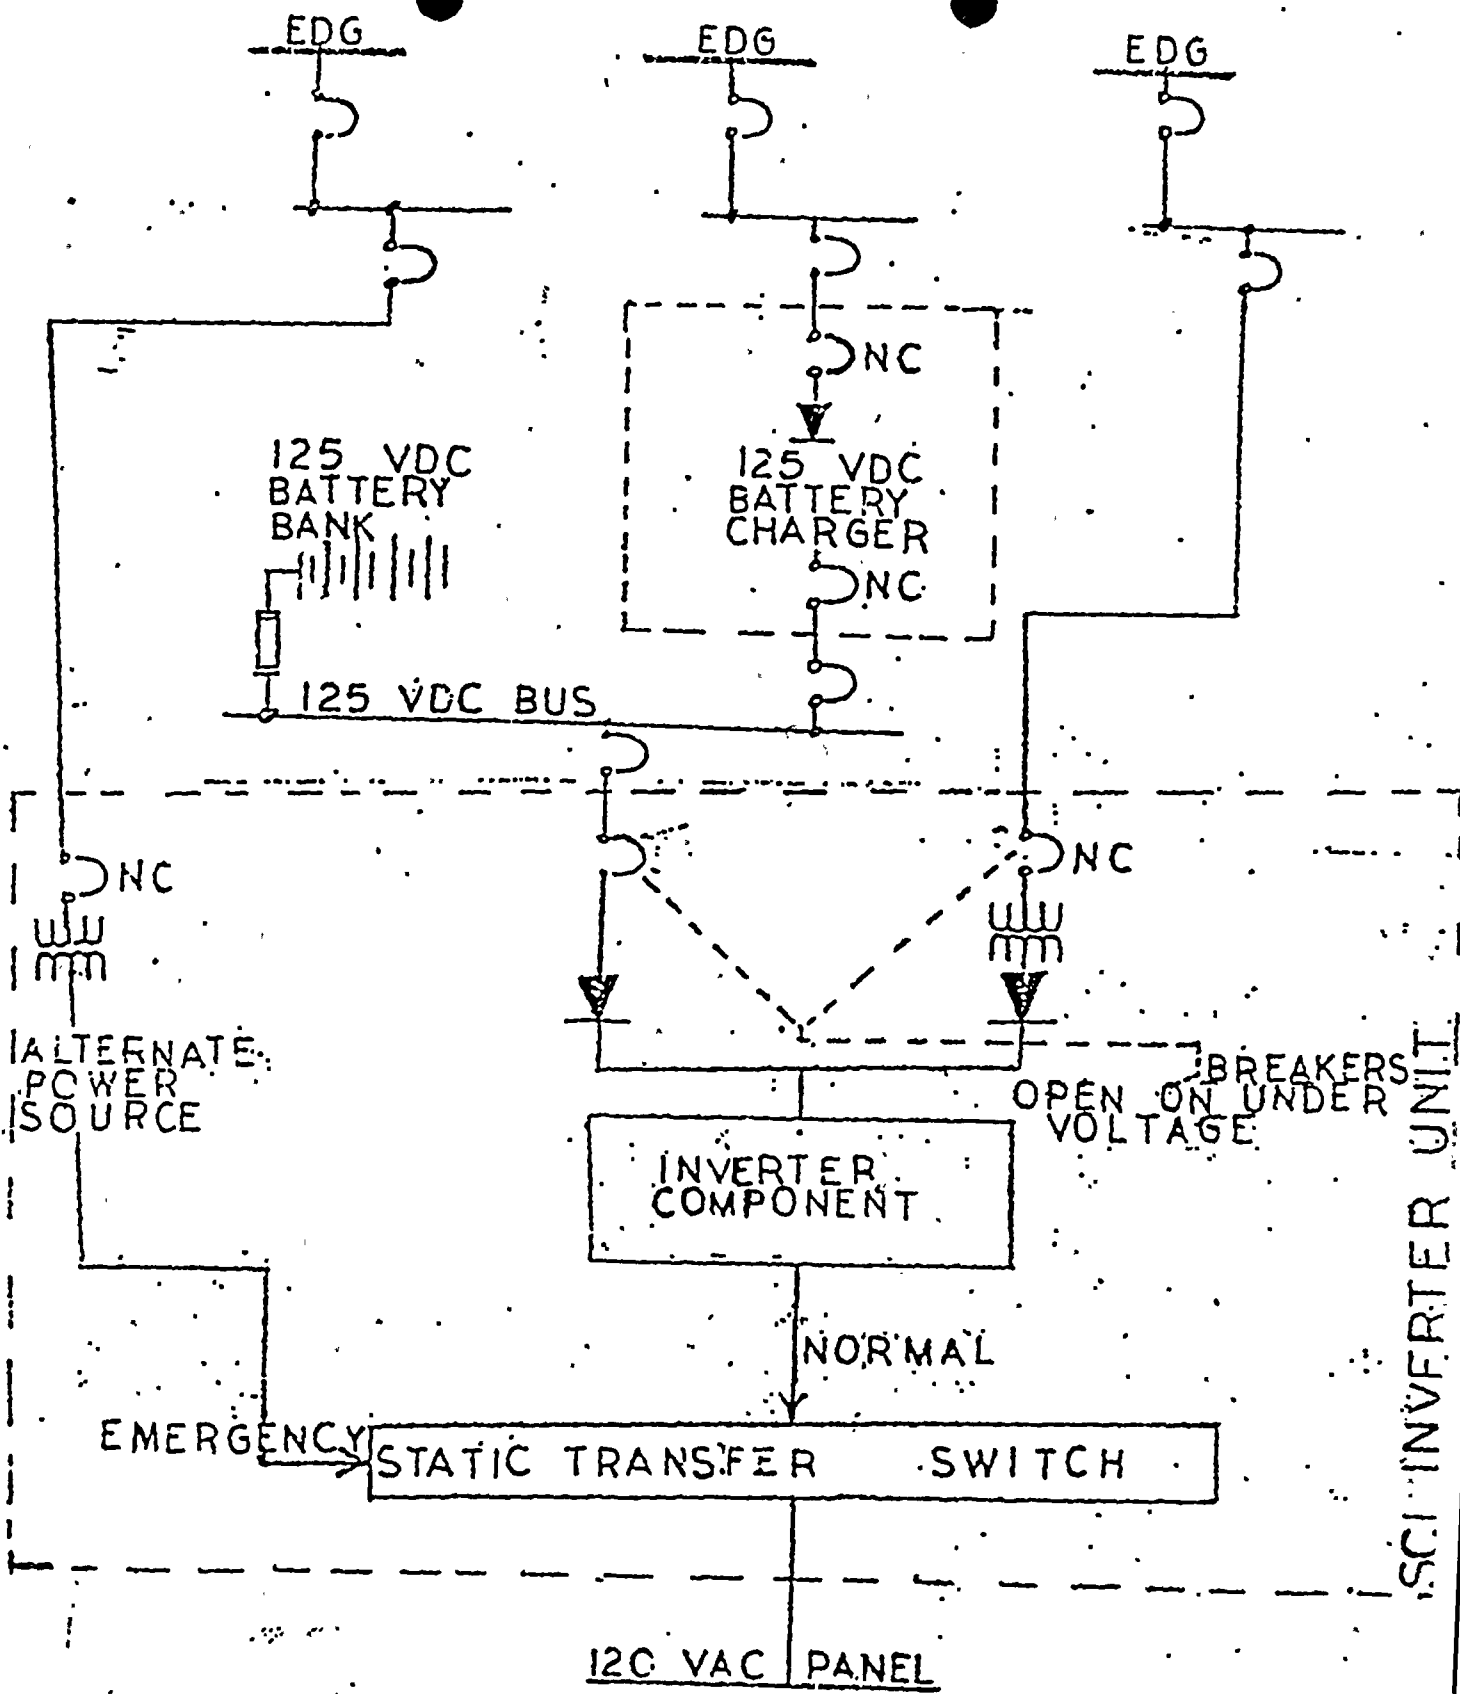
FIGURE 1  
SINGLE LINE DIAGRAM - 120 VAC

On September 16, 1978, Arkansas Nuclear One - Unit 2, while in hot functional testing preceding initial criticality, suffered a degradation of both of the independent off-site power sources. This produced an undervoltage condition on the Engineering Safety Features (ESF) Buses and caused an inadvertent ESF actuation. The licensee determined that the ESF actuation occurred on a loss of at least two of the uninterruptible 120 volt vital AC power sources. Immediate investigation revealed that all four of the Solidstate Controls, Inc., (SCI) inverter static switches had automatically transferred to the alternate power supply (the 120 volt AC being supplied by transformers directly off the ESF buses rather than from the inverter output.) Figure 1 (attached) shows the functional interconnection of the 120 volt AC power supply system.

A single conclusive cause of the undesired SCI inverter static switch transfer could not be identified. However, the following problems were discovered during subsequent investigation.

- (a) The SCI inverters have circuitry to monitor the incoming DC voltage level which, on sensing a low voltage (nominally 104 DC volts for these inverters) will trip both input breakers to the inverter component after an adjustable time delay.

The setting of these time delay relays were not verified during either preoperational testing or subsequent maintenance. The time delay is necessary in order to accommodate transient loading conditions which may be encountered.

- (b) On one SCI inverter, a DC fuse within the inverter component was found blown. The vendor indicated that this fuse will blow due to an excessive DC voltage to the inverter component caused by a transient on the 480 AC input. The licensee has subsequently reset the taps on the 480V to 120V three-phase AC input transformer to limit the DC voltage to the inverter to less than the nameplate maximum rating in the event of a high AC input voltage transient.

- (c) The SCI inverter static switch is designed to transfer to an alternate source on inverter output overcurrent or undervoltage. Initially, these trips were set at 125 percent overcurrent and 80 percent undervoltage. An explanation for the transfer of two of the inverter static switches is that during one of the transfers of site loads, the instantaneous inductive load caused these trip set points to be exceeded. The licensee has subsequently adjusted the transfer sensing circuitry to higher overcurrent and lower undervoltage trip settings to assure that the inverter will maintain load over the widest possible range of voltage and current. (Note that in this case, once the SCI inverter transfers to the alternate source, it will not automatically transfer back to normal source.)

1. Determine whether or not time delay circuitry is used in your inverter units. If so, have they been adjusted to the appropriate set point as required by equipment and the integrated system designs?

2. Determine if the AC input voltage and transformer tap settings are optimized to prevent exceeding the inverter component name-plate maximum rated DC input voltage in the event of a high AC input voltage transient.

3. If an alternate 120 volt source is used in your design, determine if the protection transfer circuitry of the inverter has been optimized within design limits to ensure maximum possible availability of the inverter system during transient loading conditions. An operating history of inexplicable transfers may be indicative of the above.

4. Determine if the administrative controls employed by your facility ensures operability of safety systems after its subcomponents (e.g., time delay relays, switches, etc.) have been subjected to maintenance or testing.
