Final ASP Program Analysis – Precursor

Accident Sequence Precursor Program – Office of Nuclear Regulatory Research			
Arkansas Nuclear One – Unit 1		Automatic Start of an Emergency Diesel Generator Following a Partial Loss of Offsite Power due to Severe Weather	
Event Date: 04/26/2017		LER: 313-2017-001 IR: 05000313/2017002	CCDP= 1×10^{-5}
Plant Type: Pressurized Water Reactor (PWR); Babcock & Wilcox Two-Loop with a Large, Dry Containment			
Plant Operating Mode (Reactor Power Level): Mode 1 (100% reactor power)			
Analyst: Ian Gifford	Reviewer: Christopher Hunter	Contributors: N/A	Approval Date: 12/06/2017

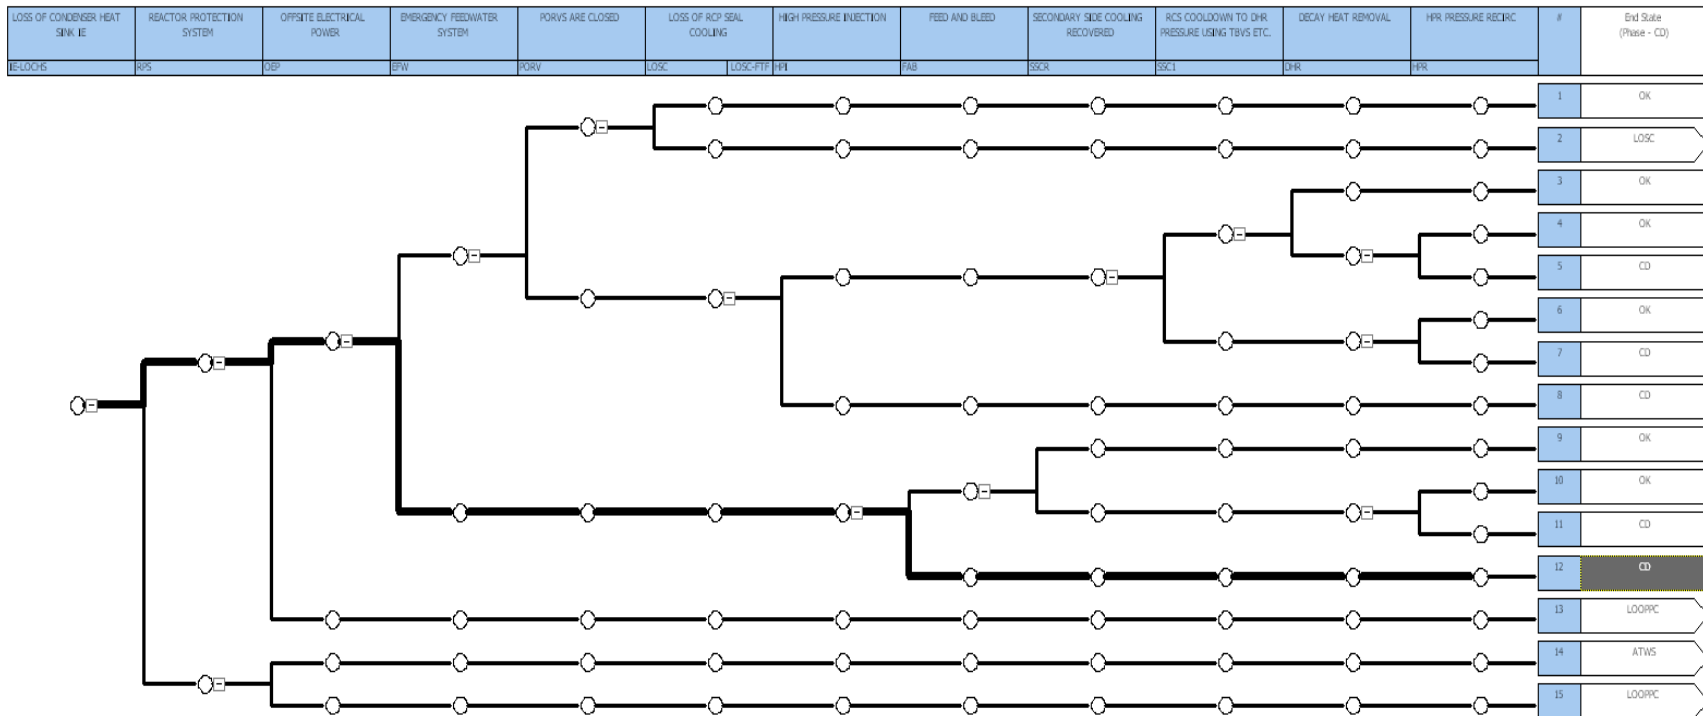
Figure A-1. Arkansas Nuclear One Loss of Condenser Heat Sink Event Tree

Dominant Sequence. The dominant accident sequence is loss of condenser heat sink sequence 12 (CCDP = 9.4×10^{-6}) that contributes approximately 94 percent of the total internal events CCDP. [Figure A-1](#) in Appendix A illustrates this sequence. The sequences that contribute to at least 1 percent of the total internal events CCDP are provided in the following table:

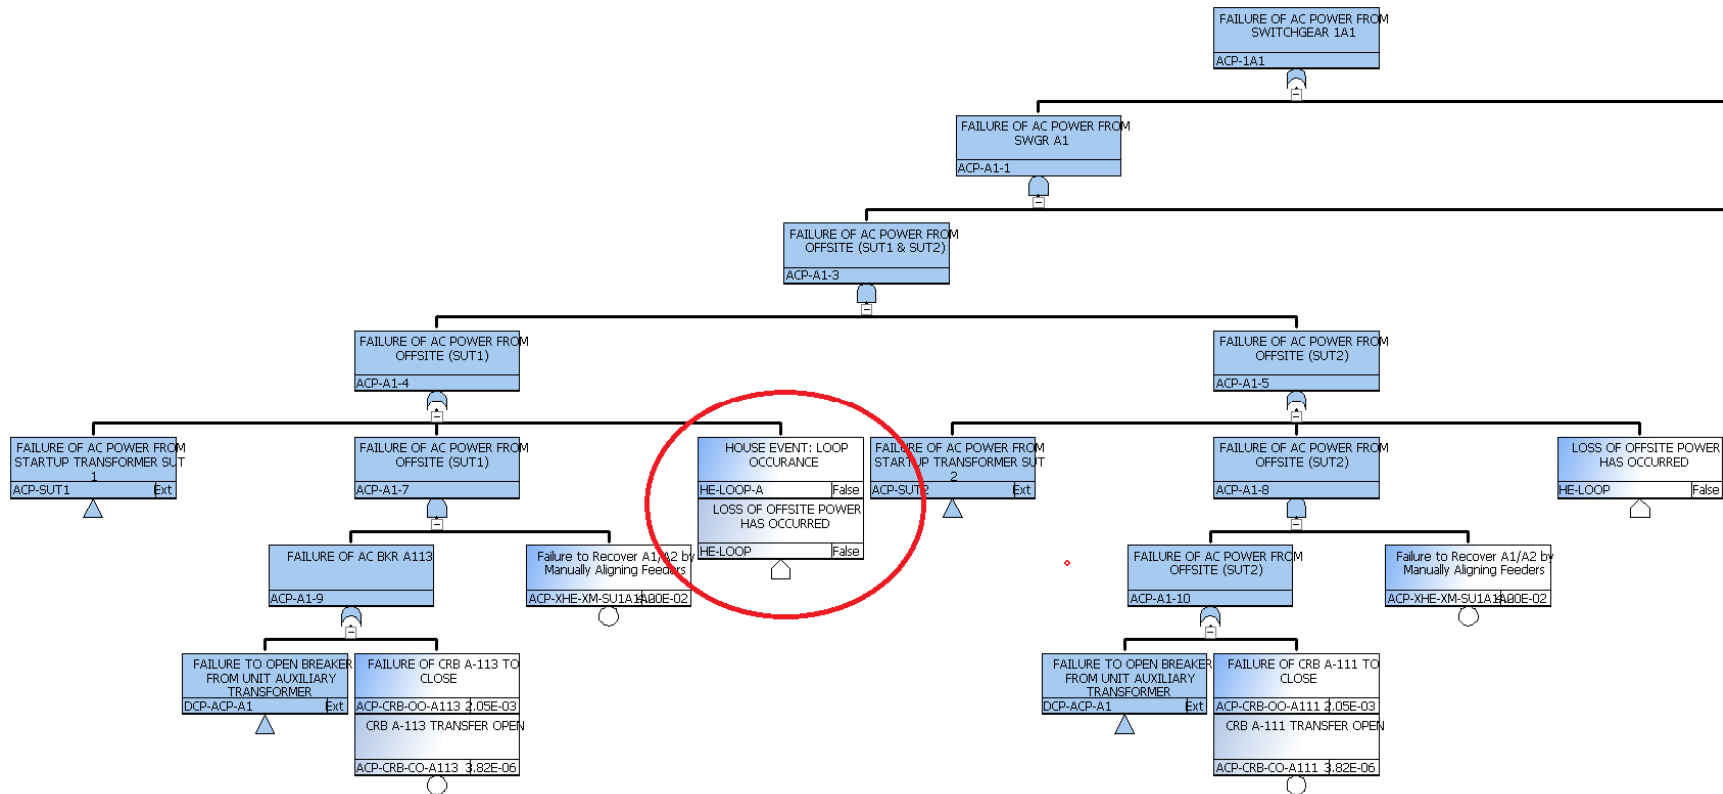
Figure B-1. Modified ACP-1A1 Fault Tree

- In the fault tree ACP-1A1 (*failure of AC power from the switchgear 1A1*), house event HE-LOOP-A (*house event: LOOP occurrence*) was inserted under the OR gate ACP-A1-4 (*failure of AC power from offsite (SUT 1)*). This modification is shown in [Figure B-1](#).

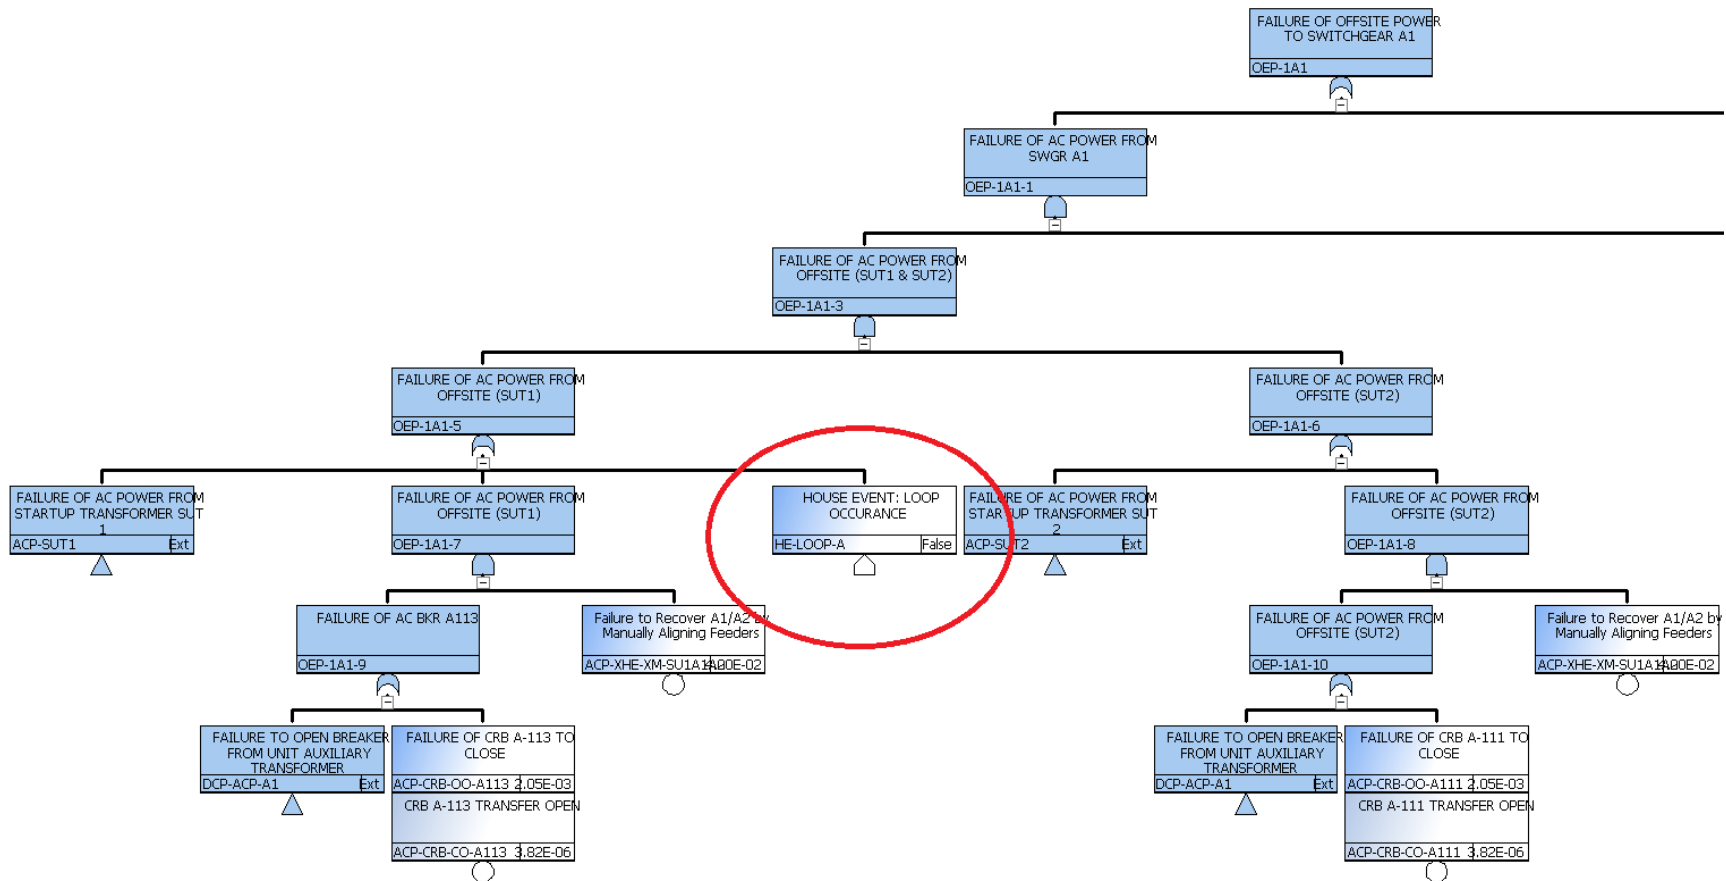
Figure B-2. Modified OEP-1A1 Fault Tree

- In the fault tree OEP-1A1 (*failure of offsite power to switchgear A1*), house event HE-LOOP-A was inserted under the OR gate OEP-1A1-5 (*failure of AC power from offsite (SUT 1)*). This modification is shown in [Figure B-2](#).

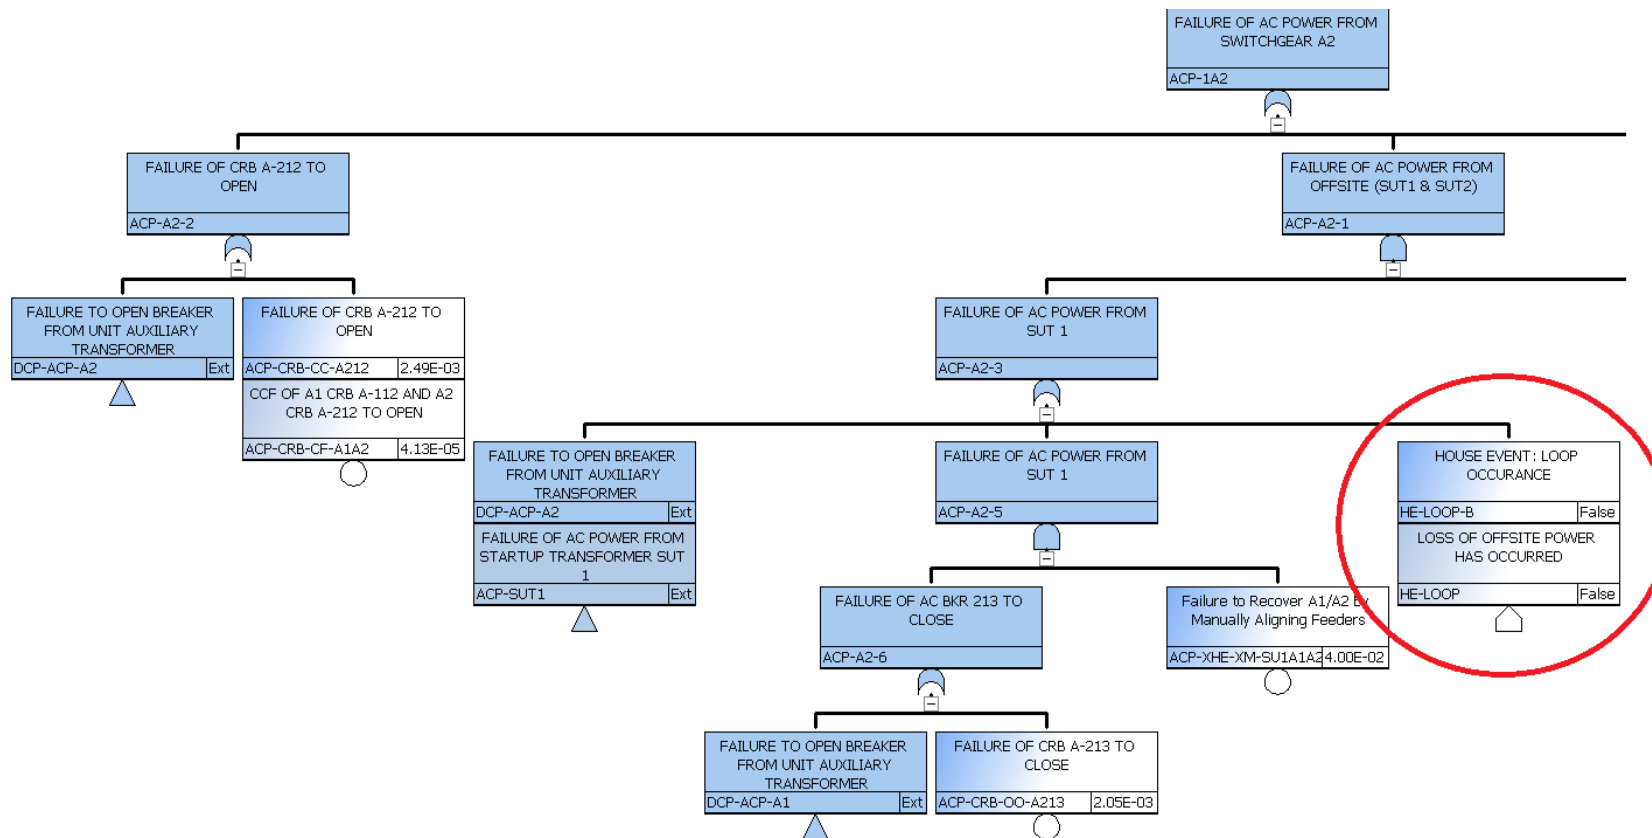
Figure B-3. Modified ACP-1A2 Fault Tree

- In the fault tree ACP-1A2 (*failure of AC power from switchgear A2*), house event HE-LOOP-B (*house event: LOOP occurrence*) was inserted under OR gate ACP-A2-3 (*failure of AC power from SUT 1*). This modification is shown in [Figure B-3](#).

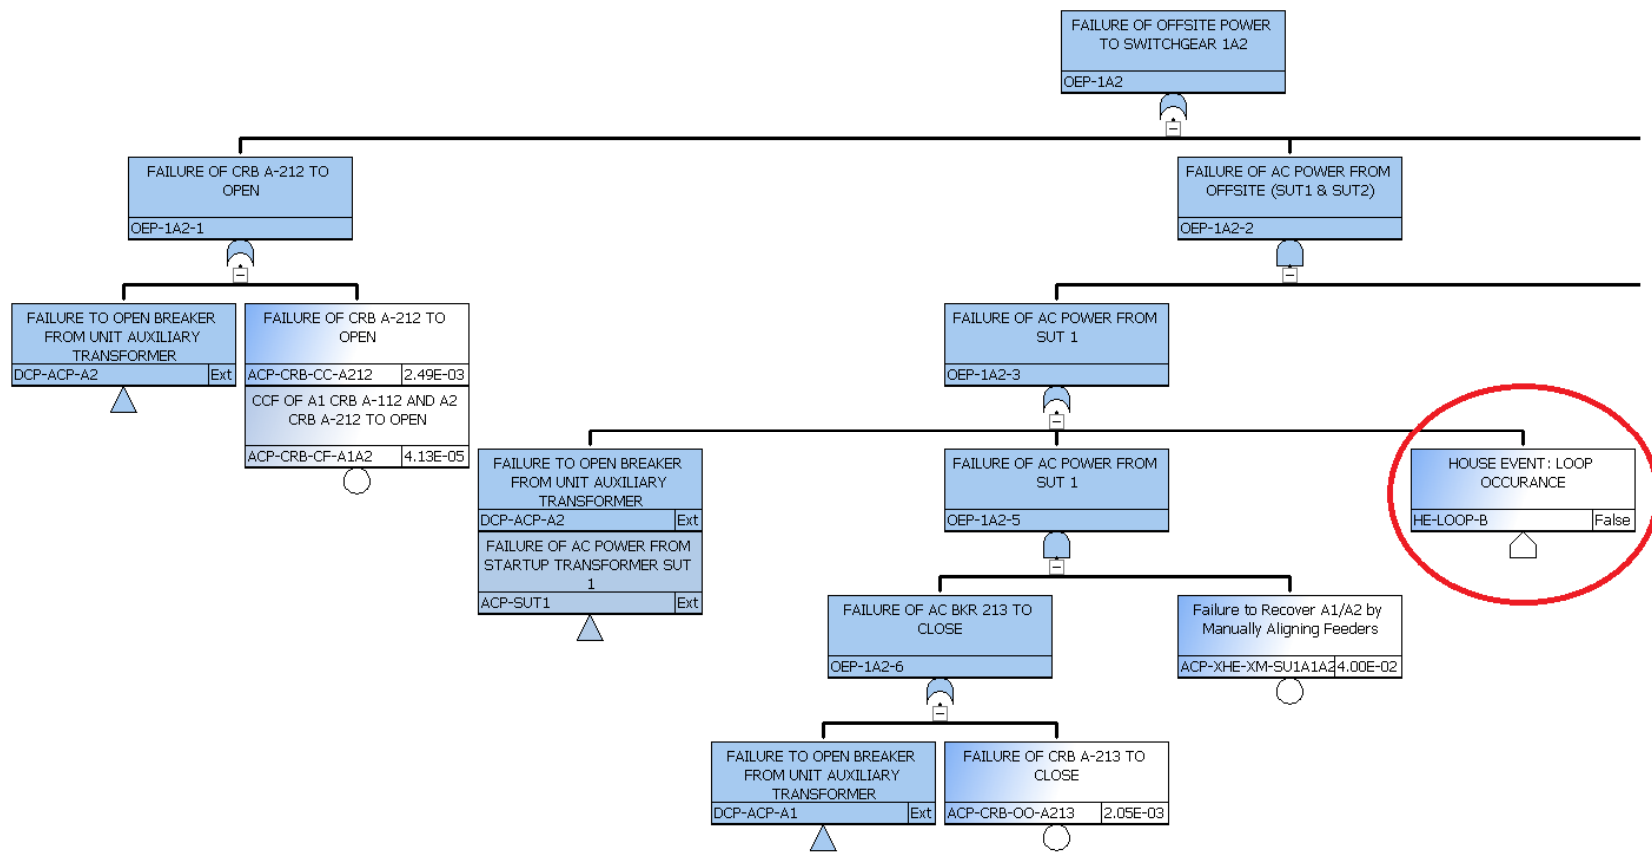
Figure B-4. Modified OEP-1A2 Fault Tree

- In the fault tree OEP-1A2 (*failure of offsite power to switchgear A2*), house event HE-LOOP-B was inserted under the OR gate OEP-1A2-3 (*failure of AC power from SUT 1*). This modification is shown in [Figure B-4](#).
