Final ASP Program Analysis – Precursor

Accident Sequence Precursor Program – Office of Nuclear Regulatory Research			
Arkansas Nuclear One – Unit 1		Automatic Start of an Emergency Diesel Generator Following a Partial Loss of Offsite Power due to Severe Weather	
Event Date: 04/26/2017		LER: 313-2017-001 IR: 05000313/2017002	CCDP= 1×10^{-5}
Plant Type: Pressurized Water Reactor (PWR); Babcock & Wilcox Two-Loop with a Large, Dry Containment			
Plant Operating Mode (Reactor Power Level): Mode 1 (100% reactor power)			
Analyst: Ian Gifford	Reviewer: Christopher Hunter	Contributors: N/A	Approval Date: 12/06/2017

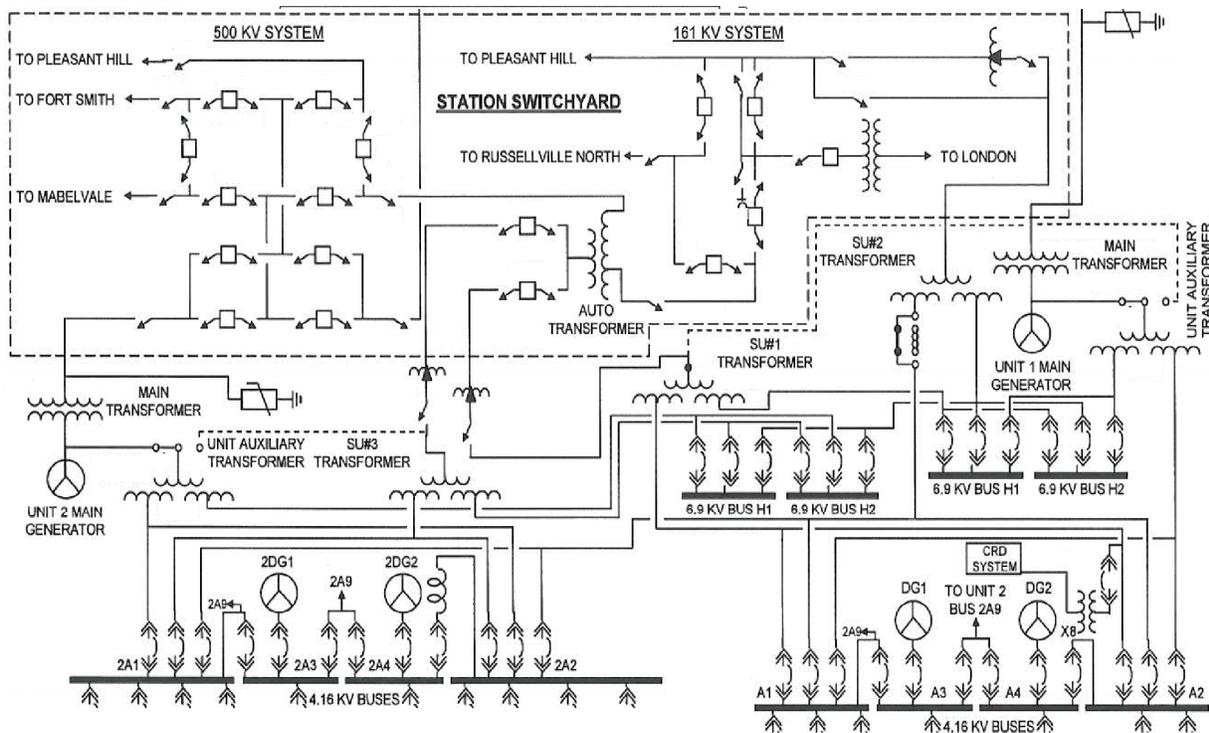
Figure 1. ANO-1 Simplified Electrical Diagram.

Additional Plant Information. During normal operation of ANO-1, station equipment is supplied from the main generator through the UAT. During startup and shutdown conditions, station equipment is supplied from the offsite utility grid through SUT 1 (preferred) or SUT 2 (non-preferred). Following a turbine generator trip, station loads are designed to automatically fast transfer to SUT 1 or SUT 2 without a loss of power to the plant loads. The UAT and SUT 1 are capable of providing power to all four Unit 1, 4.16 kV buses (A1, A2, A3, and A4). Because SUT 2 is shared between both units, it is only aligned to automatically power buses A1 and A3. If all normal and offsite power sources are lost, engineered safety feature (ESF) buses A3 and A4 are powered by their respective EDGs. As a final protection in the event of a station blackout, power to the ESF buses can be provided by the alternate AC diesel generator. A simplified electrical diagram is shown in Figure 1.

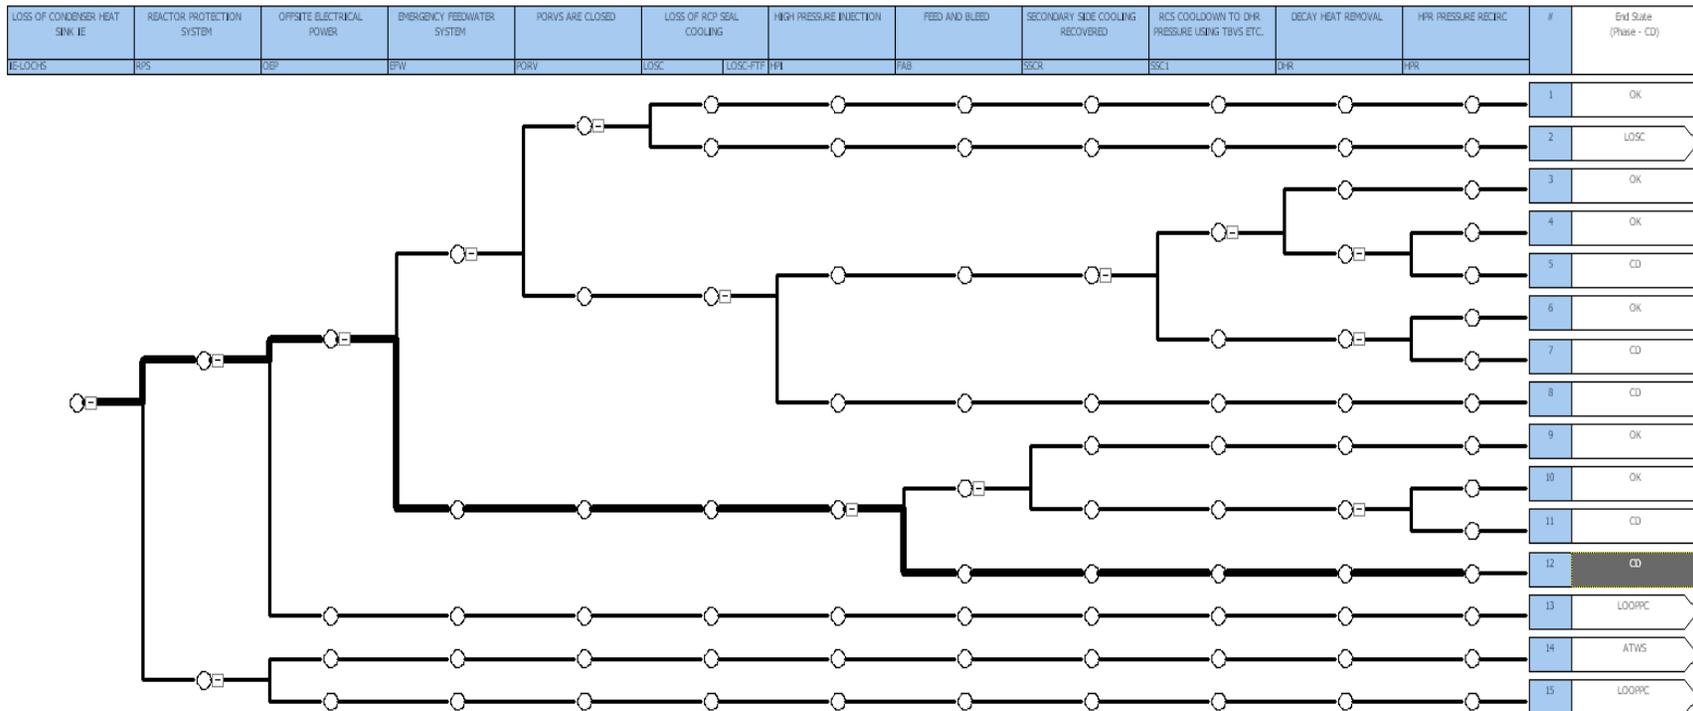
Figure A-1. Arkansas Nuclear One Loss of Condenser Heat Sink Event Tree

Dominant Sequence. The dominant accident sequence is loss of condenser heat sink sequence 12 (CCDP = 9.4×10^{-6}) that contributes approximately 94 percent of the total internal events CCDP. [Figure A-1](#) in Appendix A illustrates this sequence. The sequences that contribute to at least 1 percent of the total internal events CCDP are provided in the following table:

Sequence	CCDP	% Contribution	Description
LOCHS 12	9.42×10^{-6}	94.1%	Successful reactor trip; offsite power is available; EFW fails; and feed and bleed fails
LOCHS 13-15	1.86×10^{-7}	1.9%	Successful reactor trip; consequential loss of offsite power occurs; emergency power succeeds; EFW fails; and feed and bleed fails
LOCHS 13-16-28-4	1.53×10^{-7}	1.5%	Successful reactor trip; consequential loss of offsite power occurs; emergency power fails; EFW fails; offsite power is recovered within 1 hour; and EFW fails
LOCHS 11	1.21×10^{-7}	1.2%	Successful reactor trip; offsite power is available; EFW fails; feed and bleed succeeds; secondary-side cooling is not recovered; and high-pressure recirculation fails

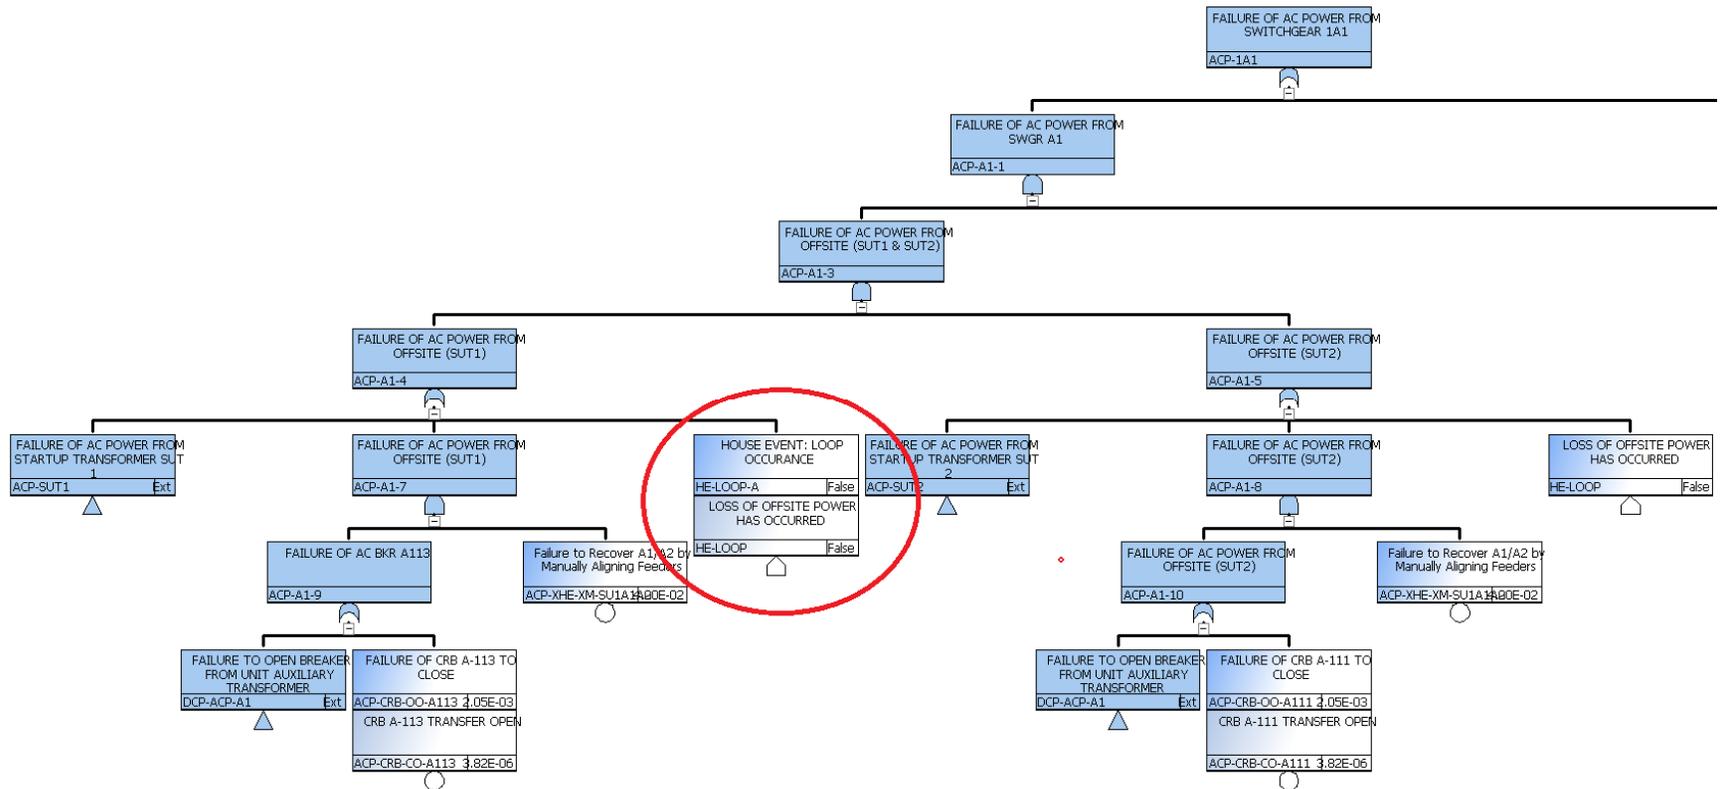
Figure B-1. Modified ACP-1A1 Fault Tree

- In the fault tree ACP-1A1 (*failure of AC power from the switchgear 1A1*), house event HE-LOOP-A (*house event: LOOP occurrence*) was inserted under the OR gate ACP-A1-4 (*failure of AC power from offsite (SUT 1)*). This modification is shown in [Figure B-1](#).

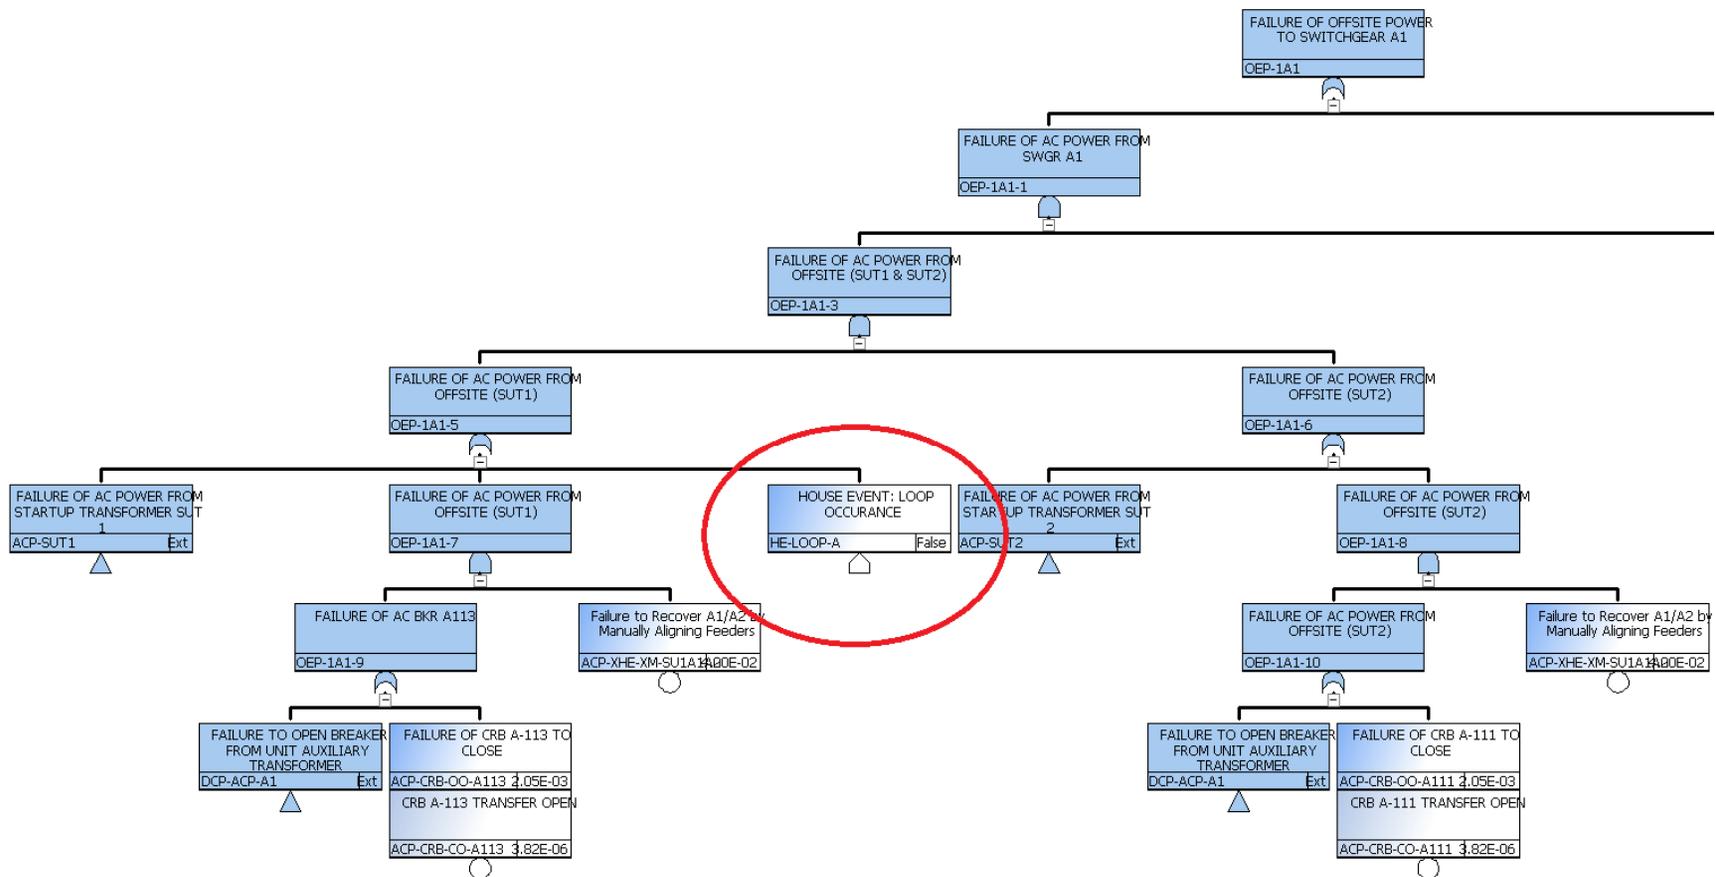
Figure B-2. Modified OEP-1A1 Fault Tree

- In the fault tree OEP-1A1 (*failure of offsite power to switchgear A1*), house event HE-LOOP-A was inserted under the OR gate OEP-1A1-5 (*failure of AC power from offsite (SUT 1)*). This modification is shown in [Figure B-2](#).

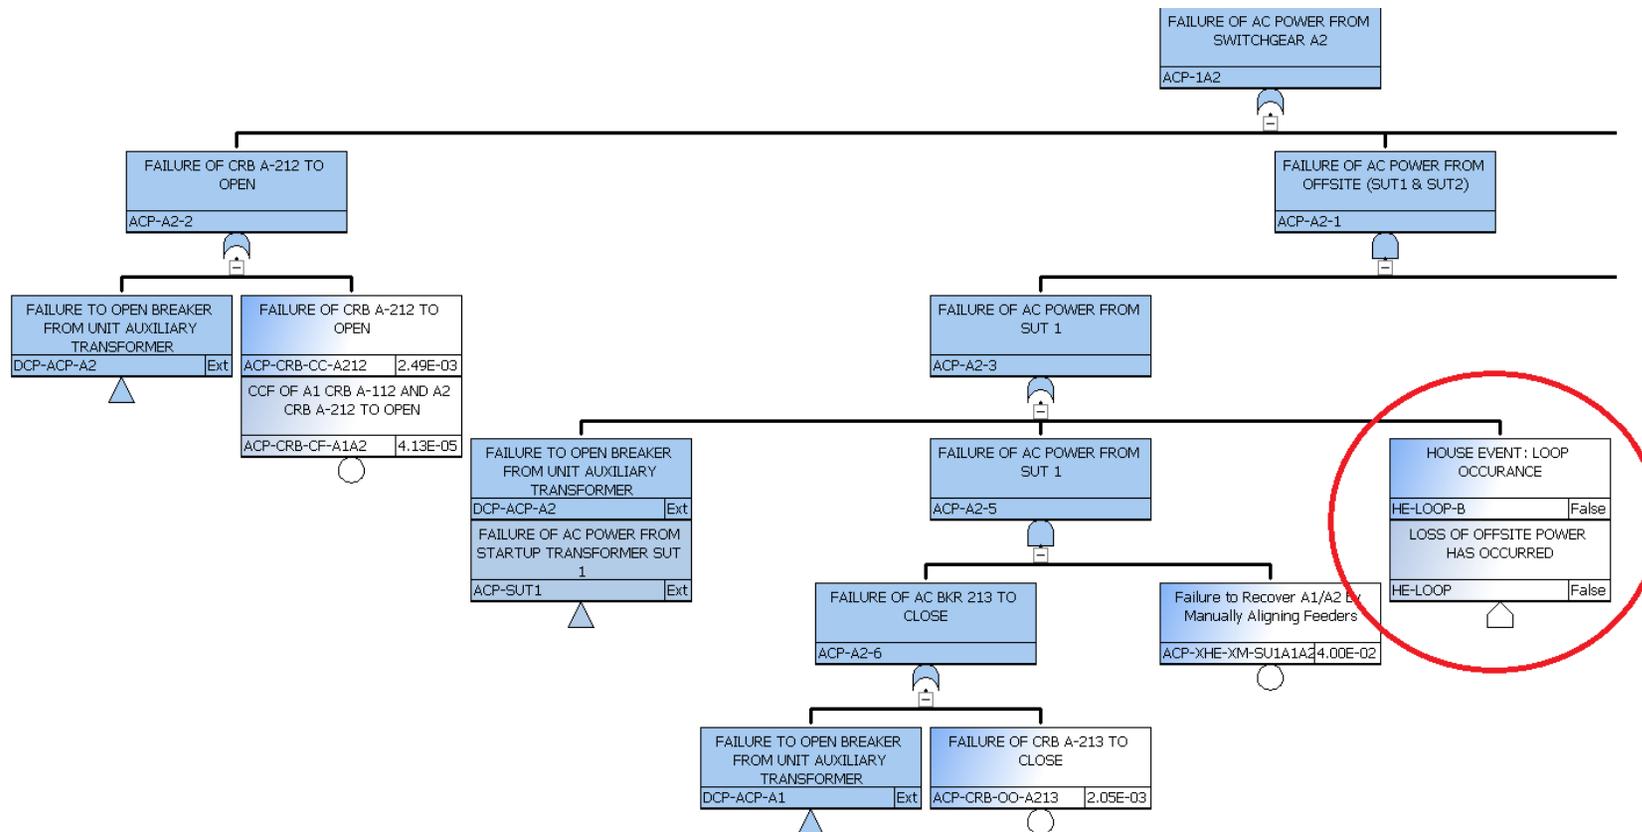
Figure B-3. Modified ACP-1A2 Fault Tree

- In the fault tree ACP-1A2 (*failure of AC power from switchgear A2*), house event HE-LOOP-B (*house event: LOOP occurrence*) was inserted under OR gate ACP-A2-3 (*failure of AC power from SUT 1*). This modification is shown in [Figure B-3](#).

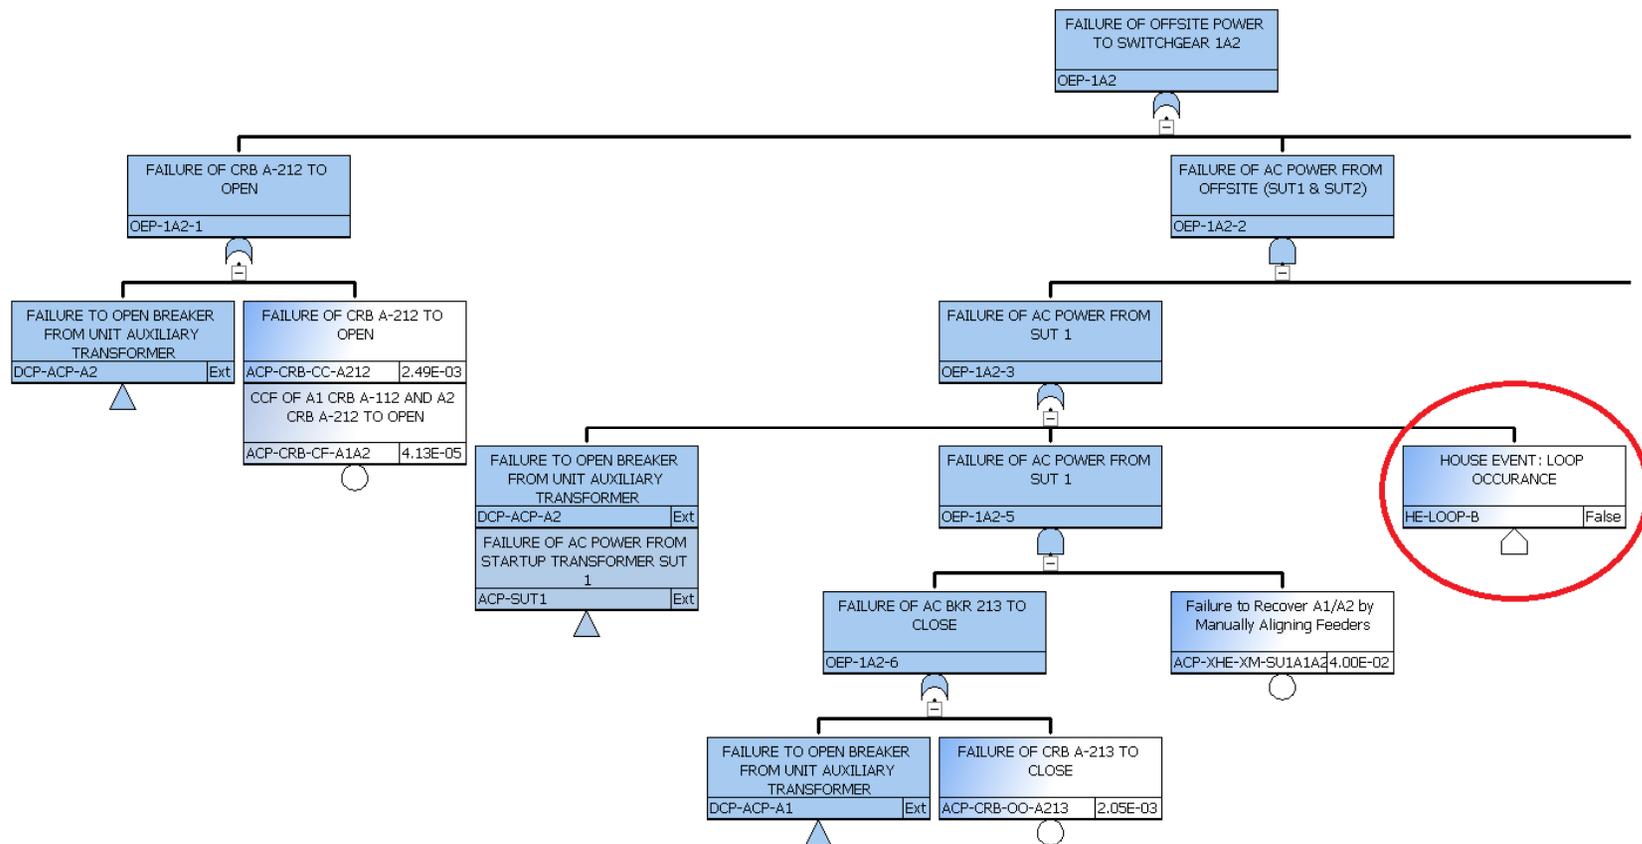
Figure B-4. Modified OEP-1A2 Fault Tree

- In the fault tree OEP-1A2 (*failure of offsite power to switchgear A2*), house event HE-LOOP-B was inserted under the OR gate OEP-1A2-3 (*failure of AC power from SUT 1*). This modification is shown in [Figure B-4](#).
