SUBJECT: Revised application for amend to License DPR-74, providing  
 addl info on frequency for torque testing ice condenser  
 inlet doors & capability to isolate containment svc air.Rept  
 on test dates & drawing of isolation valves encl.

Donald C. Cook Nuclear Plant Unit 2  
Docket No. 50-316  
License No. DPR-74  
AMENDMENT TO TECHNICAL SPECIFICATION CHANGE REQUEST

STP.207 I/C Lower Inlet Door Test Dates and the Dates Condition Reports Were Written

Condition Reports, Dates, Causes, and Corrective Action

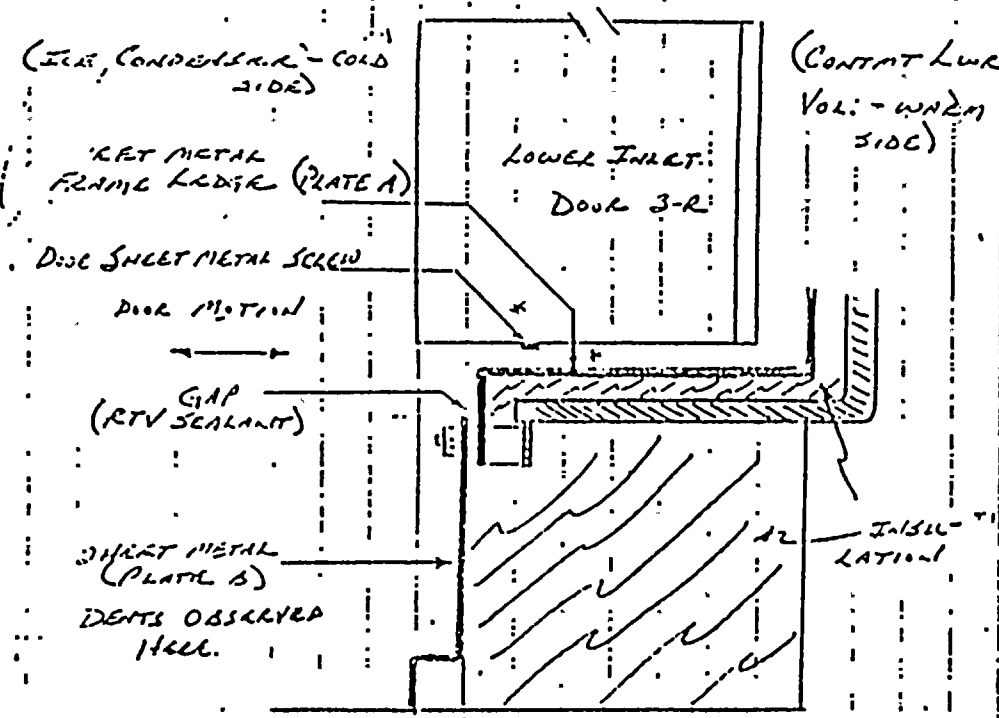
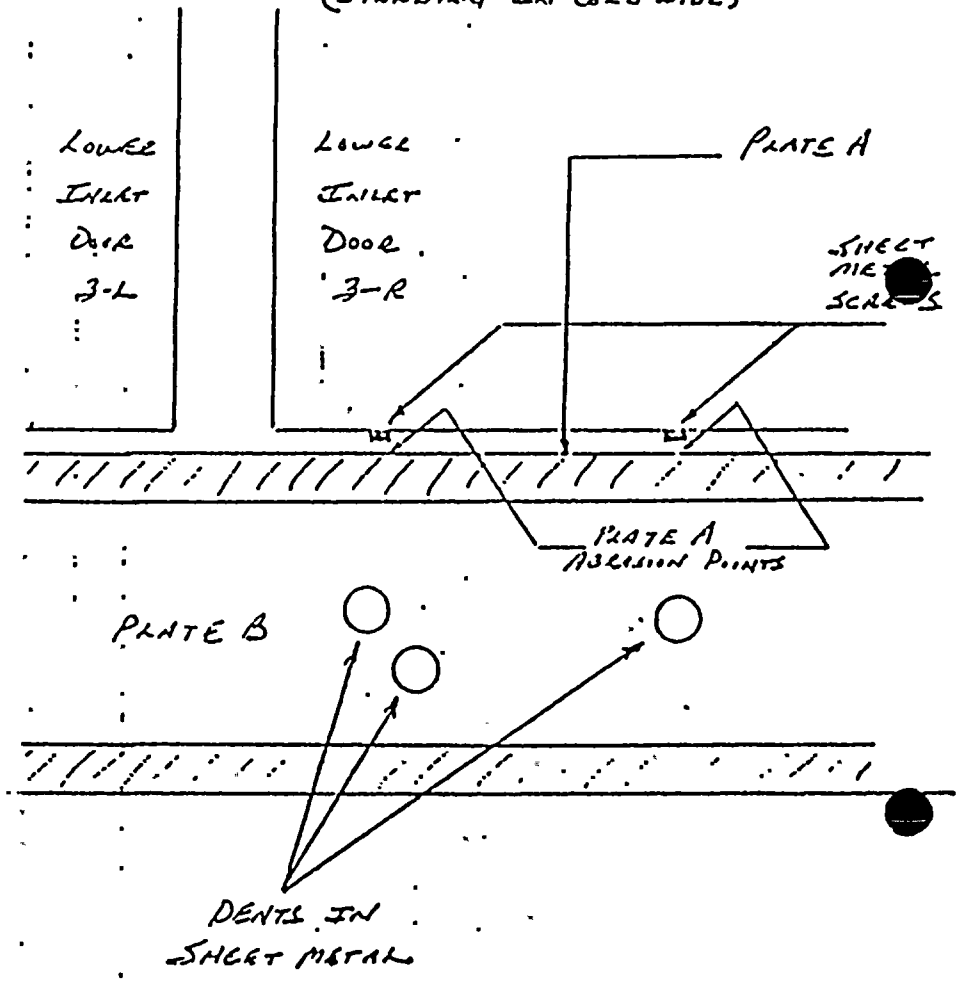
UNIT #1. LOWER ICE CONDENSER  
 Door 3-R 4/10/79  
 KAT.

The torque required to open lower inlet door 3-R beyond 6 inches of travel was measured to be 902 in.- lbs. The applicable Technical Specification limit is 675 in.- lbs. Upon inspecting the door, it was found that sheet metal screws along the bottom of the door were rubbing against the surface of the bottom edge of the door frame.

- 1) abrasion marks appeared on the door frame bottom ledge where two of the door's sheet metal screws were making contact as the door was opened,
- 2) large dents in plate B were observed directly below the abrasion points thereby suggesting that a mechanical force, imparted on plate B, may have resulted in forcing plate A upwards and also increasing the size of the gap between plates A & B,
- 3) the RTV sealant, previously installed in the gap between plates A & B, was found missing thereby allowing the possibility of condensation to run from atop plate A down into the insulation to freeze and push plate A upwards and
- 4) mineral residue, indicating condensation flow across plate A (from warm side to cold side) and down toward the gap between plates A & B, was observed.

Based on the observations made during these inspections, it is apparent that door 3-R plate A was forced upwards (and in contact with the door's sheet metal screws) as a result of a combination of mechanical impact transmitted from plate B and insulation expansion as a result of freezing condensation. During the insulation, it became obvious that not only did the blows to plate B force plate A upwards but also resulted in widening the gap between plates A & B which resulted in a high probability of increasing condensation flow into the insulation.

\* CONTACT BETWEEN THESE TWO POINTS INDICATED BY ABRASION MARKS ON FRAME LEDGE (PLATE A)

Depressed lower inlet door 3-R frame bottom edge surface to allow door to be opened beyond 6 inches utilizing an opening torque of 328 in lbs.

Upon completing the inspections described in the attached investigation report, Dayco Sheet Metal Inc. replaced all of the frozen insulation along the bay 3 door frame bottom ledge and plates A & B were reinstalled in both bay 3 and bay 14. In addition, RTV sealant was installed along the entire length of the gap between plates A & B in both bays. The RTV sealant is considered a permanent fix in prohibiting condensation flow down through the gap and into the insulation.

To completely eliminate the possibility of this problem in the future, a RFC has been written to replace the horizontal plate A with a plate that would slope down in the direction as shown in Attachment #2. The sloping feature of the this plate would provide a significantly greater clearance between the plate and the door's sheet metal screws. The greater clearance will allow plate B to absorb impact without causing plate A to interfere with the door's opening travel. It is planned to install the RFC in each unit during each unit's upcoming refueling outage. (This has been completed)

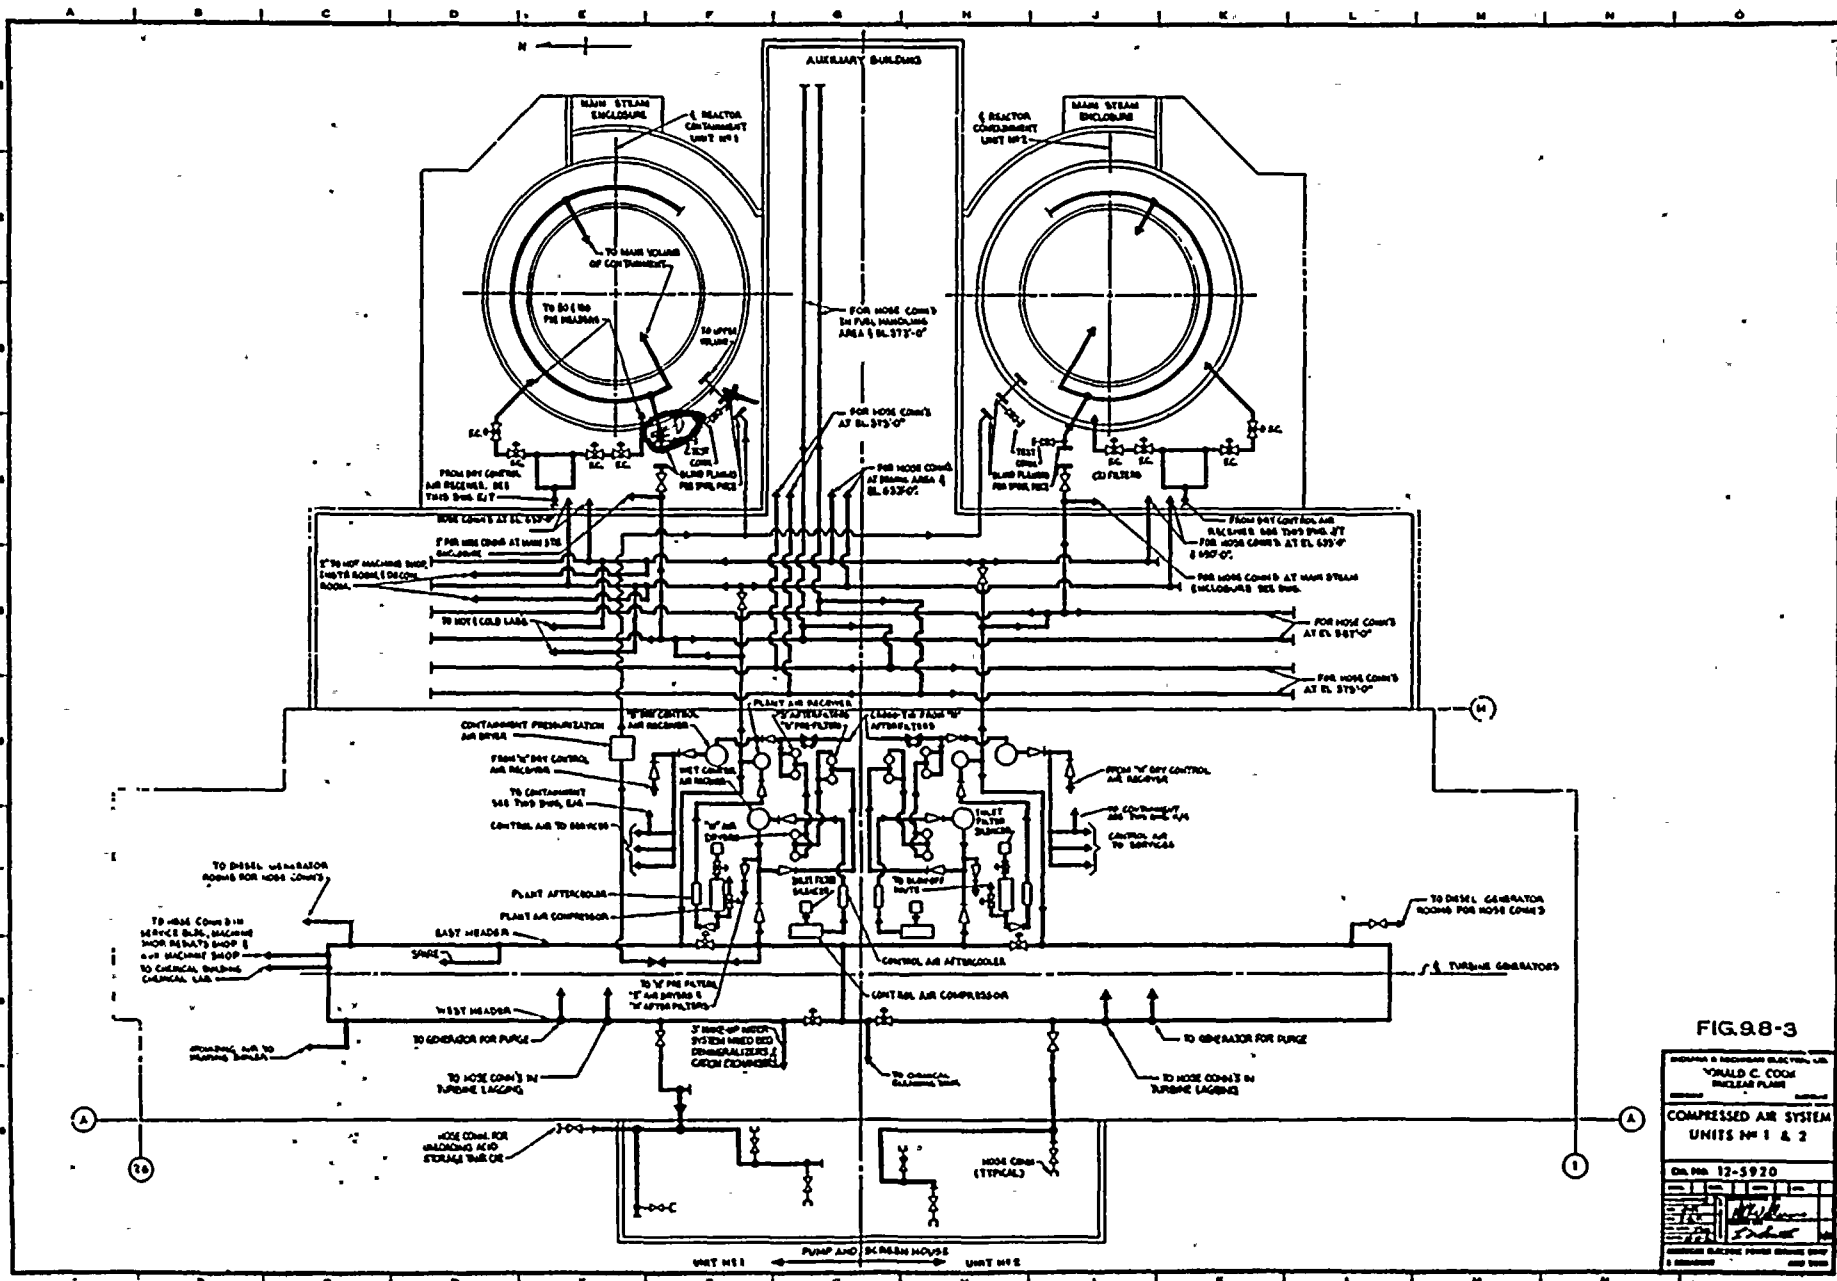
DRG. NO. 12-5920

The fourth change involved the capability to isolate containment service air in Modes 1, 2, 3, and 4. Specifically, we requested Table 3.6-1 be changed to add valve PCR-40 to list A and valve PA-342 to list E and to delete valve PA-243 and a blind flange (Item 47) from list E. Attachment 2 to this letter contains a figure and drawing which show the location of the above valves. Figure 9.8.3 from the updated FSAR shows the physical location of the valves. Drawing 1-2-PO-01 shows the isometric location of the valve PCR-40, which would replace a manually operated valve at that location. Upon the initiation of the containment isolation signal, this valve is to close automatically, thus providing containment isolation.
