ACCESSION NBR: 8710270344 DOC. DATE: 87/10/19 NOTARIZED: NO DOCKET #
 FACIL: 50-315 Donald C. Cook Nuclear Power Plant, Unit 1, Indiana & 05000315
 AUTH. NAME AUTHOR AFFILIATION
 SAMPSON, J. R. Indiana Michigan Power Co.
 SMITH, W. G. Indiana Michigan Power Co.
 RECIP. NAME RECIPIENT AFFILIATION

SUBJECT: LER 87-020-00: on 870917, determined that in event of fault of balance-of-plant cables, loss of control power on both independent trians of related panels could occur. Caused by deficient design. Design changes implemented. W/871019 ltr.

TITLE (4) Lack of Isolation Between Balance of Plant and Essential Safety System Loads Due to Potential Design Deficiency

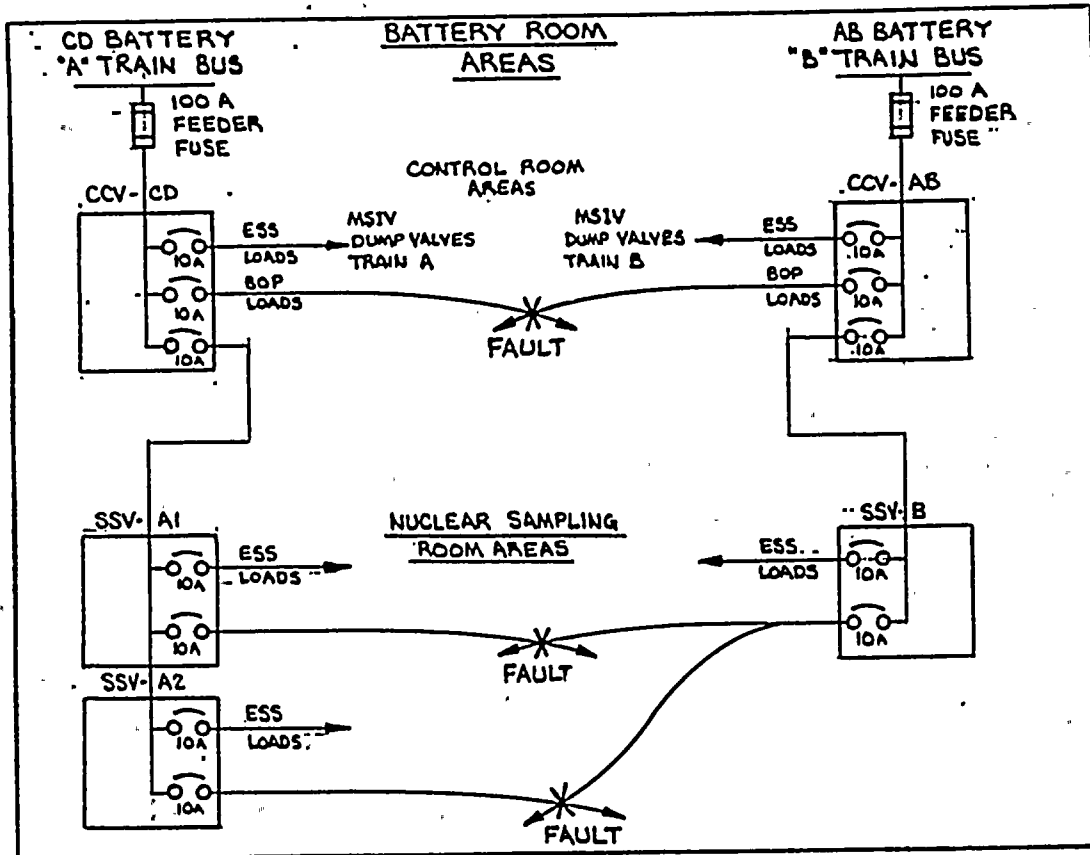
**ATTACHMENT NO. 1
DEMONSTRATION OF FAULT CONDITIONS**

On September 17, 1987, at approximately 1730 hours, during a review of an internal Safety System Functional Inspection on our auxiliary feedwater system (EIIS/BA), it was determined that in the event of a fault in certain Balance Of Plant (BOP) cables (EIIS/CBL), which would involve distribution panels from both independent trains (see Attachment 1), a loss of control power on both independent trains of related Essential Safety System (ESS) distribution panels could occur.

The following distribution panels (EIIS/BL) utilize electrical circuit breakers (EIIS/BKR) manufactured by the Heinemann Electric Company (Series 0441).

(Refer to Attachment 1)

The breakers are used for 250 VDC service. It was discovered that the interrupting capability of the Heinemann breakers, as used for D. C. Cook, is not specified by the manufacturer at 250 VDC. Furthermore, with the specified lower voltage (125 VDC) interrupting curves (trip current vs. time), a comparison of the breakers with their upstream fuses (Gould-Shawmut Trionic, or Bussman FRN) (EIIS/FU) indicates a lack of coordination for fault currents above approximately 1500 amps. Investigation concluded that this condition has existed since the initial startup of the units.

The cause of this event was a potential deficient design which could have caused insufficient breaker interrupting capability in conjunction with a lack of isolation betewwn BOP and ESS loads.
