SUBJECT: LER 88-004-00: on 880606, use of improperly aligned test
 recorder results in nuclear instrumentation channel error.
w/8 ltr.

FACILITY NAME (1) **D. C. COOK NUCLEAR PLANT - UNIT 1** DOCKET NUMBER (2) **0 5 0 0 0 3 1 5** PAGE (3) **1 OF 0 5**

TITLE (4) **USE OF IMPROPERLY ALIGNED TEST RECORDER RESULTS IN NUCLEAR INSTRUMENTATION CHANNEL BEING OUT OF SPECIFICATION**

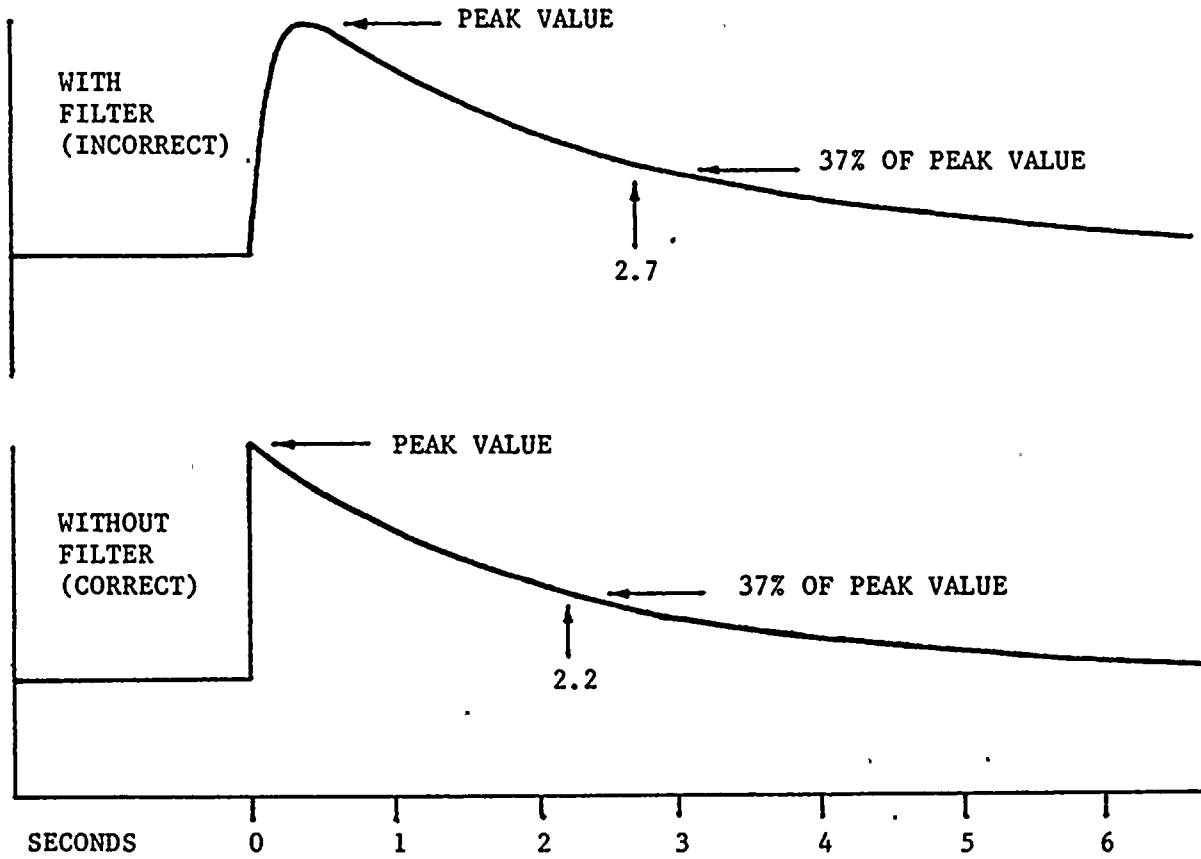
During the routine supervisory review of the test data, the supervisor observed that the shape of the recorder trace was different than expected (see attached graphs) and initiated an investigation. The test equipment used was a Western Graphtec, Model 3101 two channel strip chart recorder. The recorder is equipped with an input filter that can be switched in or out of service. The input filter is used to dampen rapid fluctuations or noise during certain applications. The investigation revealed that during the calibration of Power Range Channel N-41, the input filter was in the IN position, which is incorrect for this application. The input filter being in the circuit affected the recorder output graph which is used to determine the response of the instrument circuit.

The input filter switch is located inside the recorder and is an integral part of a module that is plugged into the recorder. Its position is not readily apparent. The input filter switch is normally kept in the OFF position. Lack of identification on the test recorder that the input filter was switched into the circuit as an off normal condition was the primary cause of the event.

EFFECT OF FILTER ON RECORDED OUTPUT
OF RATE MODULE TIME CONSTANT
ADJUSTED AT 2.2 SECONDS

The test equipment misconfiguration was corrected and the rate module time constant recalibrated on June 7, 1988.

To control the recorder filter switch position, a "Limited Use" tag will be affixed to the recorder during times that the filter is on.
